ТЕХНИЧЕСКОЕ СОСТОЯНИЕ ПЛАНИРУЕМОЙ ПОД РЕКОНСТРУКЦИЮ ЧАСТИ ЗДАНИЯ – СПОРТЗАЛА БЫВШЕЙ ШКОЛЫ ПО АДРЕСУ Спорди 2, Кохтла-Ярве

**TECHNICAL CONDITION OF THE PART OF THE
FORMER SCHOOLBUILDING - GYM, WHICH IS
PLANNED TO BE RECONSTRUCTED.**

Инженер: Айво Рауд (Zoroaster OÜ)
Engineer: Aivo Raud (Zoroaster OÜ)

Kohtla-Järve, 23.05.2012

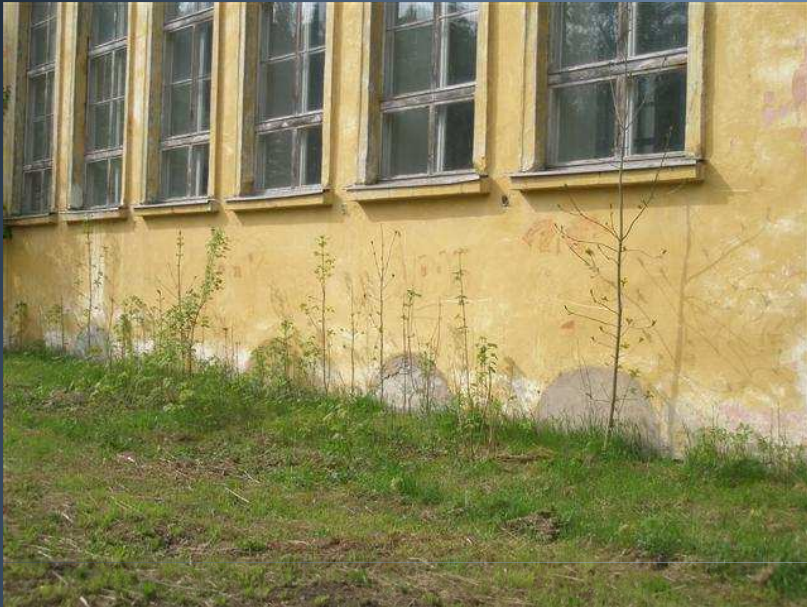
Vertical layout does not meet the requirements; ground level has gone up; blind area and drainage system are missing, which leads to water and moisture leaking through into the building's underground structures.

1. Ensure that water does not enter the underground structures by building a proper blind area around the building, resolving the vertical layout, and installing drainage system. Provide the foundation and basement walls with heat insulation up to ground level and install waterproofing. Provide removal of rain water from the roof.;

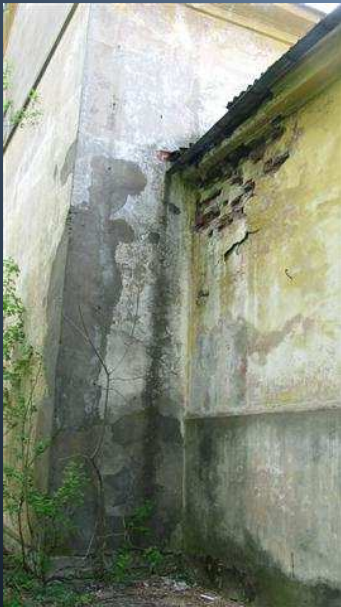
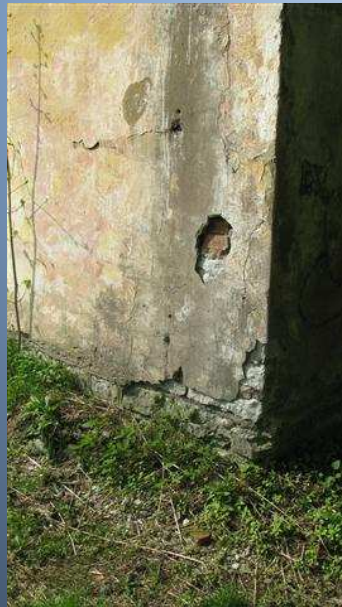
There are cracks in external walls; numerous signs of deterioration of paint and plaster layers; damaged decorative elements. However, there is no significant damage to the bearing structures.

2. Clean the damaged plasterwork off the facade, cover with new plaster and paint. Carry out the necessary research and paint layer probing in order to determine the original shade of plaster and composition of the existing plastering layer;

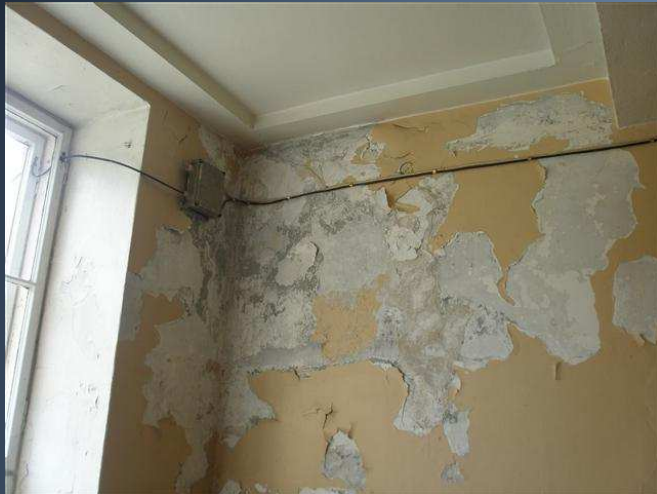
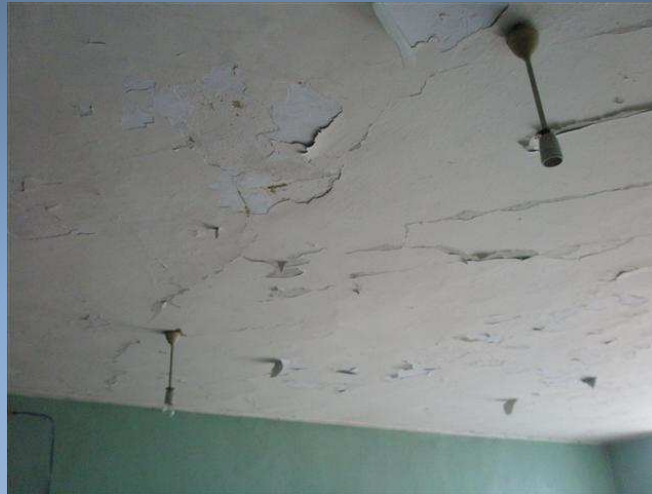
Finishing layer on the internal structures shows signs of damage.

5. Renovate internal walls following proper research to determine the original wall paint colour and designing a project of internal architecture;
6. Provide garret floor with heat insulation following removal of existing insulation, install new walkways;

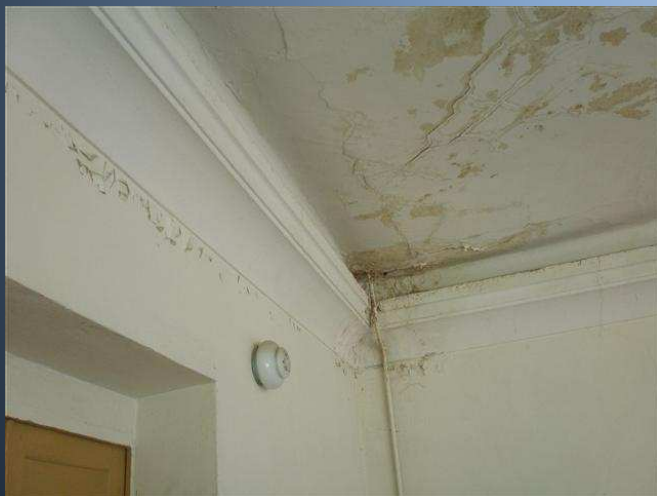
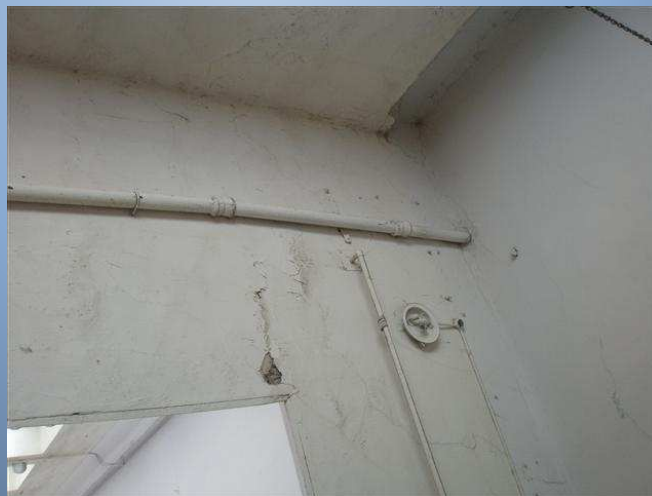
Signs of roof leakage and finishing layer damage can be observed in the gym.

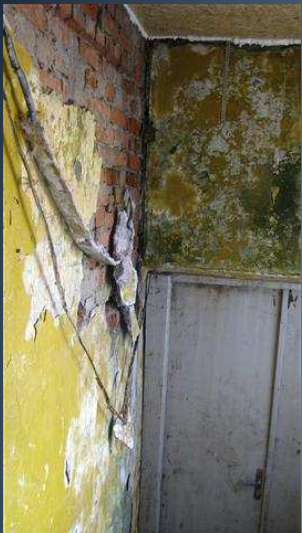
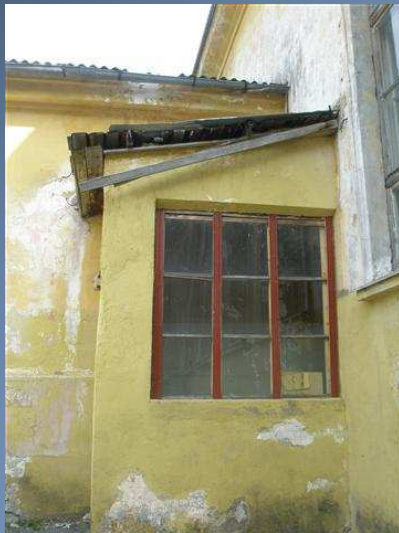
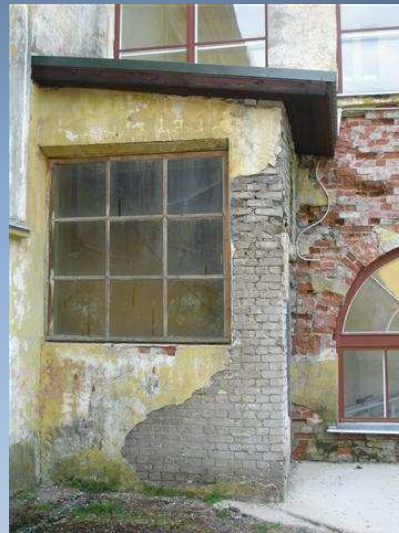
Annexes are in very poor condition.

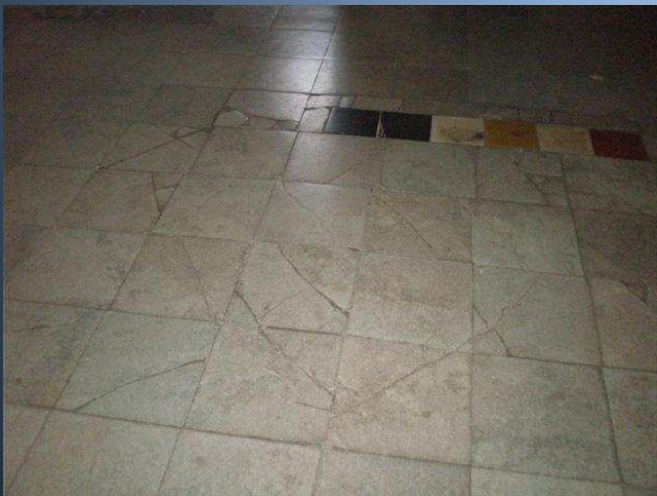
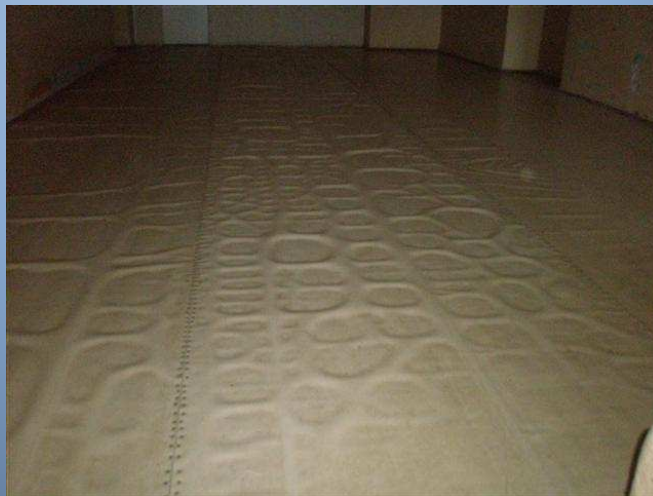
Flooring on all levels is deteriorating.

3. Renovate windows and internal doors, replace external doors. Restore blocked window openings in the basement;
4. Remove flooring off the stair landings and steps, examine the condition of floors. Restore the flooring in the gym. In the basement, replace wooden floor structures and renovate concrete ones;

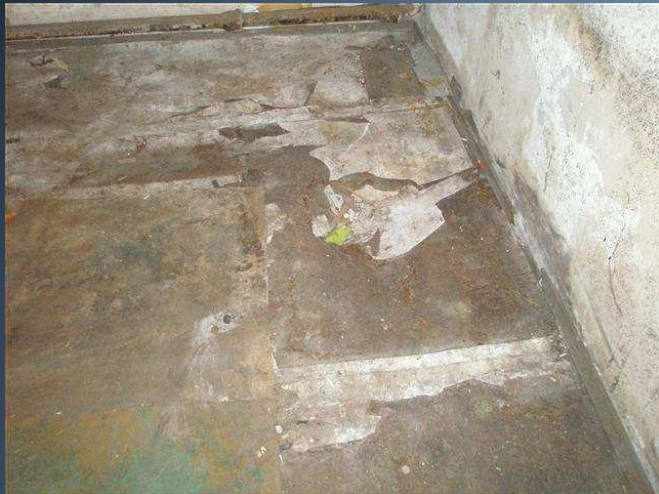
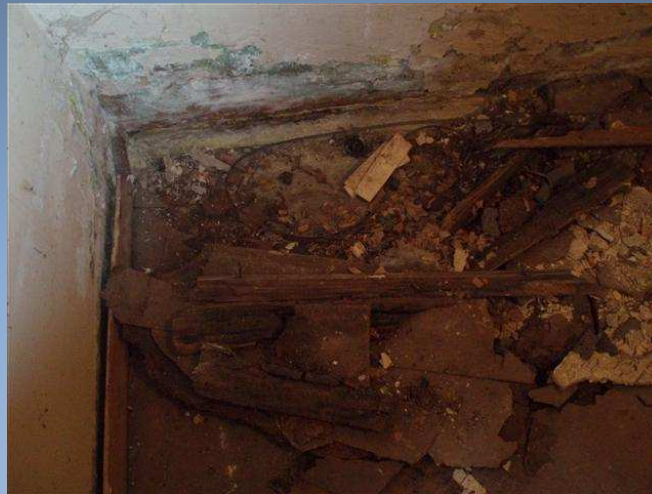
Basement floors are in disrepair; numerous signs of damage to wooden structures.

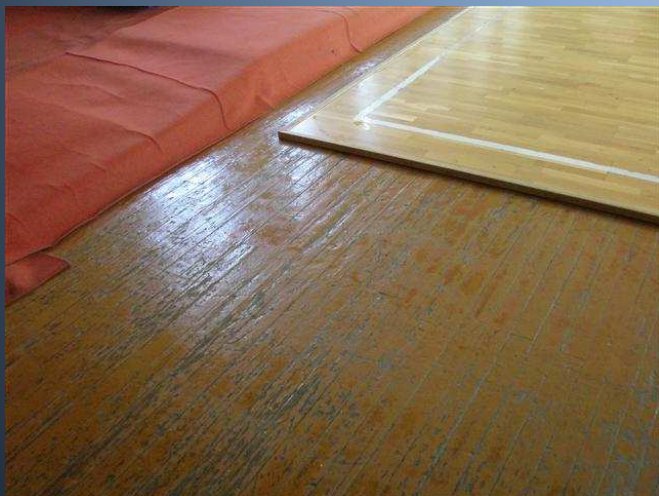
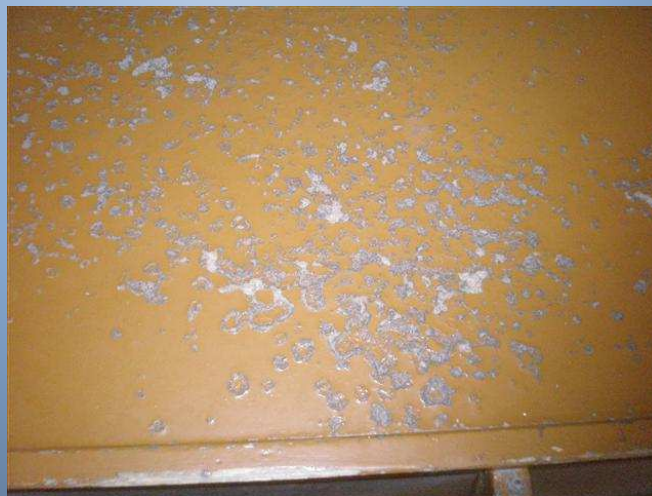
Floor covering and foundation in the gym are deteriorating.

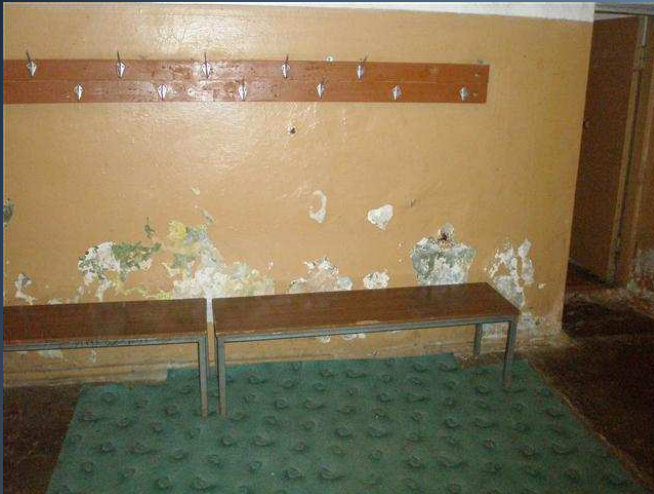
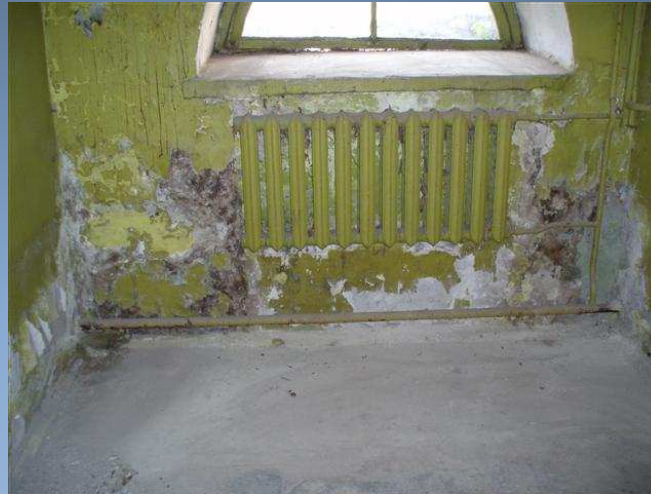
Basement walls are in very poor condition; there are numerous signs of leaks and damage to both finishing layer and wall structure proper. Mold is present in many locations.

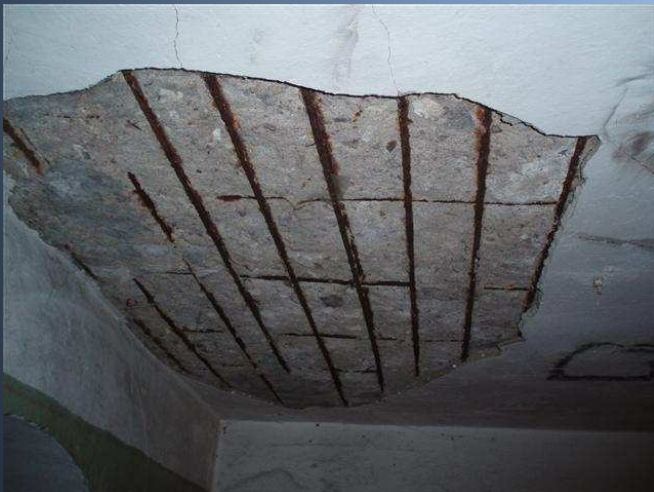
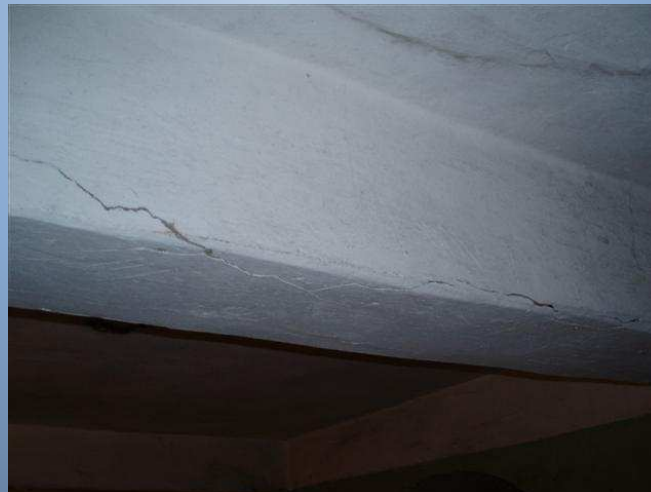
Ceiling in the basement rooms shows signs of deformation and structure damage.

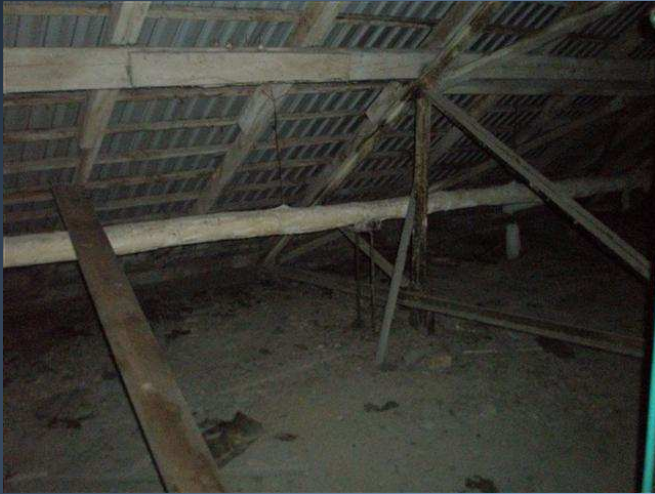
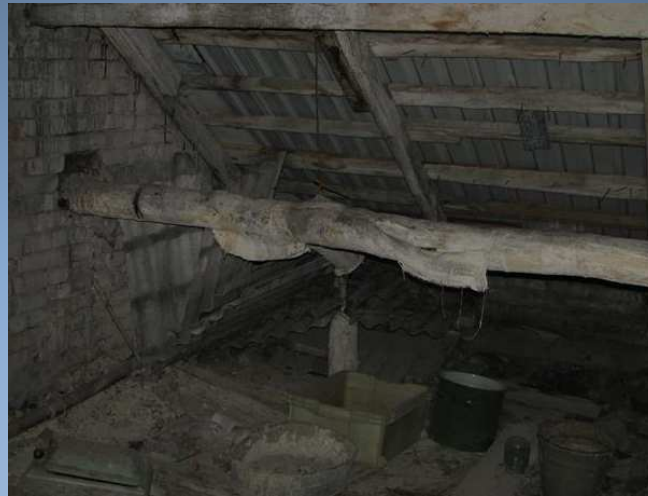
In general, the condition of bearing structures of the gym roof is satisfactory although in some locations there are signs of decay on the trussing and curb plates. There is no lighting or ventilation in the garret rooms.

7. Replace the heating assembly unit. The new unit should be triple-circuit. Install energy-saving pumps and provide hot water supply;
8. When designing the renovation project, include replacement of decaying parts of bearing structures. Replace roof covering with concrete, strengthen the structures as needed, restore dormers. Use historically suitable materials as covering;

9. Restore ventilation of garret space;
10. Provide the entire building with a ventilation system;
11. Clean and renovate the existing radiators in the gym, replace the tubing and radiators in the basement;

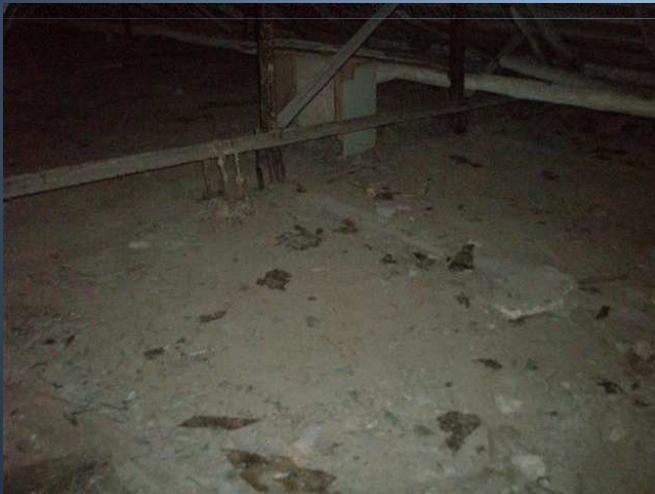
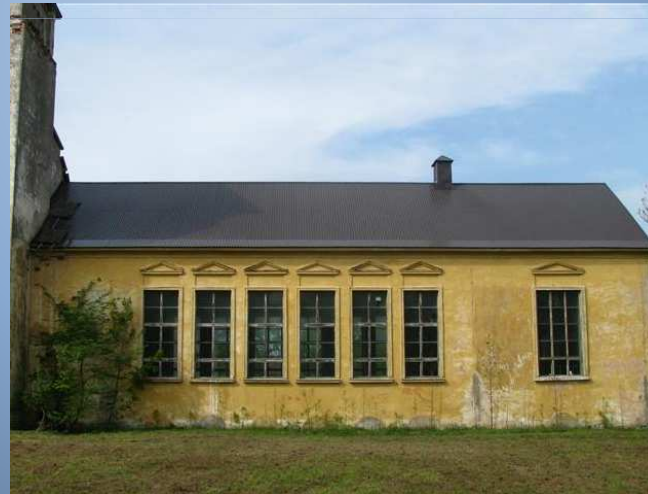
Insulation of the garret floor does not meet the quality standards.

Drainage system is missing.

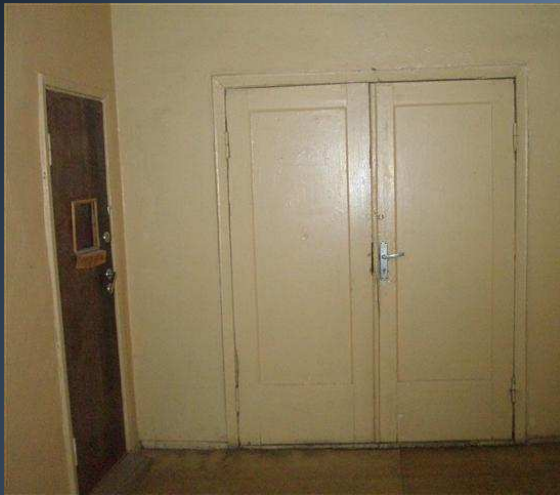
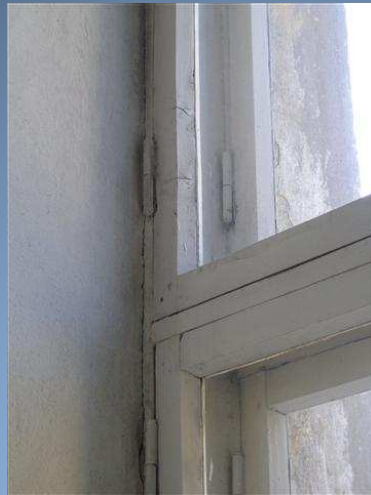
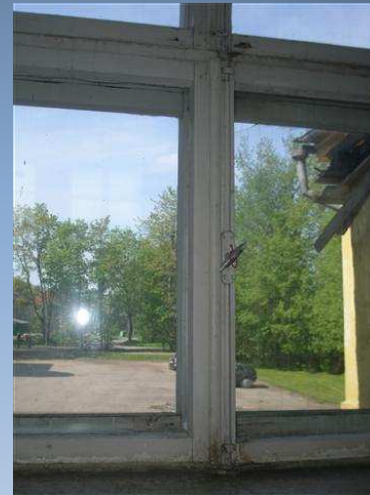
The condition of existing internal doors and windows is satisfactory. However, they do not meet the energy-saving standards and require renovation.

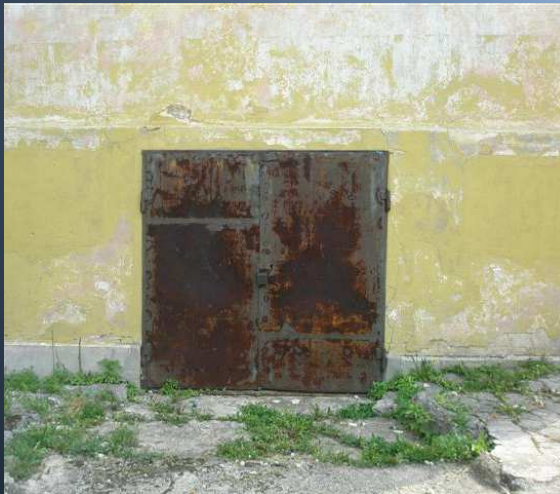
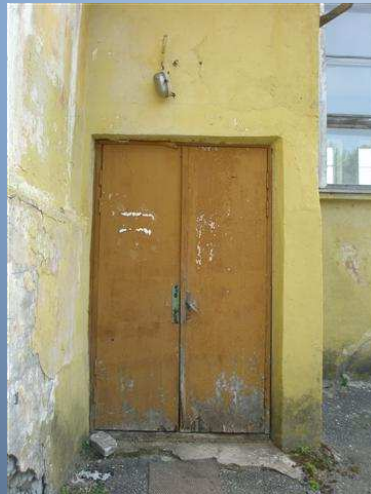
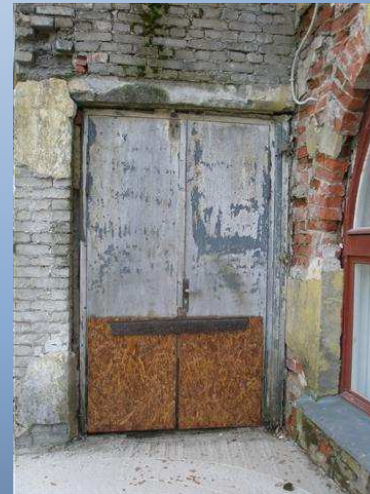
External doors need to be replaced.

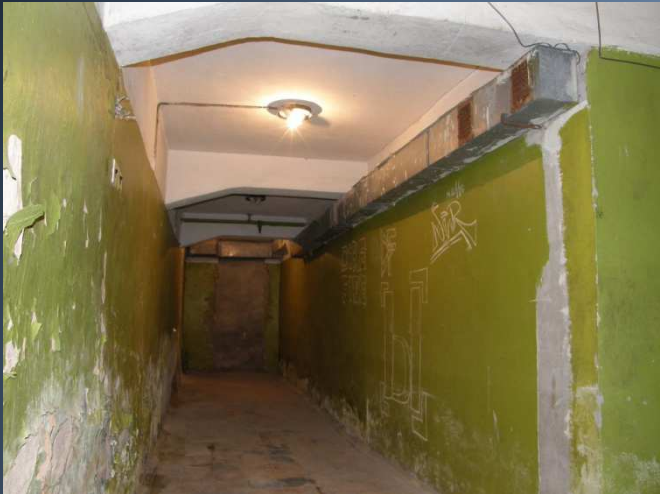
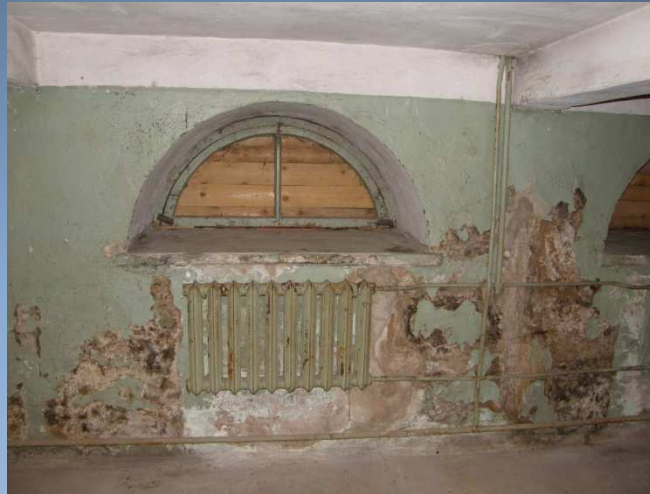
There is no ventilation system in the building.
Basement ventilation is not functioning.

The mainlines of the central heating system in the basement are oxidized.

Window openings in the basement are either blocked or shuttered with wood.

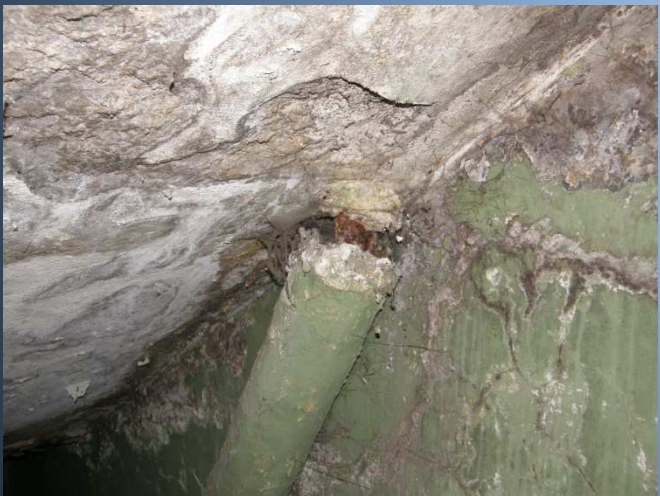
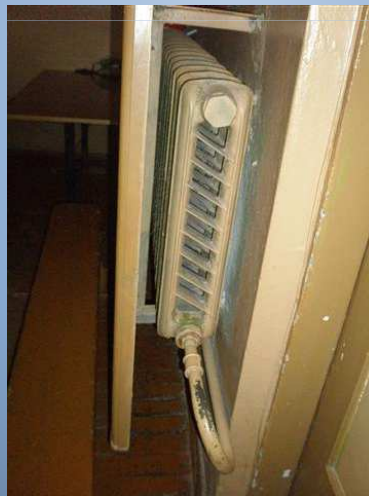
Central heating radiators in the gym are in working condition. However, they require cleaning. Tubing needs to be completely replaced.

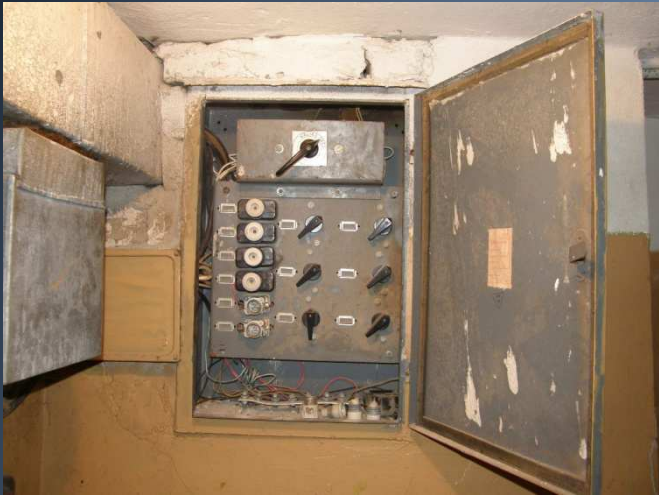
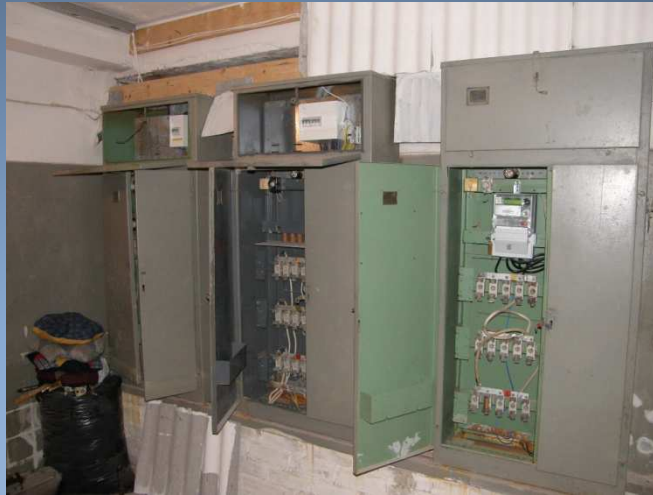
Electrical wiring and distribution units are not up to standards.

12. Completely replace the electricity supply system, install an automated system in the building.

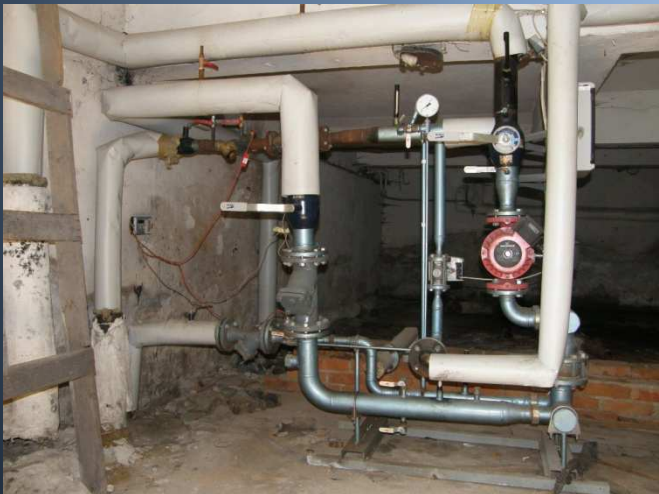
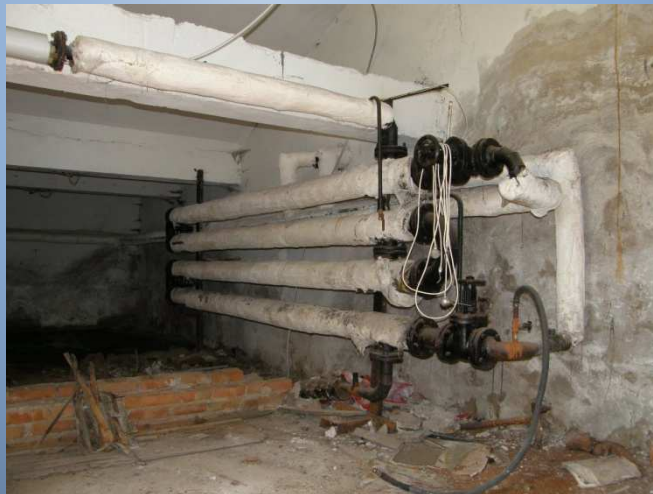
Central heating assembly unit has been renovated.
Boiler is not functioning.
