Co₂Bricks

Energy efficiency of historic brick buildings in Riga

Andra Blumberga
Gatis Zogla
Kristaps Zvaigznitis
Mikelis Dzikevics
Ize Palabinska

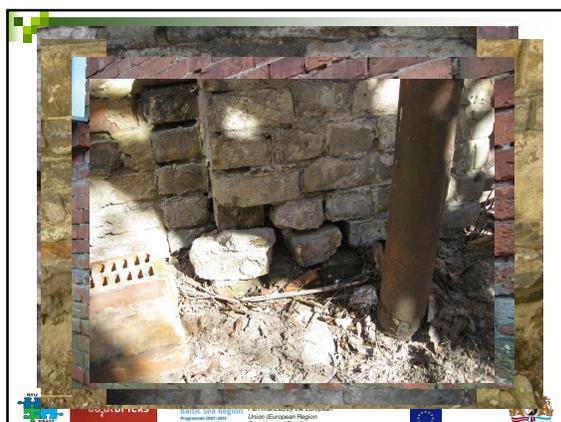
CONDITION APPRAISAL OF HISTORIC BRICK MASONRY

- ### Deterioration of historic brick masonry
- Roof and gutters damages
 - Freeze-thaw cycles
 - Soluble salts crystallization
 - Air pollution (CO₂, SO_x, NO_x, soots)
 - High groundwater
 - Poor mortar
 - Acid rains
- Part financed by the European Union (European Region Development Fund)

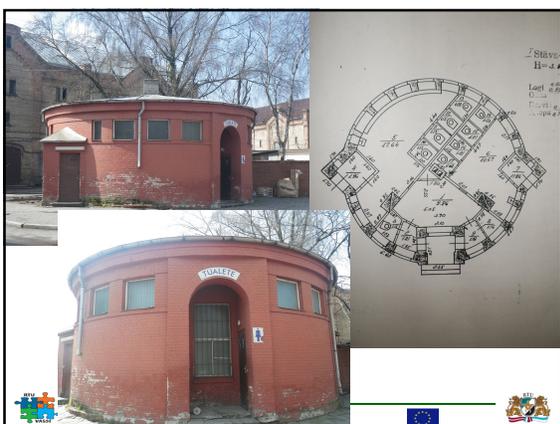
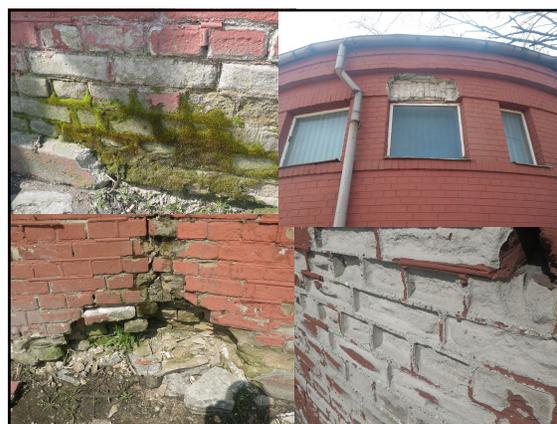
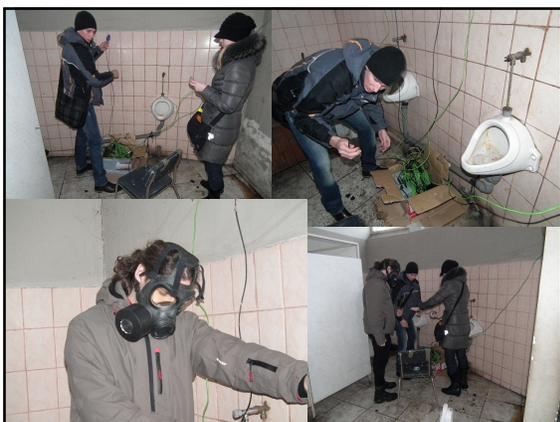
Existing situation

- Built in 1930
- Silicate bricks
- Listed on UNESCO World Heritage
- Annual heat energy consumption (calculated) ~670 kW/m²
- U value: 1.48 W/m²K
- Odour problems
- Brick deterioration
