Research principles and renovation demand of old brick apartment buildings in Estonia

Arumägi, E., Kalamees, T.,

Tallinn University of Technology, Estonia

National research project: "Technical condition and service life of Estonian brick apartment buildings" 2009-2010

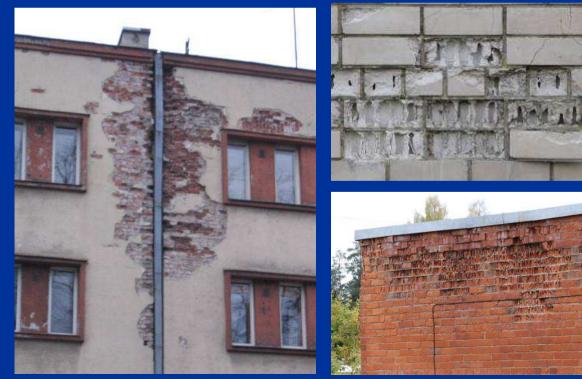
- survey of technical conditions of the constructions (walls, floors, roofs, balconies)
- frost resistance of the facades

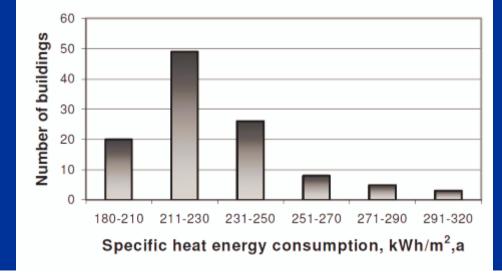
Investigation of building envelope;
Indoor climate, hygrothermal conditions
Conditions of HVAC systems
Measurement and simulation of energy use

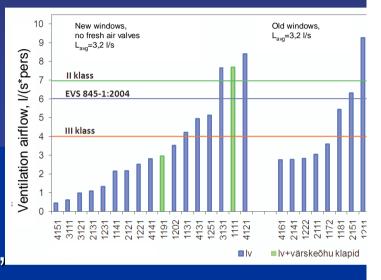
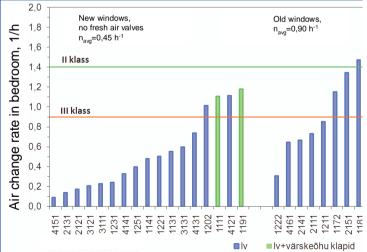
Typical problems of existing systems:

- natural ventilation (passive stack, window):
 - low air change,
 - low indoor air quality,
 - high moisture load,
- no heat recovery: large energy consumption,
- impossible to regulate air flows,
- air inflow from stack (wind),
- air tightness of old ventilation channels,
- the replacement of windows without renovation of ventilation:
 - smaller leakage rate,
 - more airtight building envelope.

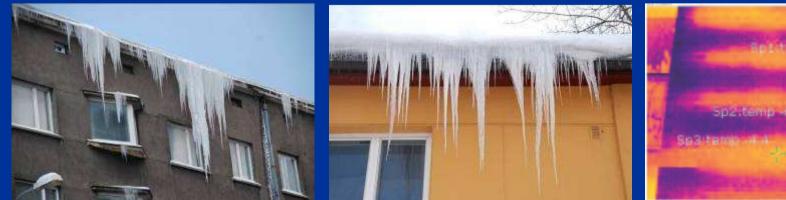
Existing problems:

high thermal transmittance:

- external walls 0.5–1.2 W/(m²·K),
- roof-ceilings 0.7–1.0 W/(m²·K),
- windows
- 2–3 W/(m²·K).

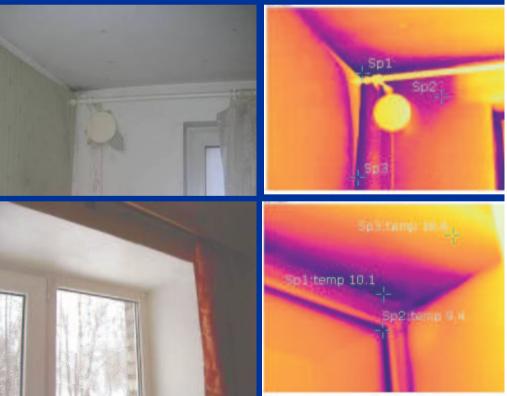
Existing problems:

- high thermal transmittance
- serious thermal bridges:

a large problem especially in old apartment buildings

mould growth and surface condensation on the internal surfaces of thermal bridges is unavoidable without:

- lowering thermal transmittance,
- lowering internal humidity loads.

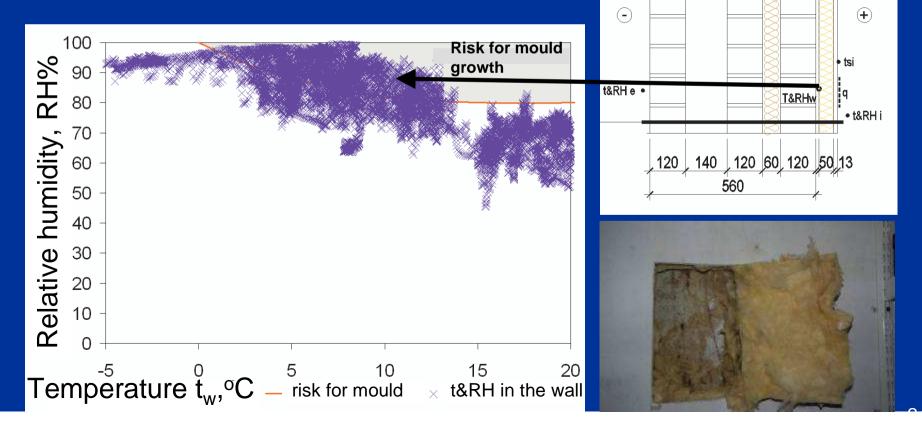
Internal thermal insulation is risky solution in cold climate: mould growth and condensation in the wall on the old wall surface

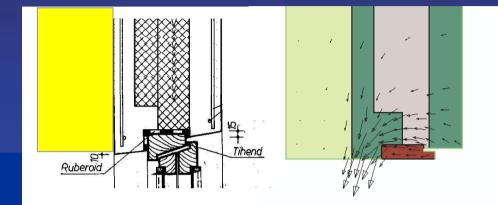
- Windows: old or new, on its original place
 - thermal bridge in connection of wall and window
 - visually bad solution

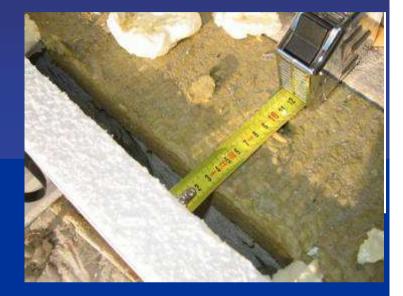
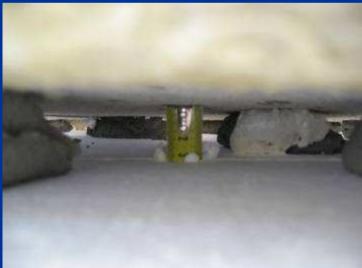
- Windows: old or new, on its original place
- Low quality: air space between old wall and new insulation;

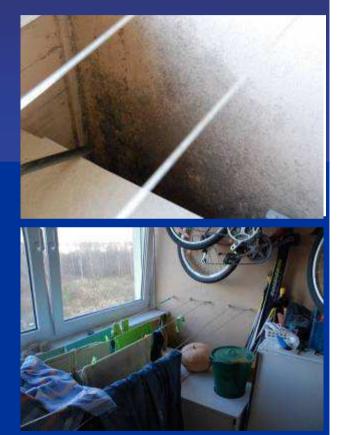
- Windows: old or new, on its original
- Low quality: air space between old wall and new insulation;
- Loggias: thermal bridges, mould

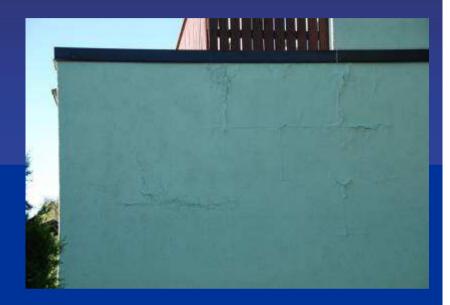
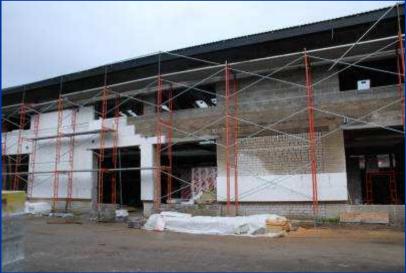
- Windows: old or new, on its original
- Low quality: air space between old wall and new insulation;
- Loggias: thermal bridges, mould
- Drying out of constructional moisture

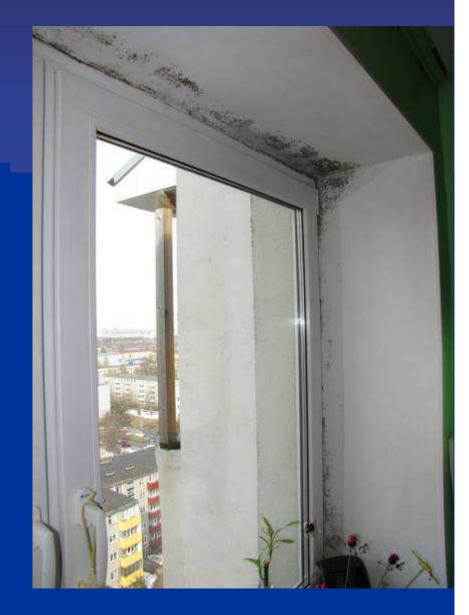
- Windows: old or new, on its original
- Low quality: air space between old wall and new insulation;
- Loggias: thermal bridges, mould
- Drying out of constructional moisture
- Complex renovation (ventilation + building envelope + heating systems) is not common: mould after insulation (ventilation was not renovated)

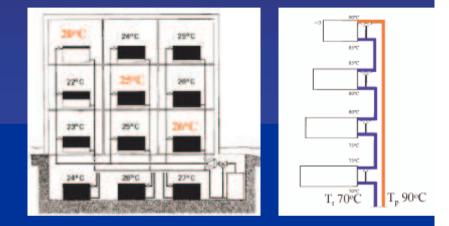
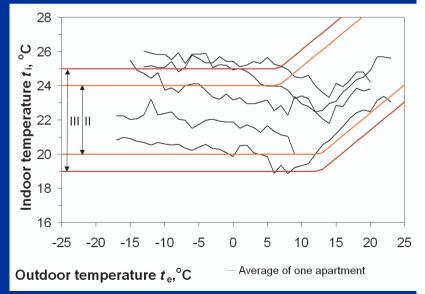
Heating systems

Typical solution:

- one-pipe heat distribution system;
- no room thermostats on radiators;

Typical problems:

- incorrect control curve of the temperature of the supply water of the heating system,
- incorrect water flow rate of the risers of the heating system,
- lack of direct room temperature control,
- difficulties to balance the one-pipe heat distribution system,
- lack of maintenance and improper modifications of the heating and ventilation systems.
