The history of brick masonry constructions in the BSR

Historic development of brick construction in the BSR

Preserving brick masonry heritage in the BSR: problems and lessons learned

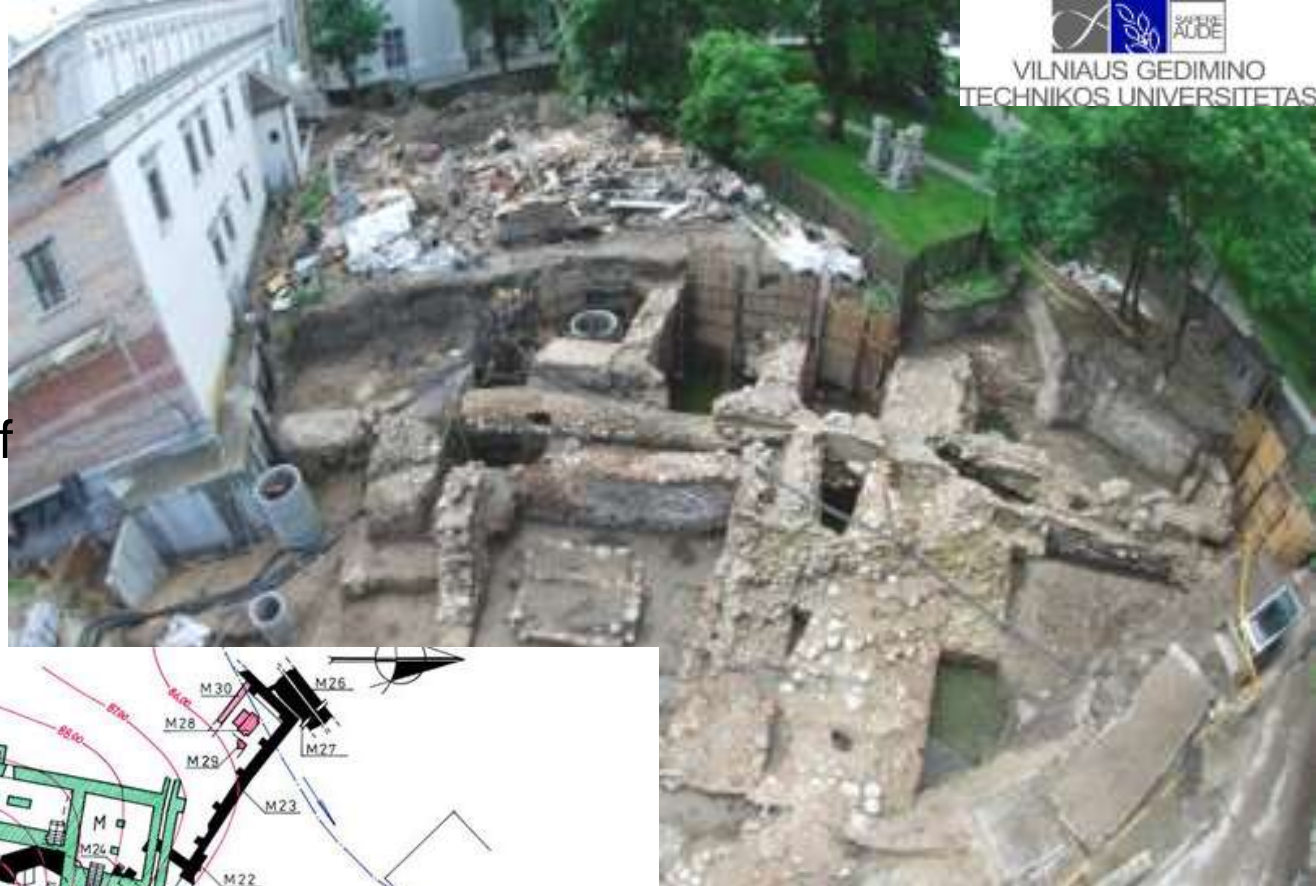
Lower Castle, Vilnius (excavation site at 2007)

Excavated foundations of stone masonry and clay-lime mortar, 1998.

Stratification of the masonry layers from 6 historic periods of reconstruction of the Lower Castle in 13th - 19th c.

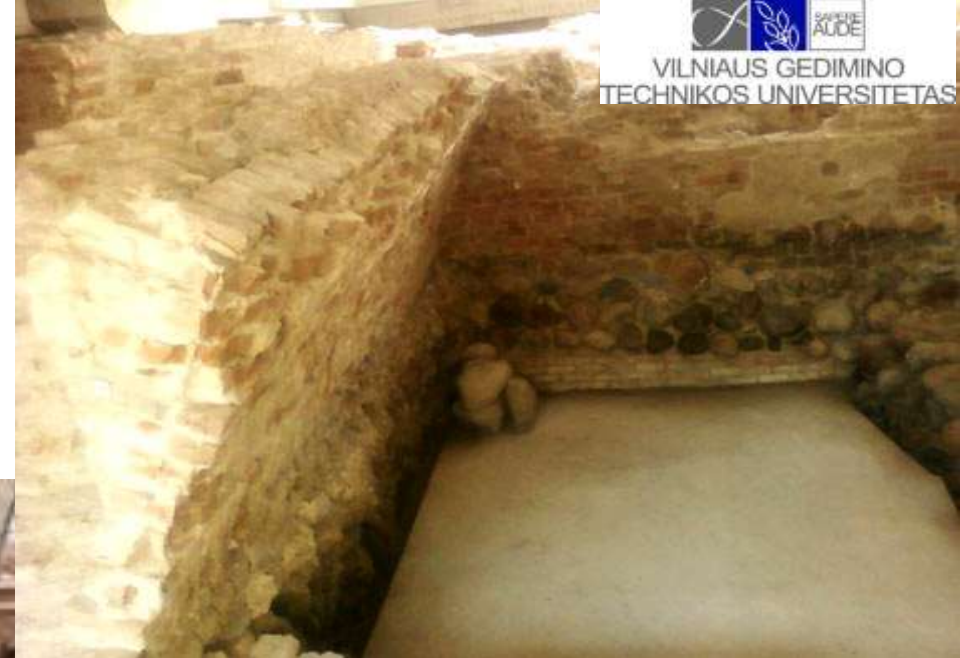
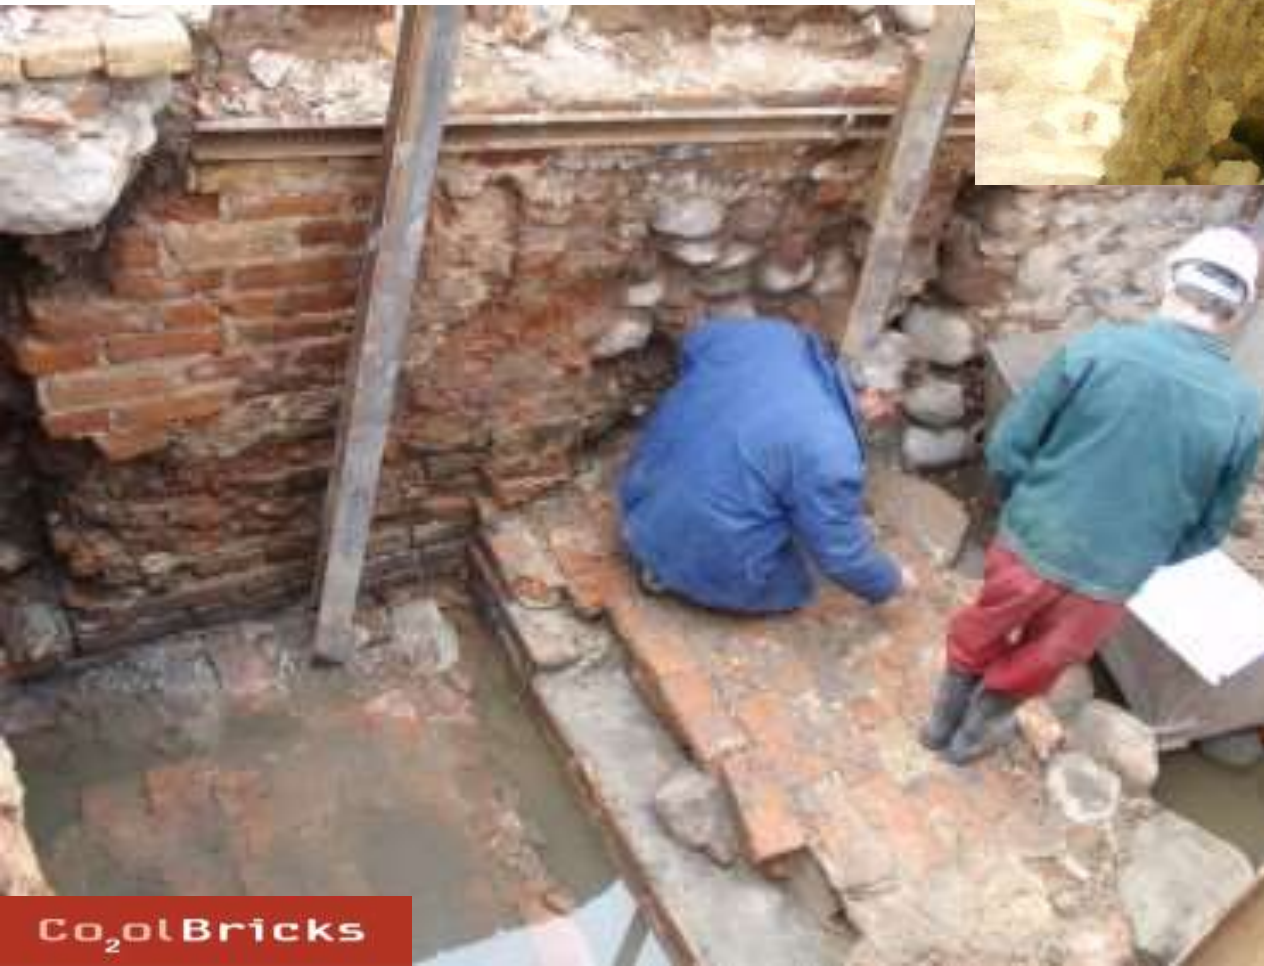
Lower Castle, Vilnius,
archaeological research and
reinforcement

Wendic (Baltic) bond
masonry from
the 13th – 14th c.
after conservation

The remains of
ground floor
masonry and brick
pavement

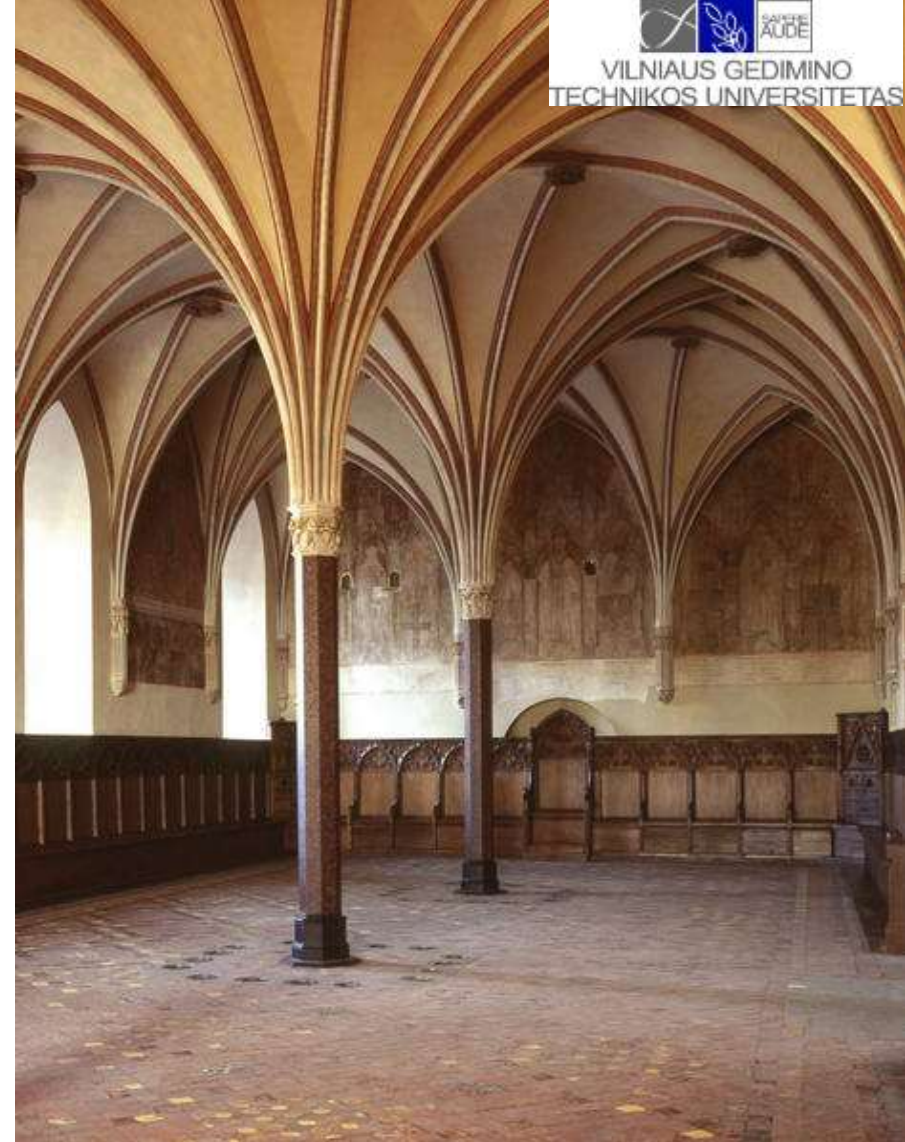
Malbork (Marienburg) castle

- Heating innovations: hypocaust system, water supply
- High quality standards of bricks and masonry

Order's Council Hall

Hypocaust stove

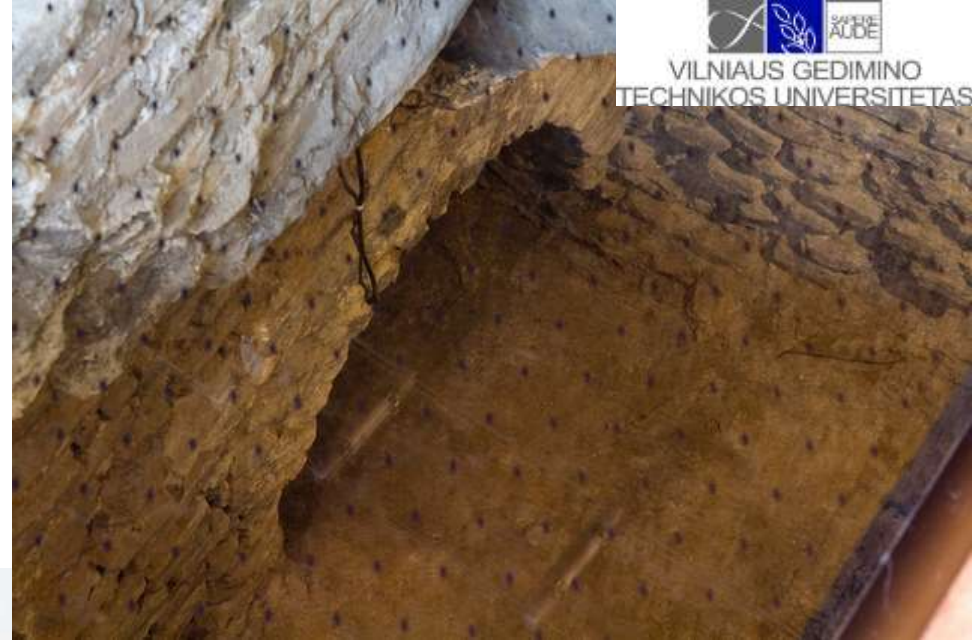
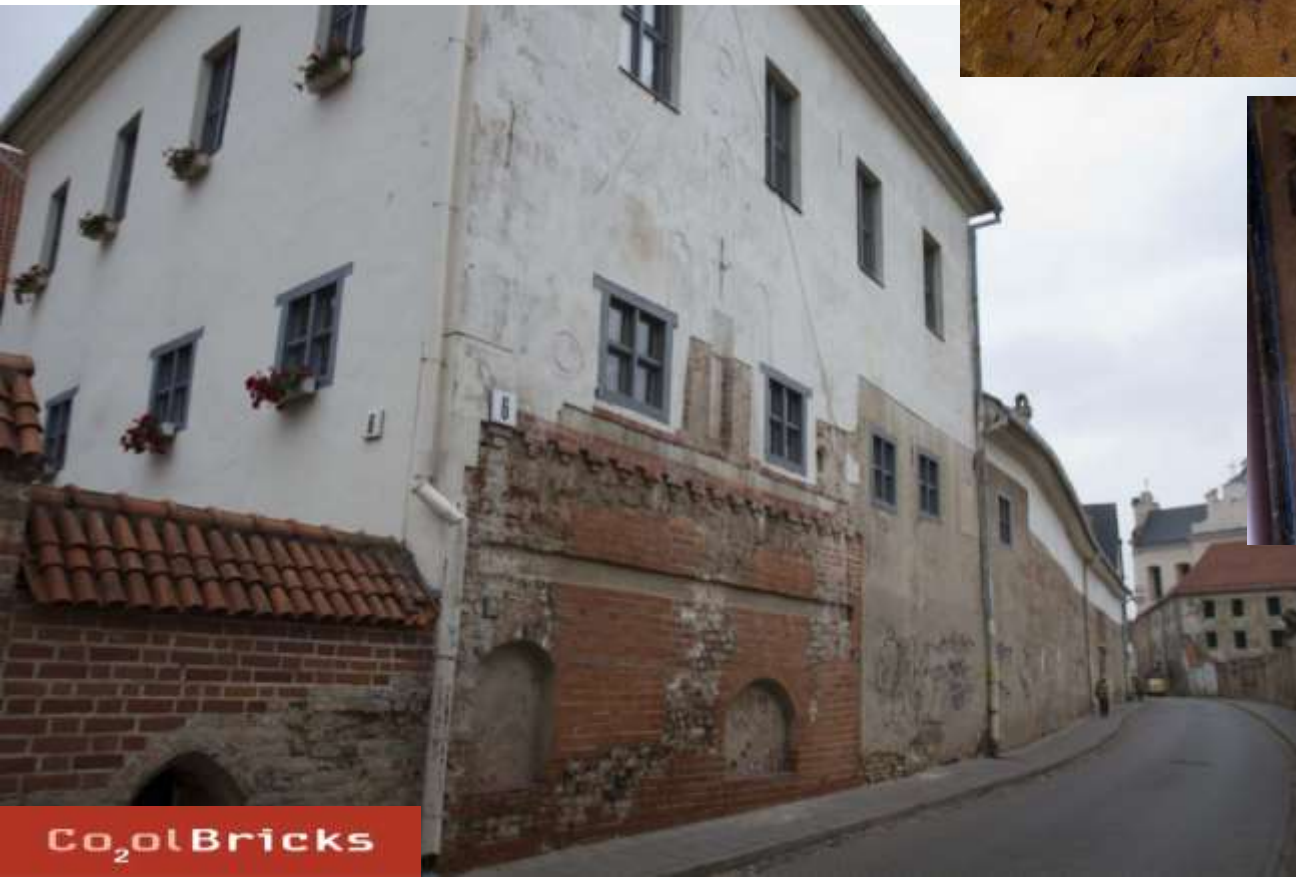
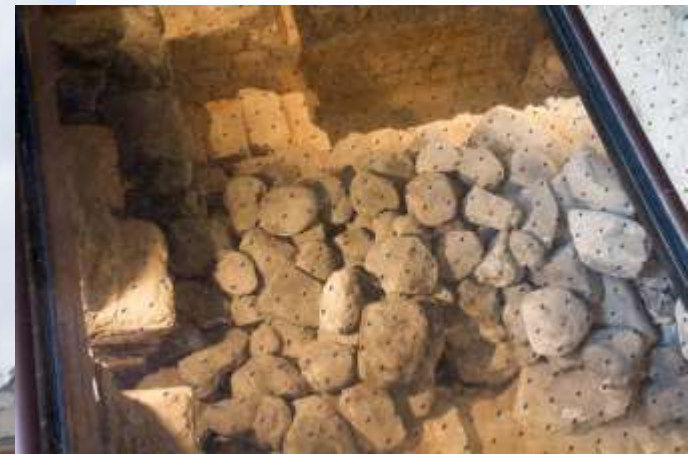
The quarter between Sv. Ignoto and Totorių str., Vilnius

The hypocaust stove (the view through the floor)

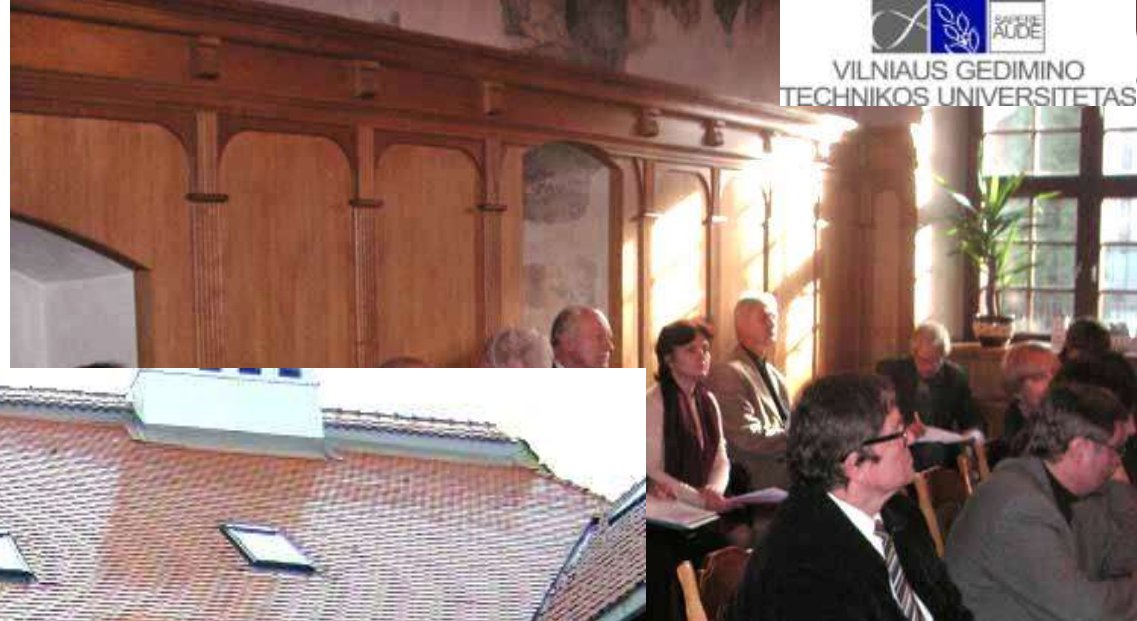
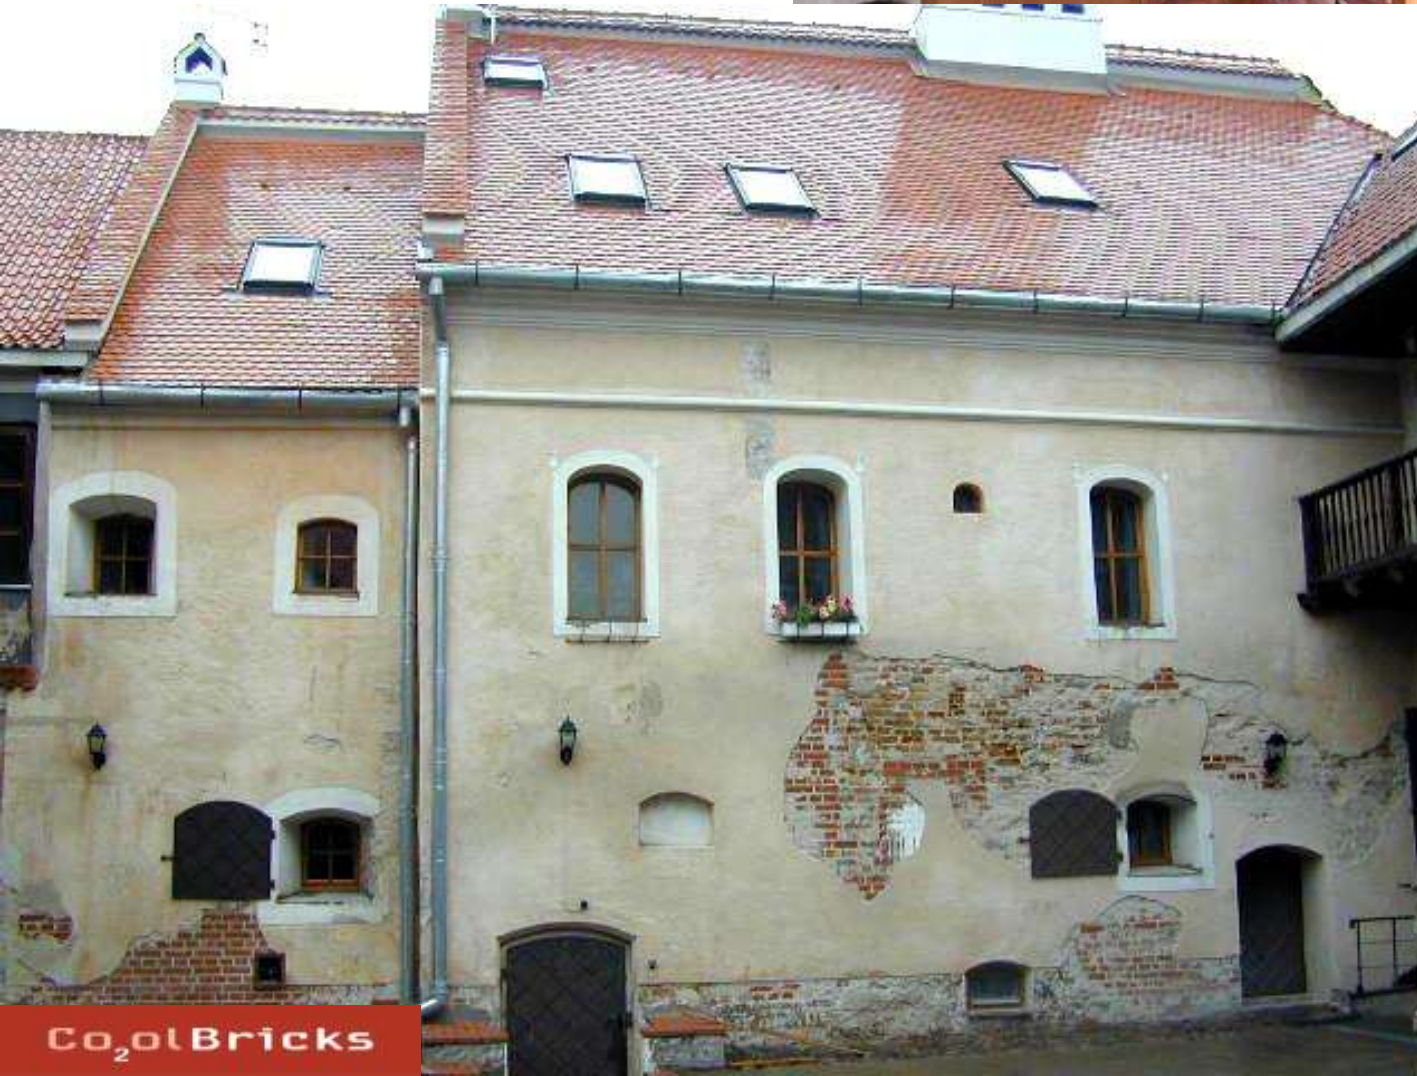
Rūdninkų str. 16,
Vilnius

Gothic bond
masonry and
Renaissance
architecture
of the
facades

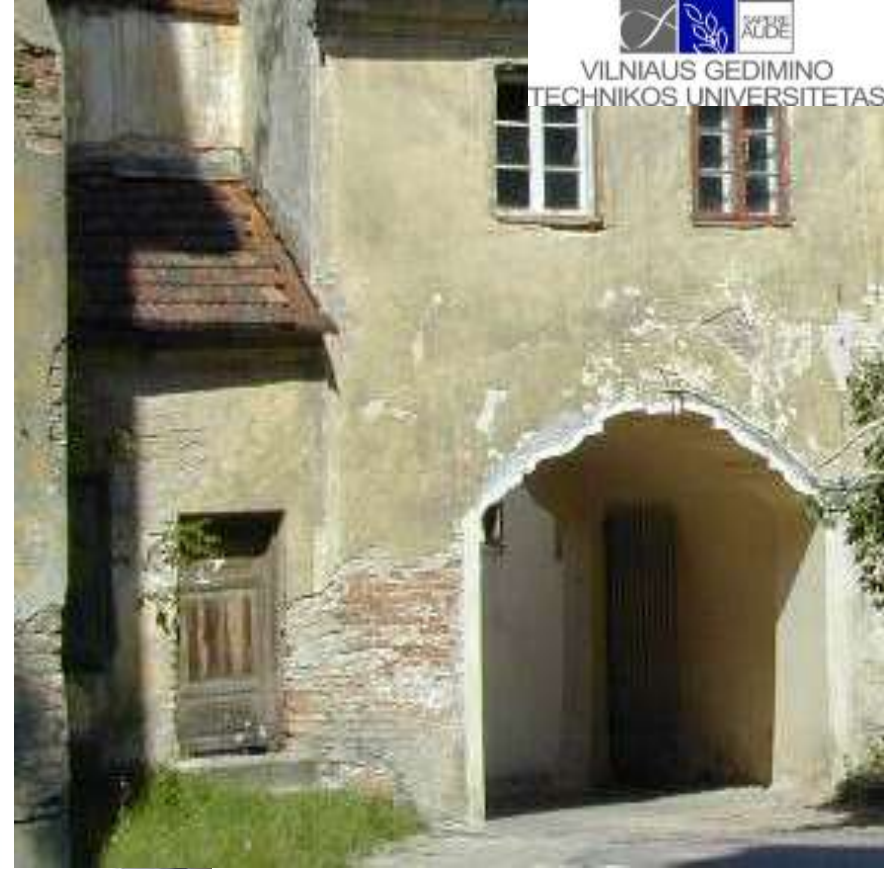
The Basilian Gate, Vilnius

Reused masonry of earlier periods

Use of lower quality bricks

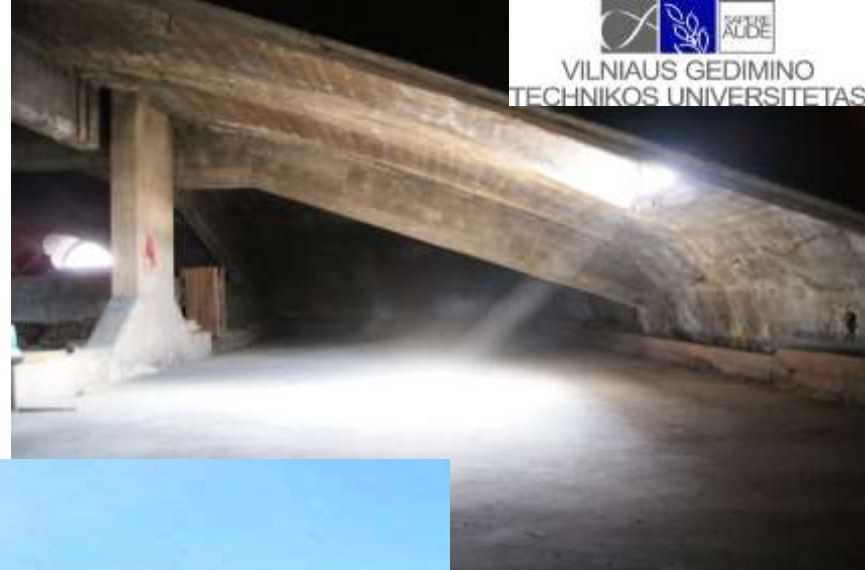
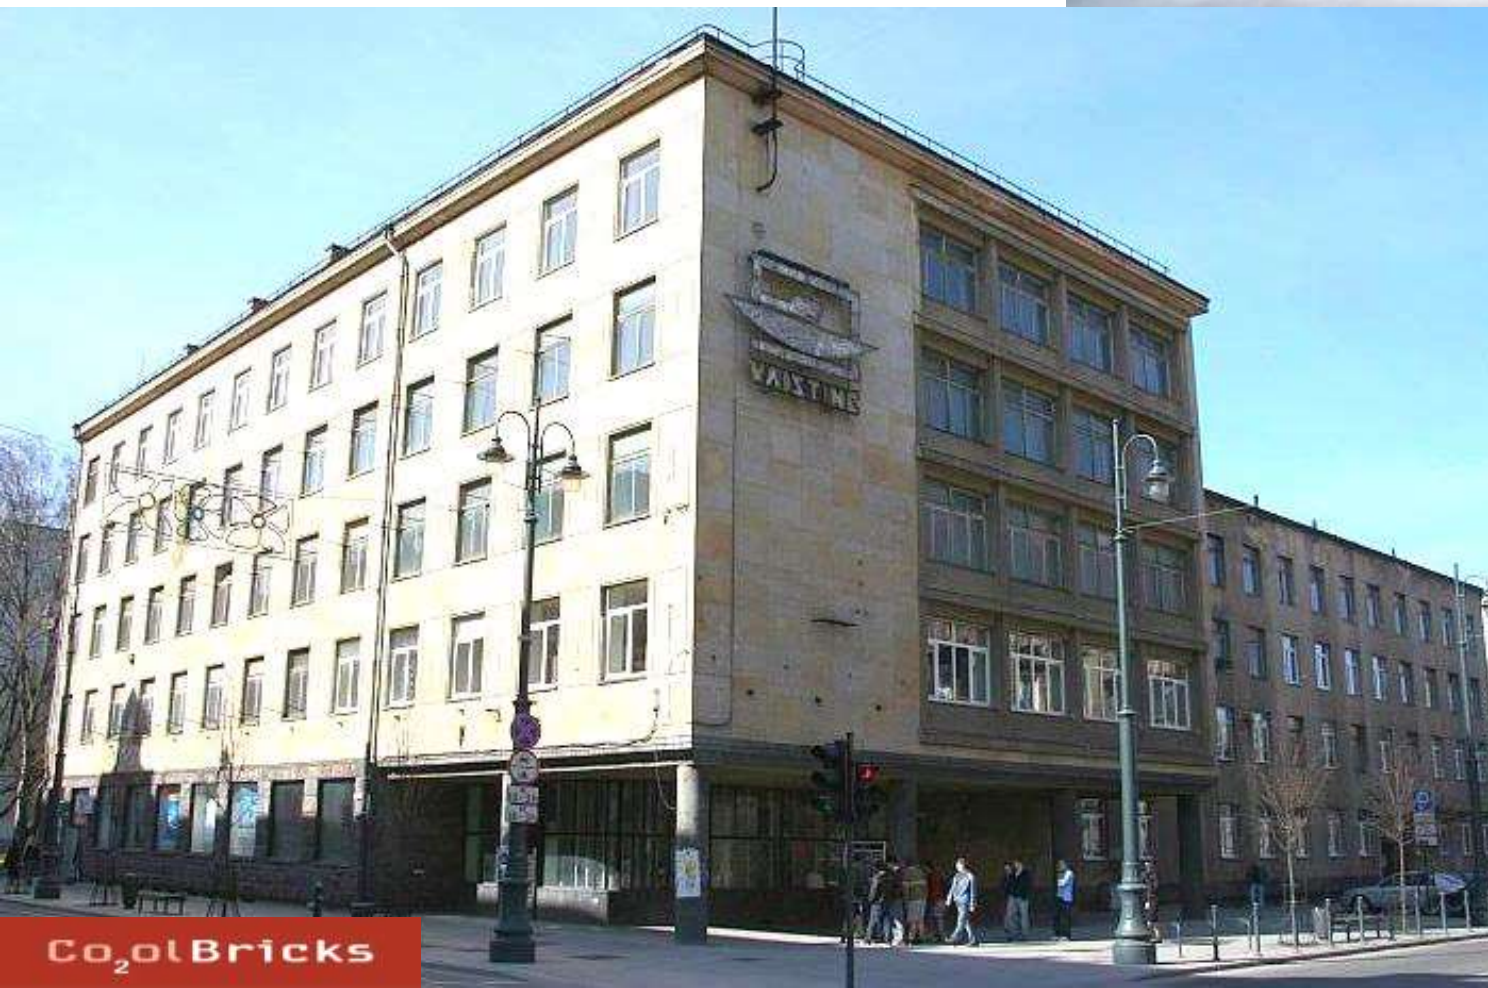
Gedimino av. 35, Vilnius, 1936

Use of
brickwork
with
reinforced
concrete
frame

Facing with
imported
sandstone
slabs

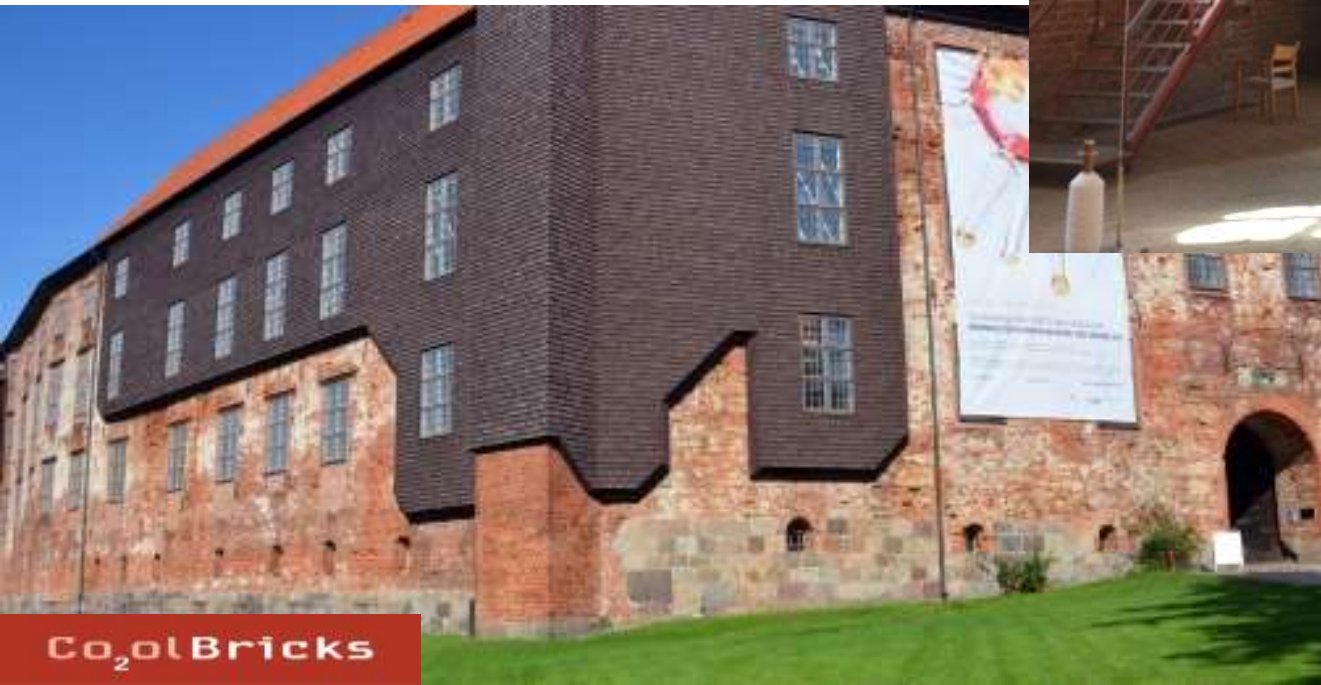
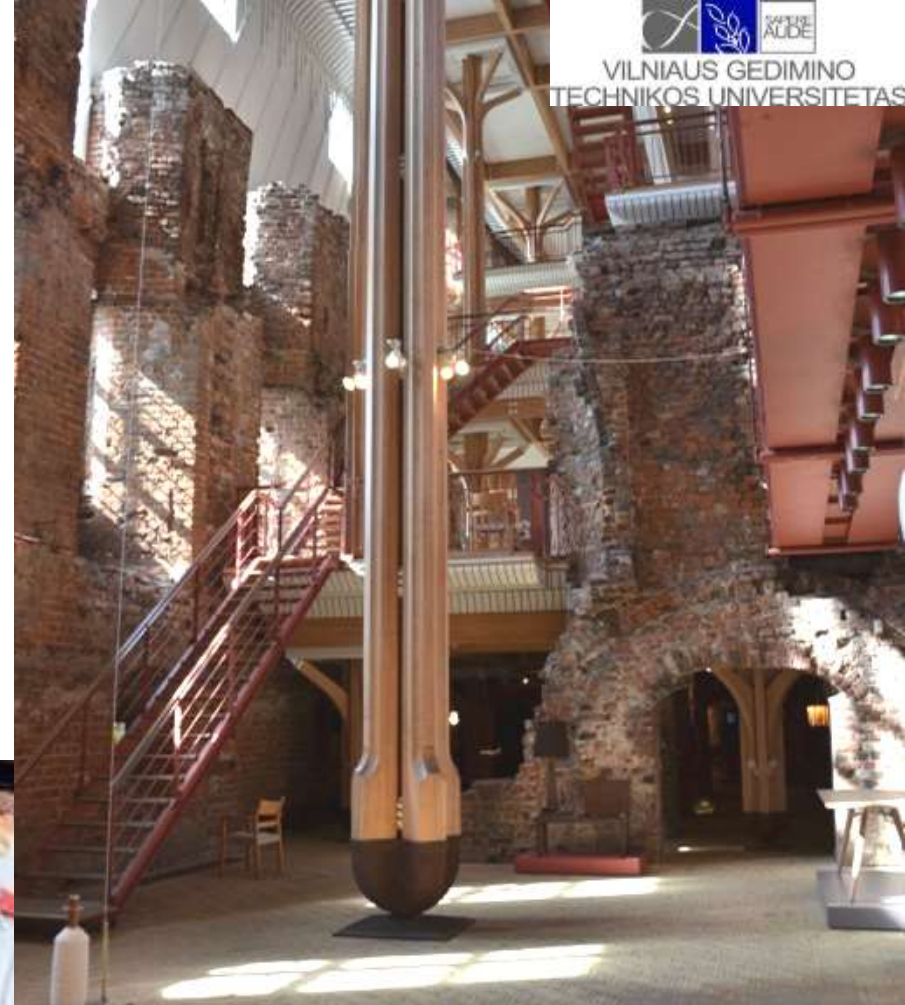
Koldinghus, Danmark,
13th – 19th c., restoration
1970's - 1991

Use of new
brickwork, floors,
and their supports
of different color,
texture, form

Replacements of missing parts must integrate harmoniously with the whole, but at the same time must be distinguishable from the original so that restoration does not falsify the artistic or historic evidence.

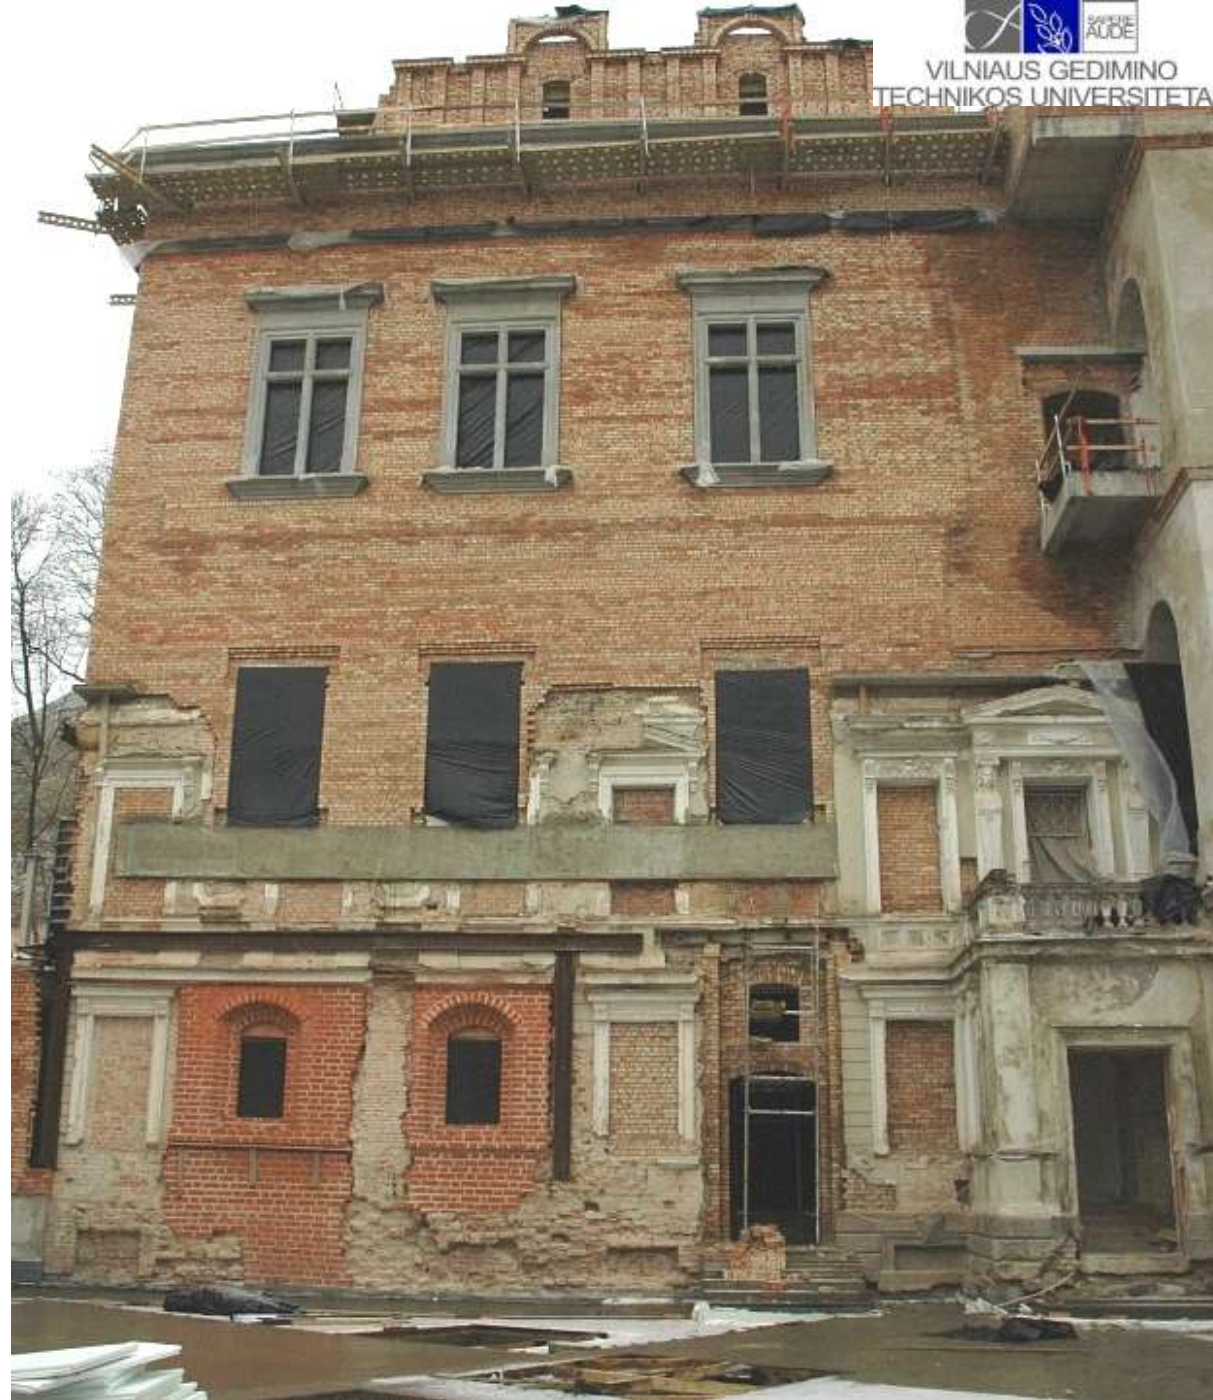
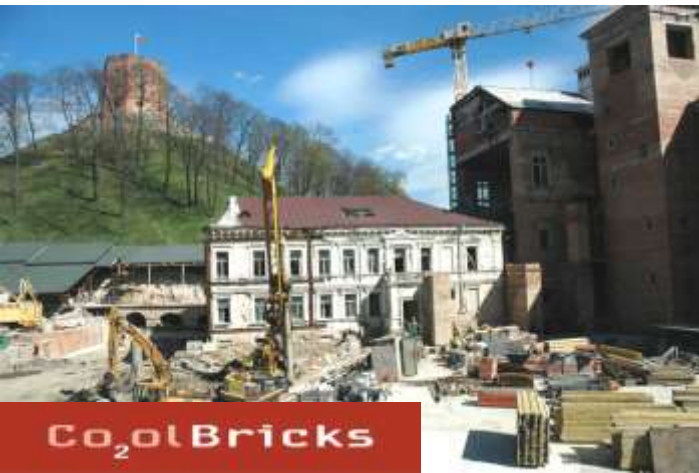
Inclusion of the facade of the 19th c. house into rebuild volume of the palace

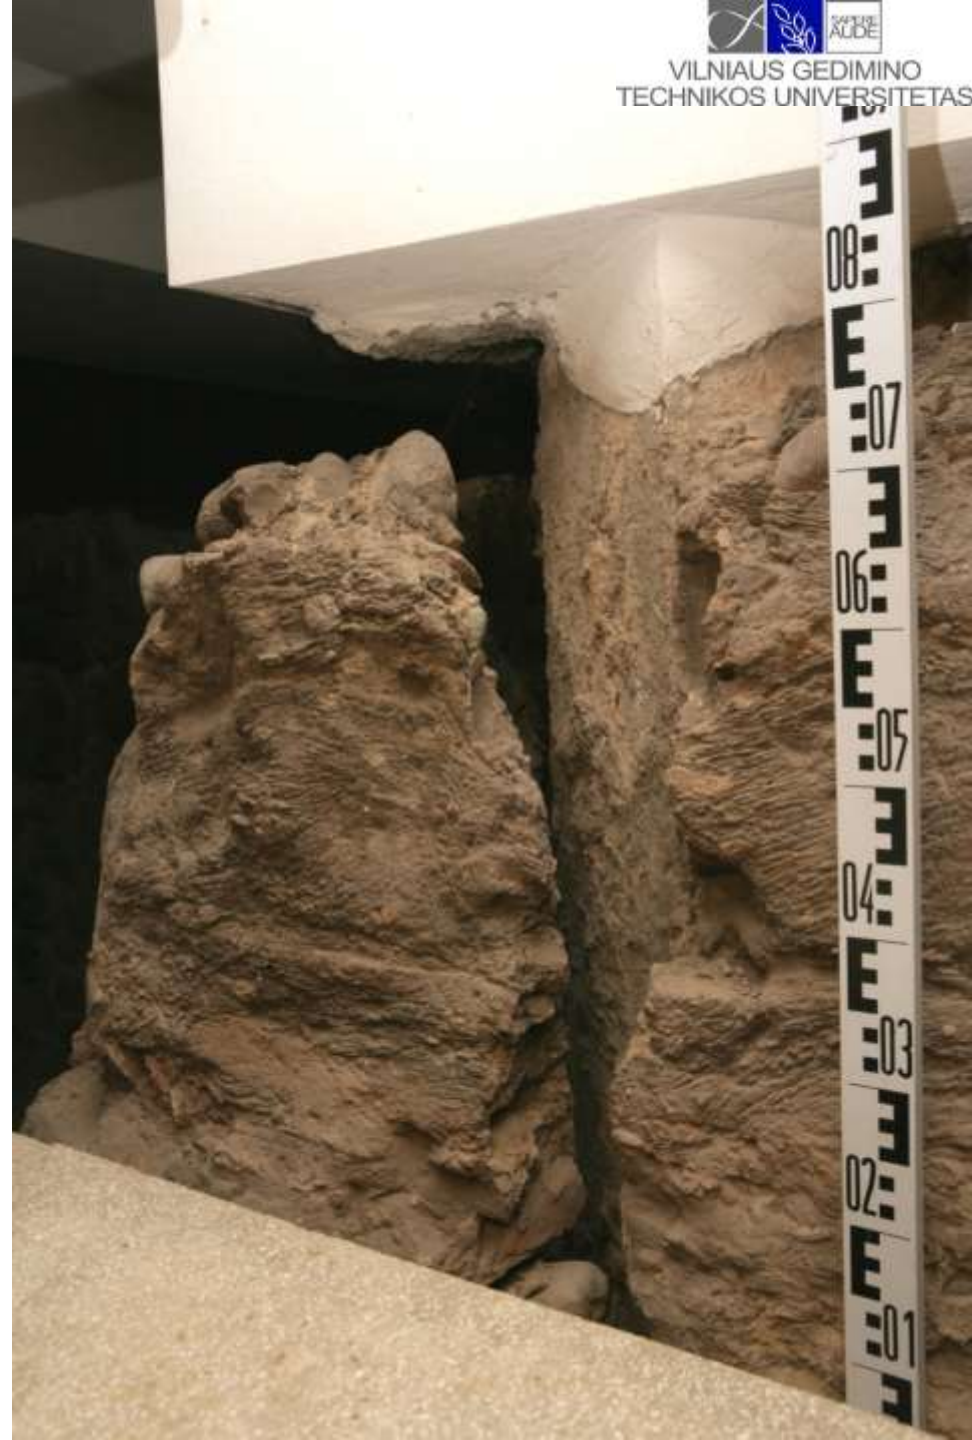
Dried and cracked
brickwork inside the
New Arsenal in Vilnius
Castle (chemical
conservation of 1987)

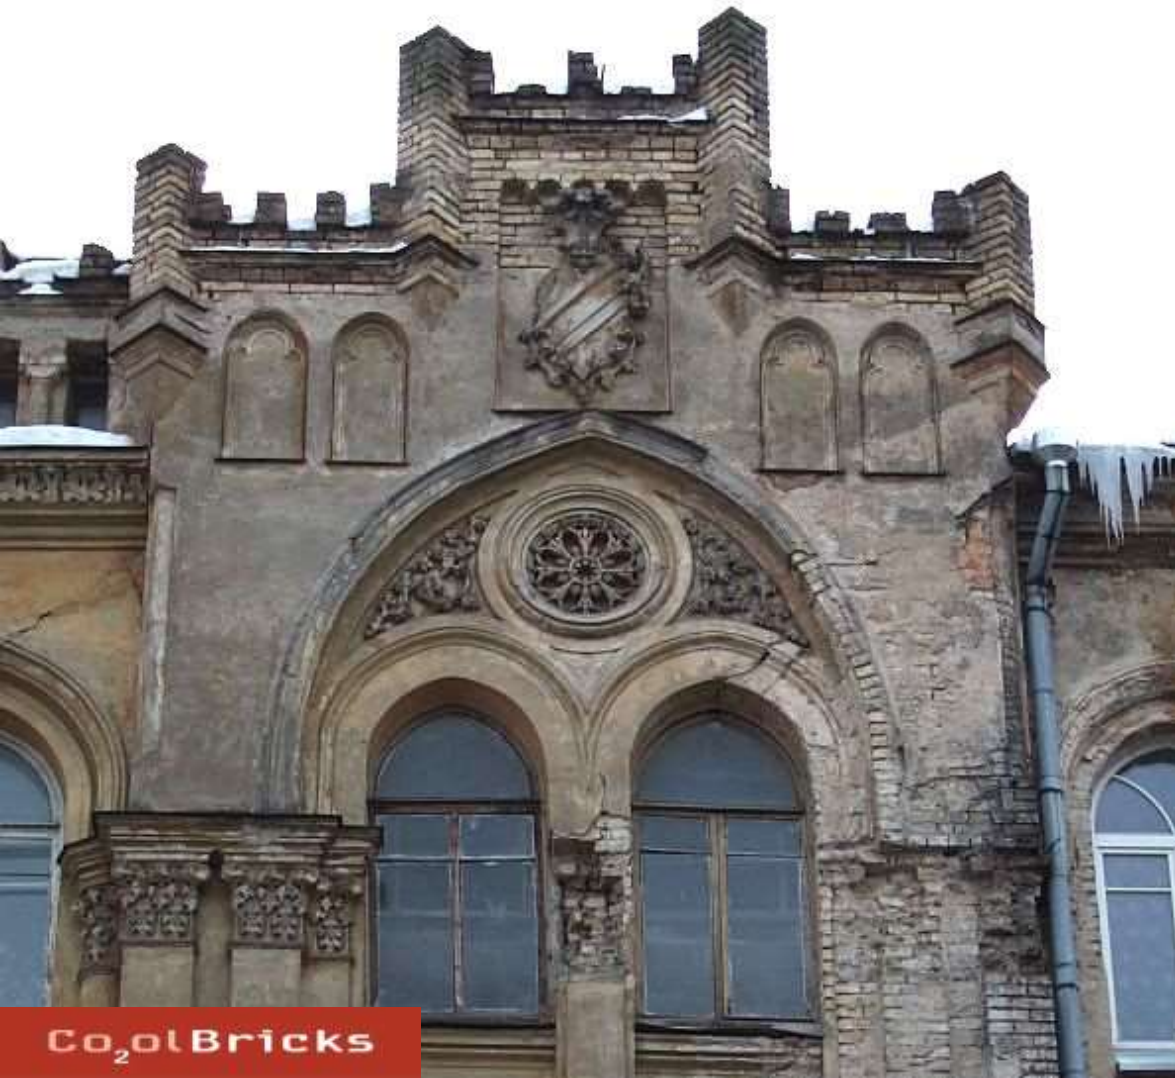
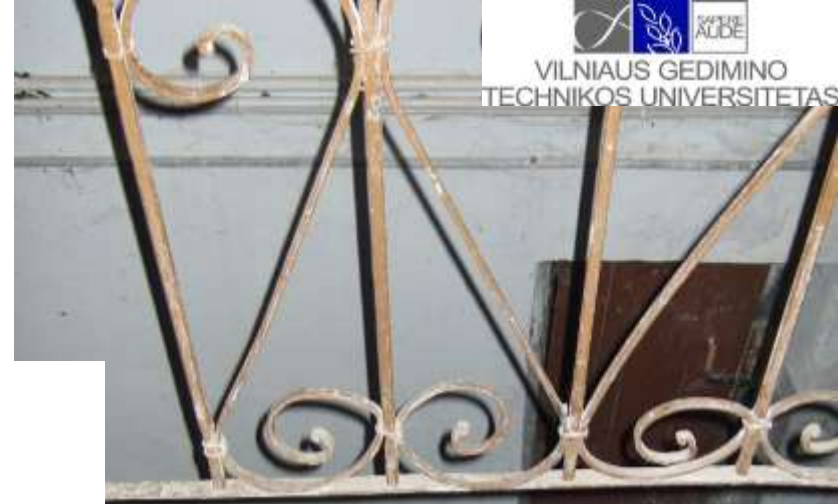
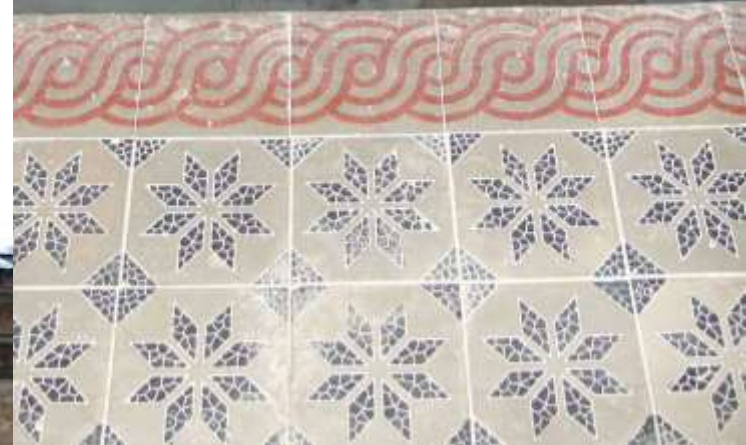
J. Basanavičiaus str. 16, Vilnius

Poor physical condition
of the facade
decoration
