INDOOR CLIMATE STUDY OF THE BRICK AND STONE BUILDINGS IN TARTU

Tallinn
2013

This report presents measurement results of two buildings indoor climate in two brick buildings in Tartu, subject to INTERREG IVB program project Nr 61 “Co₂ol Bricks” performed by Hevac Ltd for the Centre of Development Programs EMI-ECO (Project partner 12). Obtained results cover the period from 23.03.12 to 01.04.13.

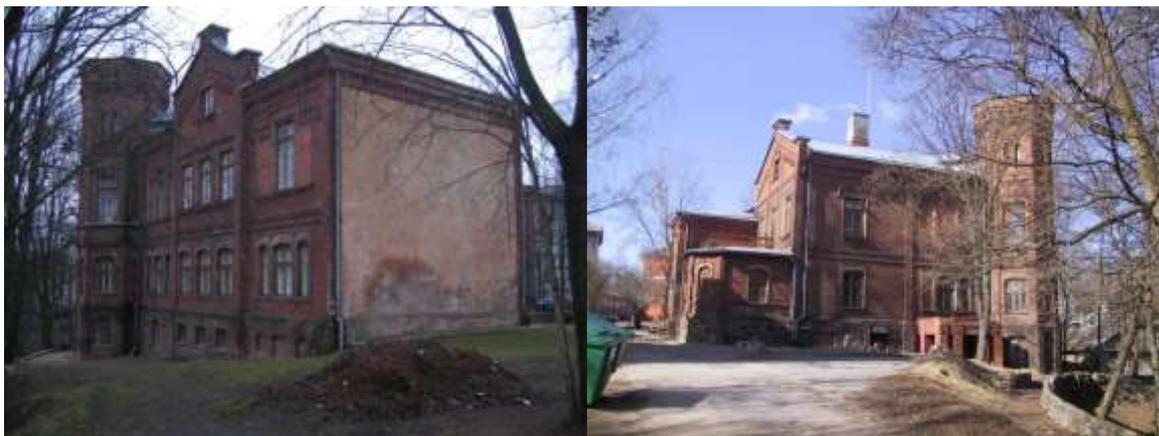
Figure 1 Tiigi 11

- 3-store brick/stone building with metal roof. Protected as architectural heritage building. Uninsulated external walls. Insulated roof.
- Water-heating system (radiators), natural ventilation, windows with an opening option.
- Building net internal area 657.7 m², net internal volume 3970 m³.

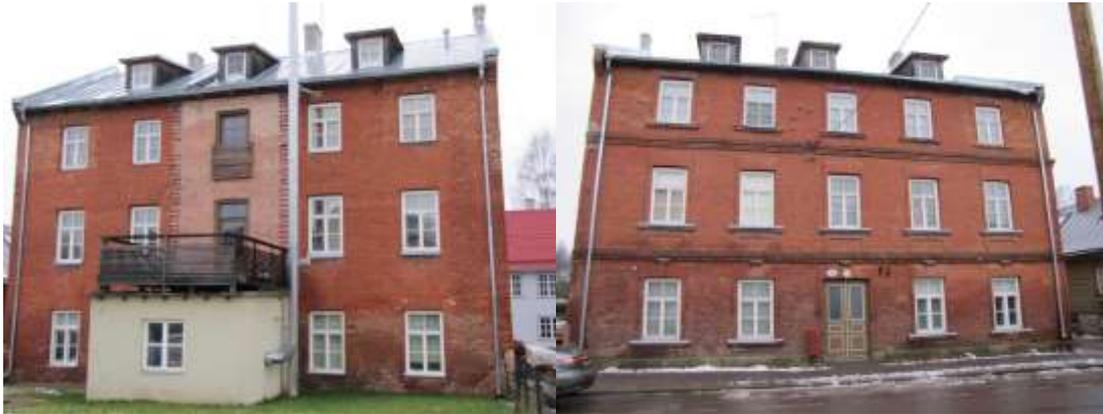
Figure 2 Herne 32

- Constructed in 1925 and renovated in 2005. Building locates in milieu area.
- 3-store brick and stone building with metal roof. Uninsulated exterior envelope. Building has an attic. Insulated roof structure.
- Building has its own boiler house and central-heating system (water radiators).
- Natural ventilation. Windows with an opening option.
- Building net internal area 530 m², net internal volume 2039 m³.

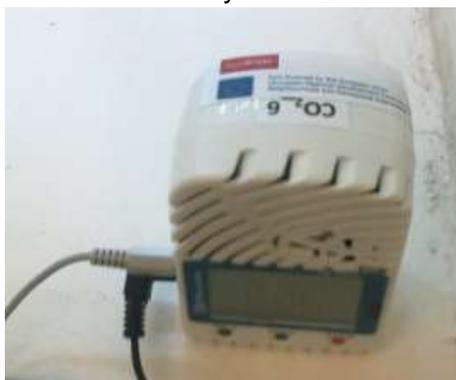
Figure 3 Data logger TR-76Ui

- CO₂: measurement range 0-5000 ppm, accuracy +/- 50 ppm;
- Air temperature: measurement range -30...+80, accuracy +/- 0,3 oC;
- Air relative humidity: 0...99%, accuracy +/- 2,5 %;
- Calculation of the moisture content in air based on the indoor air temperature and relative humidity measurement results;
- There was 3 data loggers installed in Tiigi 11 building and 5 data loggers in Herne 32 building;
- Data loggers recording interval is 0.5 hours;
- Additional data loggers were measuring outside air temperature and relative humidity near Tiigi 11 and Herne 32 location area;
- Study of the external air temperature effects and their impact on the indoor air temperature;
- Indoor air moisture content study;
- Indoor air carbon dioxide content study.

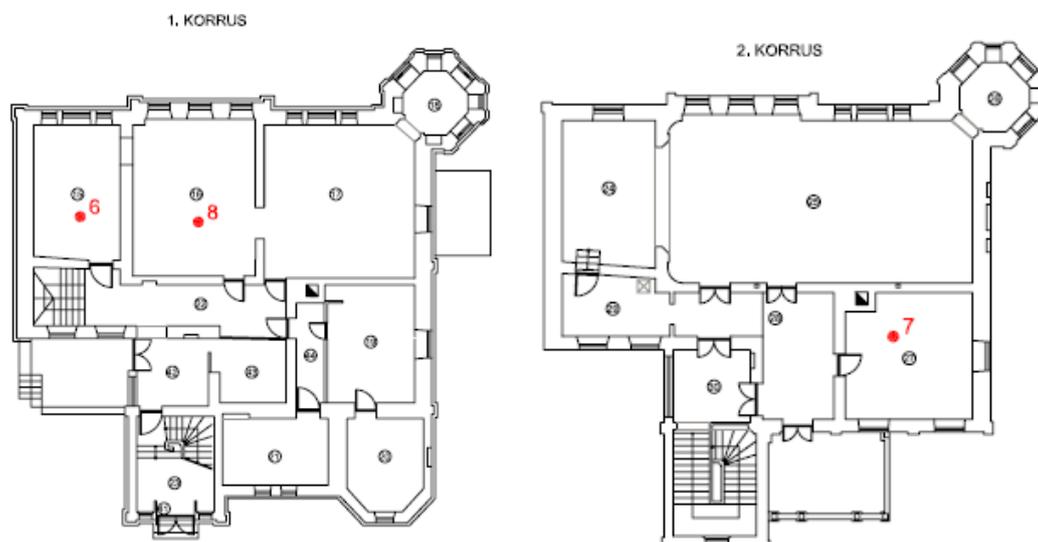
Figure 4 Data loggers location in building Tiigi 11

LOG 6 I floor room nr 15
LOG 8 I floor room nr 16
LOG 7 II floor room nr 27

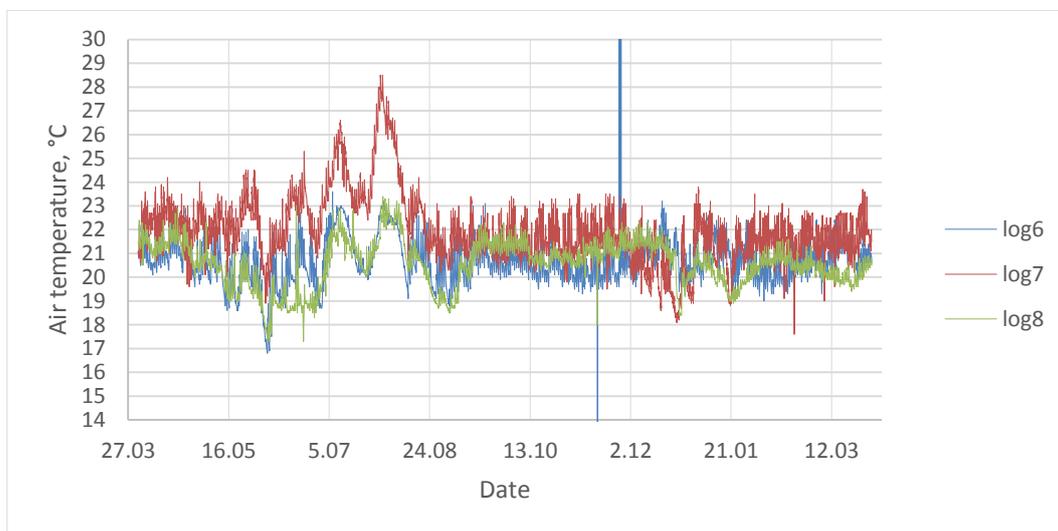
Figure 5 Room air temperature in Tiigi 11 (annual period)

The following graph (Figure 5) illustrates the indoor air temperature annual measurement results (non-working hours are included).

- Air temperature in rooms during September-May (heating period) varies 18...24 °C (indoor air temperature below 17 °C occurred due to open windows);
- During the summer indoor air temperature varies 17...28 °C;
- II floor room (logger 7) air temperature is ca 1 °C higher compared to other measured rooms;
- Air temperature in the second floor room exceeded 21 °C ca 90% of the heating period duration. First floor room (logger 6) and third floor room (logger 8) air temperature exceeded 21 °C ca 50% of the heating period duration;
- During the summer air temperature in the second floor room exceeded 25 °C about 5% of the time during the year;
- First and third floor rooms air temperature was below 25 °C during the year.

Office building (Tiigi 11). Indoor air temperature and moisture conditions in the meet the requirements. From the perspective of the building energy performance, the air temperature set point should be lowered ca 1 °C to sustain average air temperature at 21 °C. The building is naturally ventilated, though the air exchange rates are acceptable: air carbon dioxide content during the working hours exceeded 1000 ppm for only 10...20% of the time. Low moisture excess in the office building rooms, which not exceeded recommended value of 2,5 g/kg during the winter season, is the result of the fair air exchange in the rooms. During the cold period, room moisture content was in good correlation with the outside air temperature. Summer period in 2012 was relatively cool and outside air temperature exceeded 25 °C (max 33 °C) only for several days. Thanks to the building thermal inertia, indoor air temperature exceeded 25 °C only in one room out of three measured. The duration of the temperature over 25 °C in that room was relatively small. The indoor climate conditions in Tiigi 11 building are quite decent.

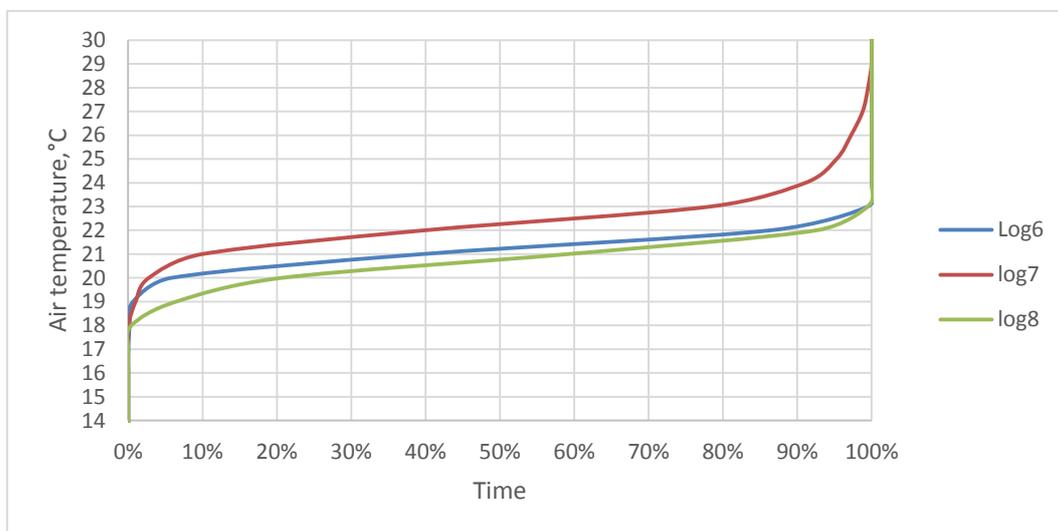
Figure 6 Duration diagram of the room air temperature in Tiigi 11 (annual period, working hours only)

The following duration diagram (Figure 6) displays the measured annual indoor air temperature within working hours (9:00 – 17:00).

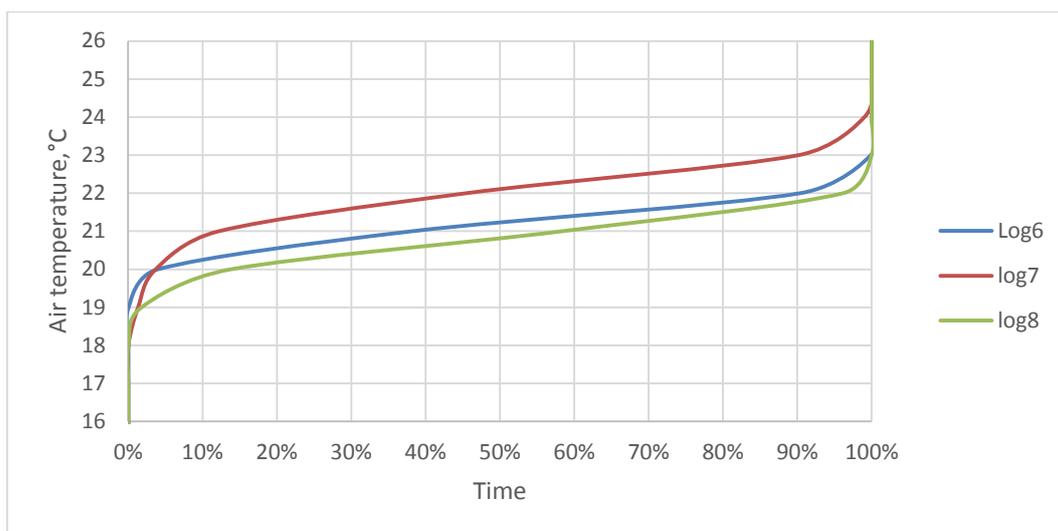
Figure 6 Duration diagram of the room air temperature in Tiigi 11 (September-May, working hours only)

The following duration diagram (Figure 7) illustrates the measured indoor air temperature within period September-May.

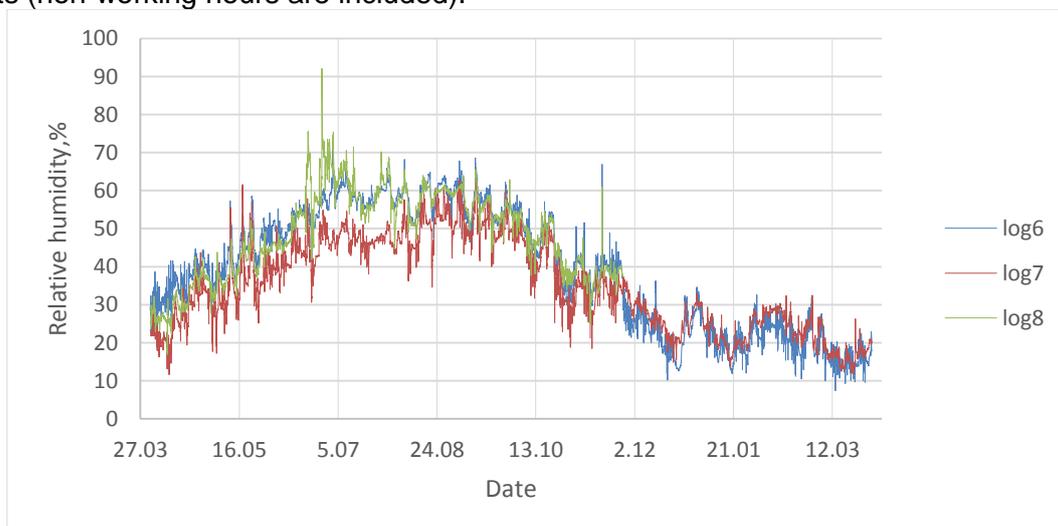
Figure 7 Room air relative humidity in Tiigi 11 (annual period)

The following graph (Figure 7) illustrates indoor air relative humidity annual measurement results (non-working hours are included).

- Room air relative humidity varies 10...70 %;
- During the May-September (summer) period indoor air relative humidity varies 45...70%;
- During the December-February (winter) period indoor air relative humidity varies 10...32%;
- Indoor air relative humidity stayed below 20% ca 10% of the time during the year;
- In comparison to second and third floor room's measurement results, the first floor room air relative humidity was lower during the winter and higher during the spring/summer.

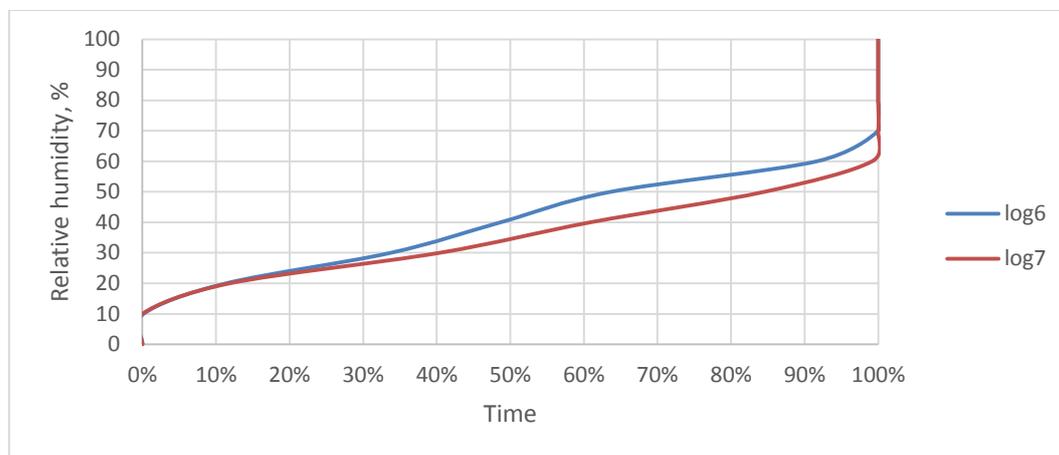
Figure 8 Duration diagram of the room air relative humidity in Tiigi 11 (annual period, working hours only)

The following duration diagram (Figure 8) displays the measured annual indoor air relative humidity within working hours (9:00 – 17:00). Due to construction works in the third floor room (logger 8), the data logger was damaged (June/July). Therefore, elaborated data from data logger 8 is not sufficient/adequate to be plotted on the duration diagram.

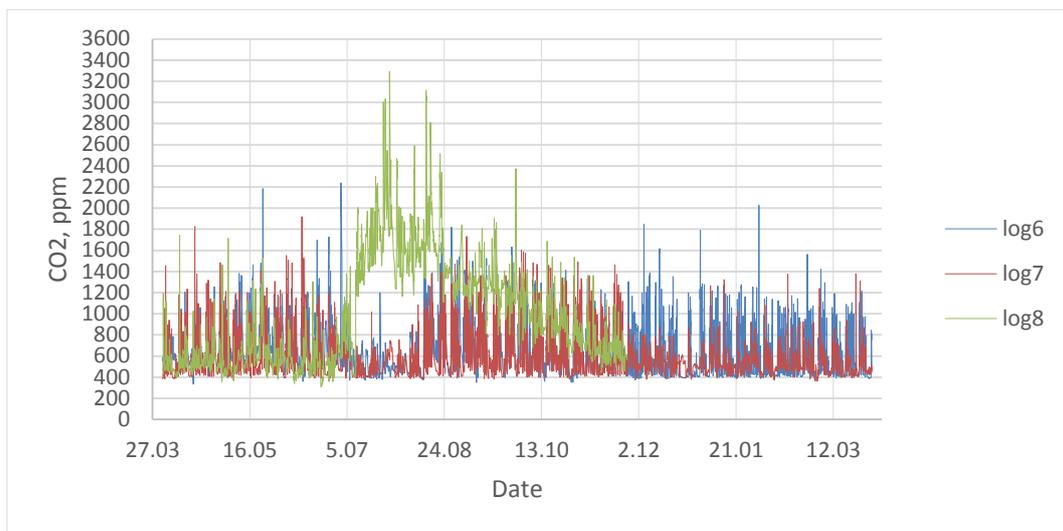
Figure 9 Room air carbon dioxide content in Tiigi 11 (annual period)

The following graph (Figure 9) illustrates indoor air carbon dioxide content annual measurement results (non-working hours are included). Due to construction works in the third floor room (logger 8), the data logger was damaged (July). Therefore, elaborated data from data logger 8 is not sufficient / adequate to be plotted on the duration diagram.

- Room air CO₂ content reached its peak value of 2200 ppm;
- Room air CO₂ content exceeded 1000 ppm ca 10...20% of the time during the year, which is quite good result for the building with natural ventilation.

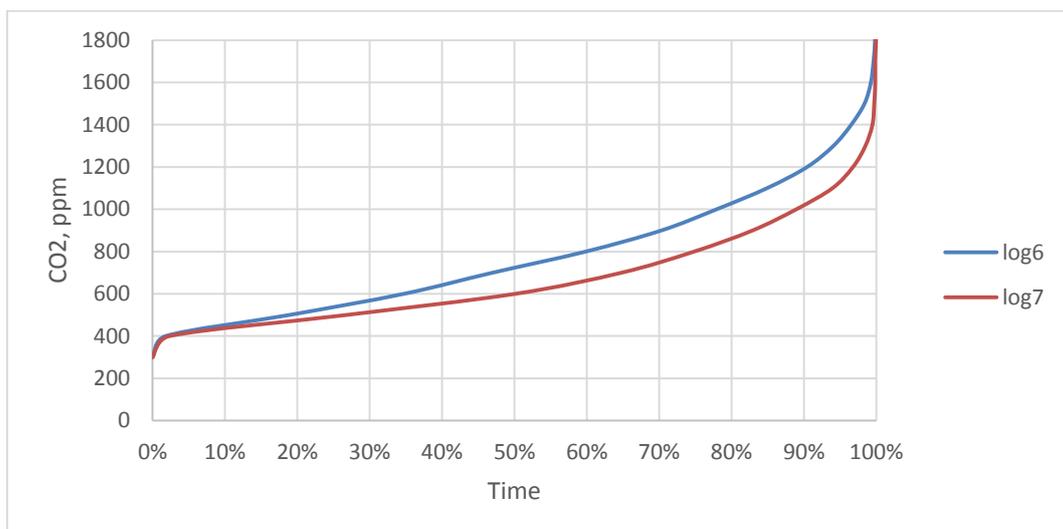
Figure 10 Duration diagram of the room air carbon dioxide content in Tiigi 11 (annual period, working hours only)

The following duration diagram (Figure 10) displays the measured annual indoor air carbon dioxide content within working hours (9:00 – 17:00).

In accordance with the World Health Organization (WHO) recommendations, CO₂ content in the indoor air should not exceed 1000 ppm.

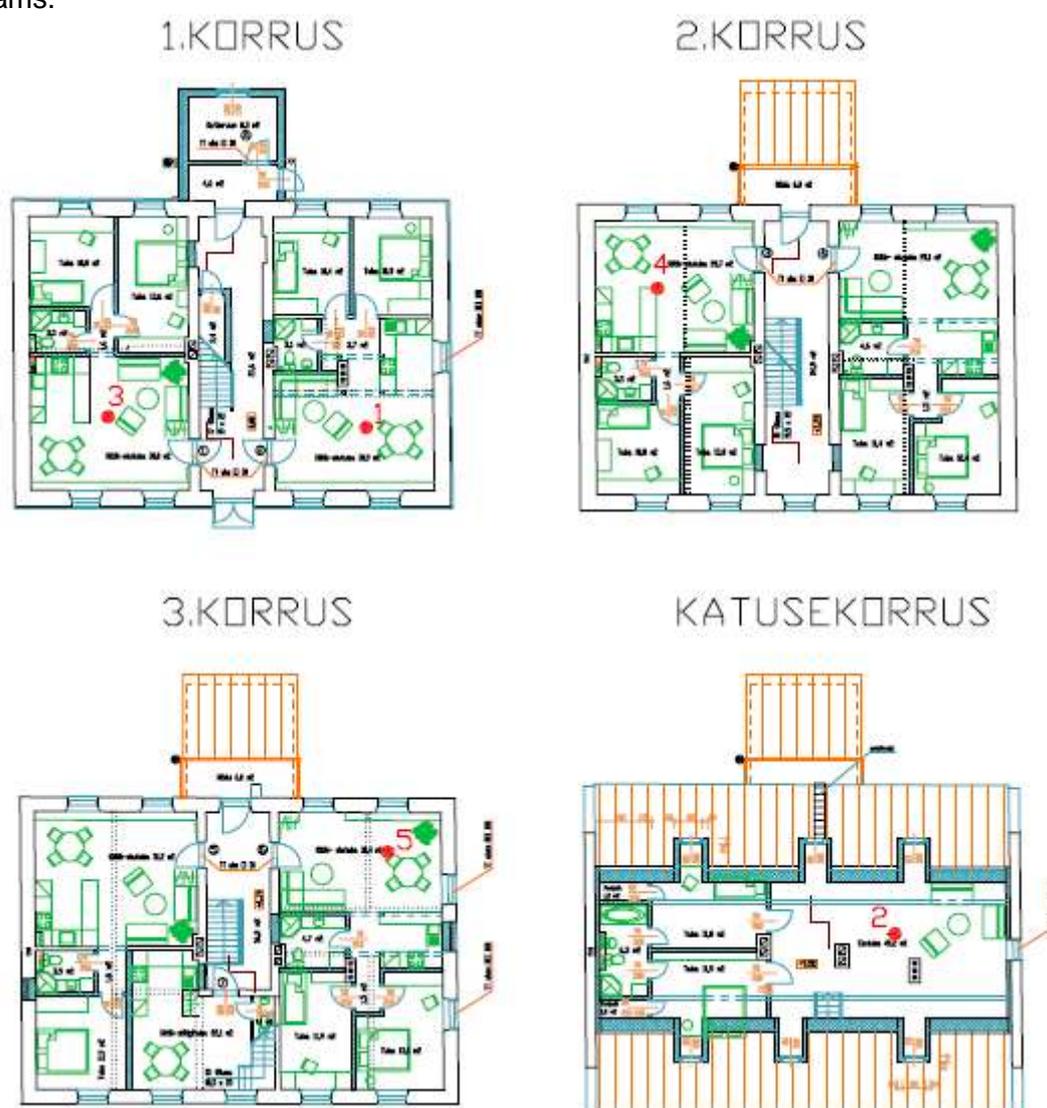
Figure 11 Data loggers location in building Herne 32

LOG 1 and LOG 3	I floor
LOG 4	II floor
LOG 5	III floor
LOG 2	attic

It was not possible to elaborate some parts of the first floor apartment logger data (logger 1), because apartment owner was out of Estonia. There is some data elaborated from the attic is missing due to lack of the power supply at some periods (May-June), where air temperature reads are quite high but no records of relative humidity measurement. Taken above into an account the data elaborated from the data logger nr.1 and nr.2 was not included in duration diagrams.

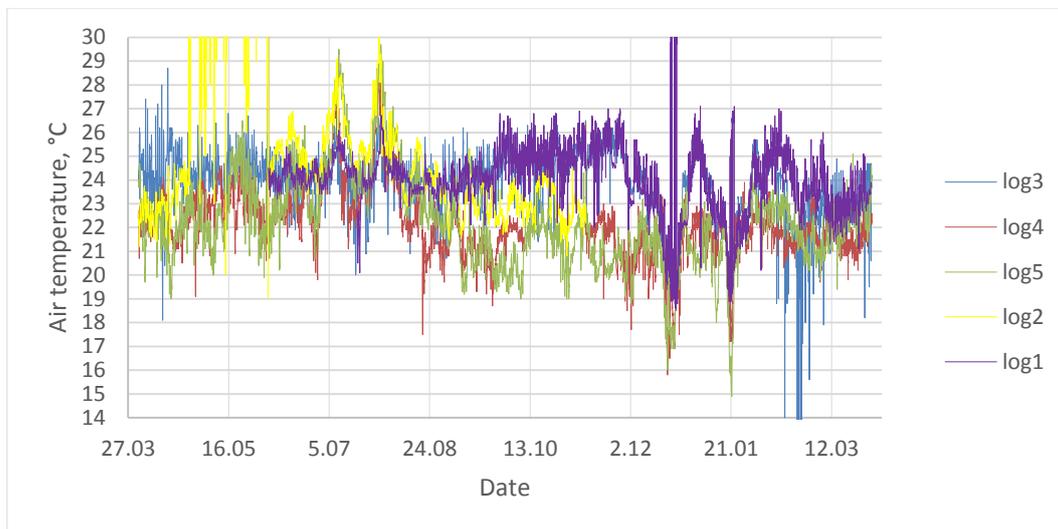
Figure 12 Room air temperature in Herne 32 (annual period)

The following graph (Figure 12) illustrates indoor air temperature annual measurement results. Data logger nr.1 and nr.2 measurement results are not included in the duration diagram.

- Air temperature in rooms during September-May (heating period) varies 15...27°C (indoor air temperature below 15 °C occurred due to open windows);
- Due to outside air temperature drop below -20 °C during the night, indoor air temperature in the third floor room (logger 5) dropped to 15 °C and lasted for ca 8 hours. At the same time air temperature in other rooms dropped to ca 17...18 °C;

- Air temperature in the first floor room (logger 3) is ca 1,5...2 °C higher in comparison to other rooms air temperature;
- Air temperature exceeds 21 °C in the first floor room for ca 95% of the heating season (September – May) duration, for ca 80% in the second floor room (logger 4) and for ca 65% in the third floor room. The building is over heated based on the results above;

Apartment building (Herne 32) was overheated and the indoor air temperature exceeded 21 °C for ca 65...95% of the heating season duration in different rooms. Throughout the summer period, indoor air temperatures continuously exceeded 25 °C. In fact, the building indoor air temperature conditions were not in the optimal range. The average daily moisture excess in the building within the winter and spring seasons exceeded sometimes twice the recommended 2,5 g/kg value. Taken above into an account, moisture conditions in the building are not acceptable and there is a risk of moisture damage. High indoor air moisture content is a result of the insufficient air exchange (ventilation) in rooms. The moisture excess has some correlation to human activity in the apartment. In different rooms air carbon dioxide content exceeded recommended 1000 ppm for ca 8...20% of the time during the year. Short-term maximum CO₂ concentration reached its peak at 2000 ppm. The apartment building indoor climate conditions cannot be considered as acceptable.

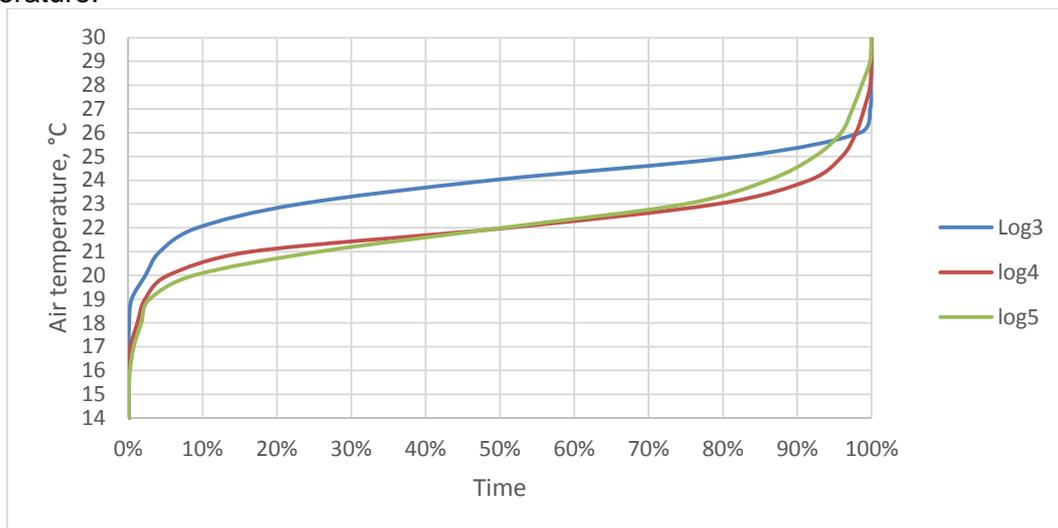
Figure 13 Duration diagram of the room air temperature in Herne 32 (annual period)

The following duration diagram (Figure 13) displays the measured annual indoor air temperature.

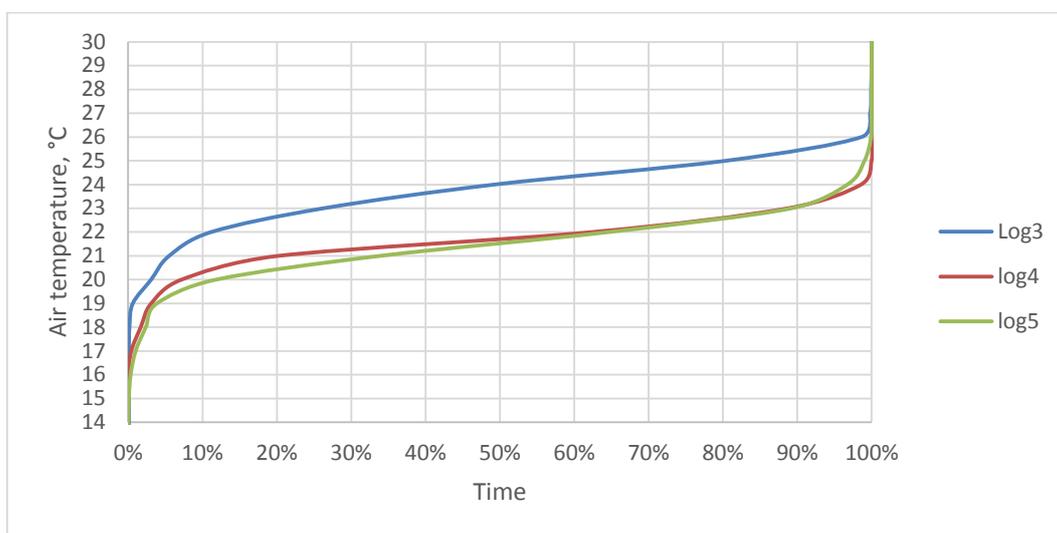
Figure 14 Duration diagram of the room air temperature in Herne 32 (September-May)

The following duration diagram (Figure 14) illustrates the measured indoor air temperature within September-May period.

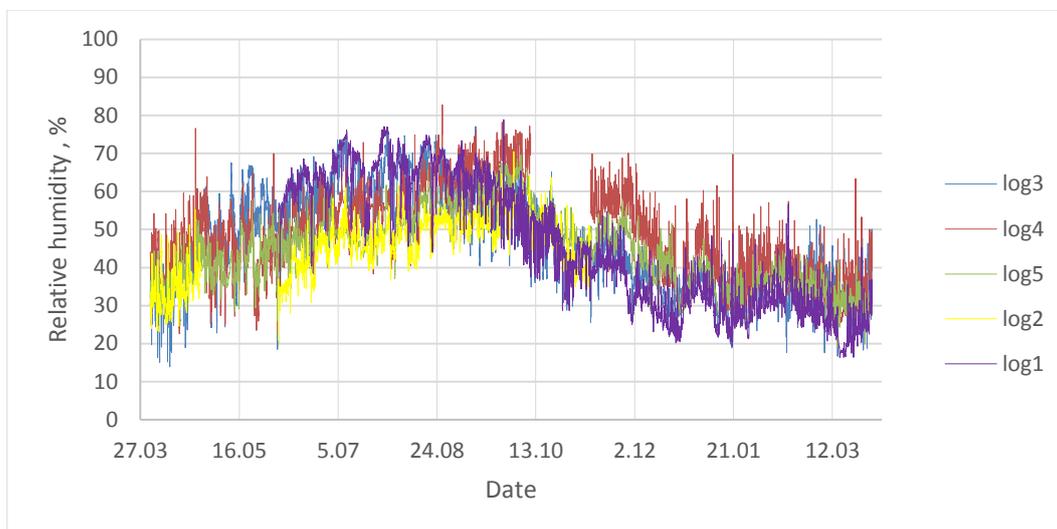
Figure 15 Room air relative humidity in Herne 32 (annual period)

The following graph (Figure 15) illustrates indoor air relative humidity annual measurement results. Data logger nr.1 and nr.2 measurement results are not included in the duration diagram.

- Room air relative humidity varies 15...80 %;
- During the May-September (summer) period indoor air relative humidity varies 30...80%;
- During the December-February (winter) period indoor air relative humidity varies 20...70%;
- Relative humidity in the first and second floor rooms exceeded 70% for ca 2% time of the year.

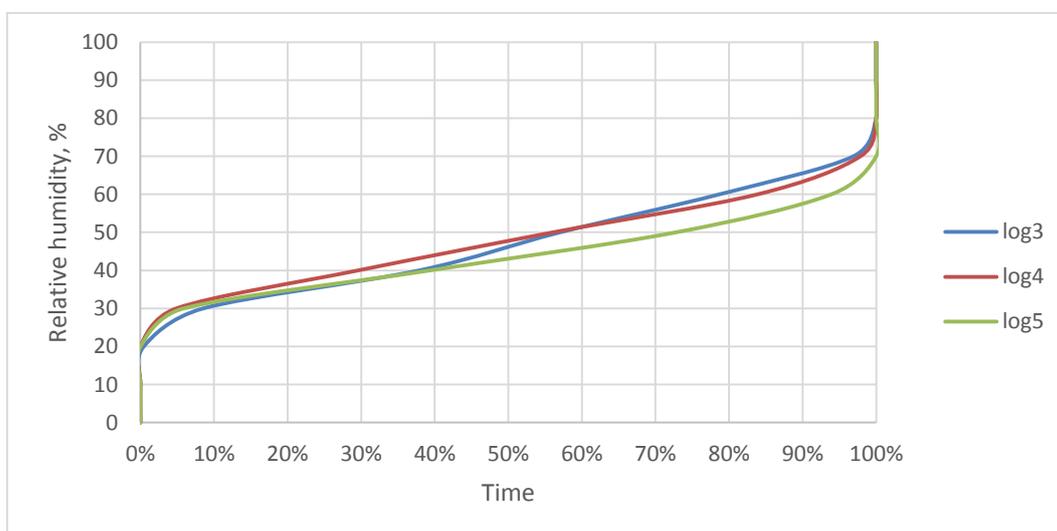
Figure 16 Duration diagram of the room air relative humidity in Herne 32 (annual period)

The following duration diagram (Figure 16) displays the measured annual indoor air relative humidity.

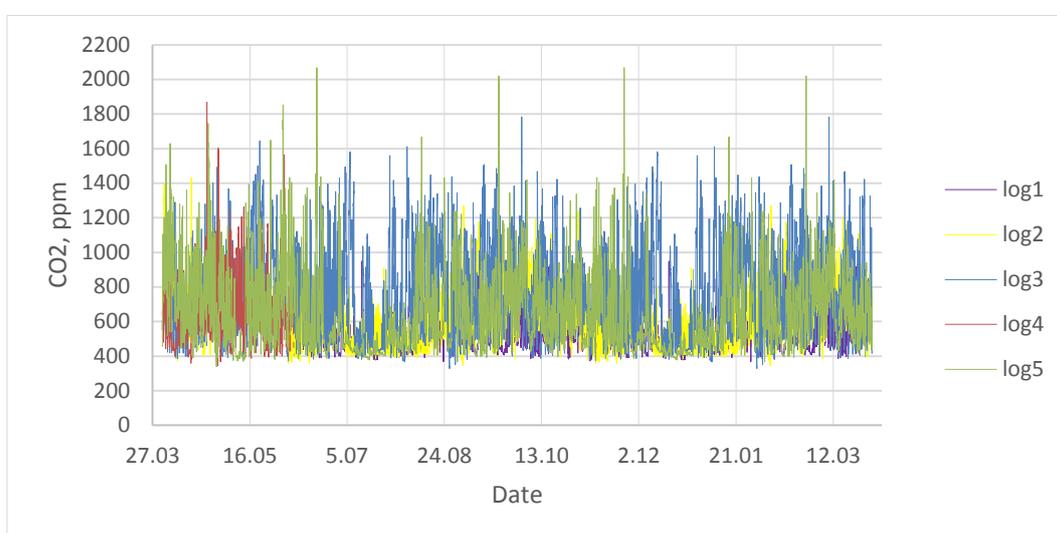
Figure 17 Room air carbon dioxide content in Herne 32 (annual period)

The following graph (Figure 17) illustrates indoor air carbon dioxide content annual measurement results. Data logger nr.1 and nr.2 measurement results are not included in the duration diagram.

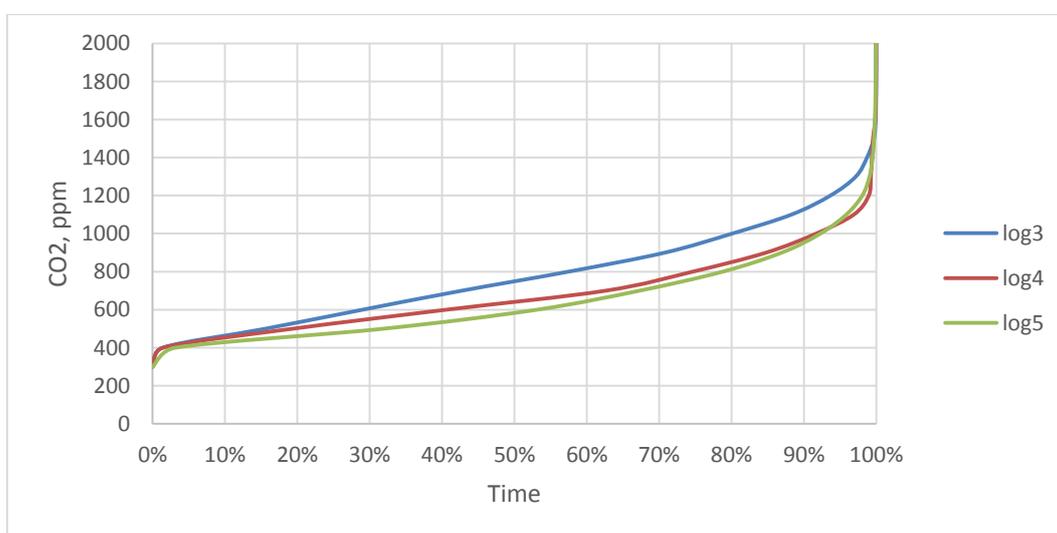
Figure 18 Duration diagram of the room air carbon dioxide content in Herne 32 (annual period)

The following duration diagram (Figure 18) displays the measured annual indoor air carbon dioxide content.

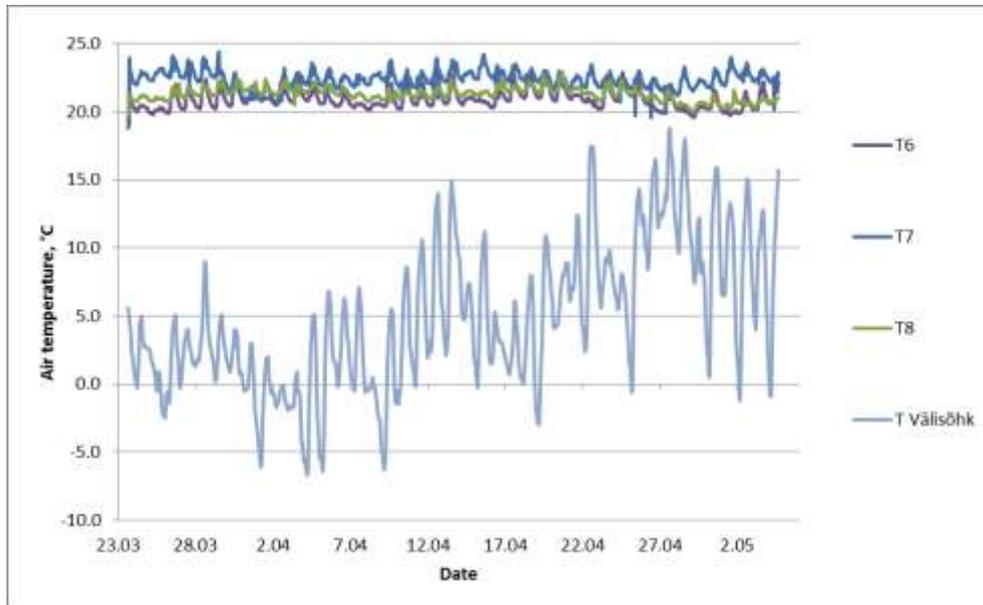
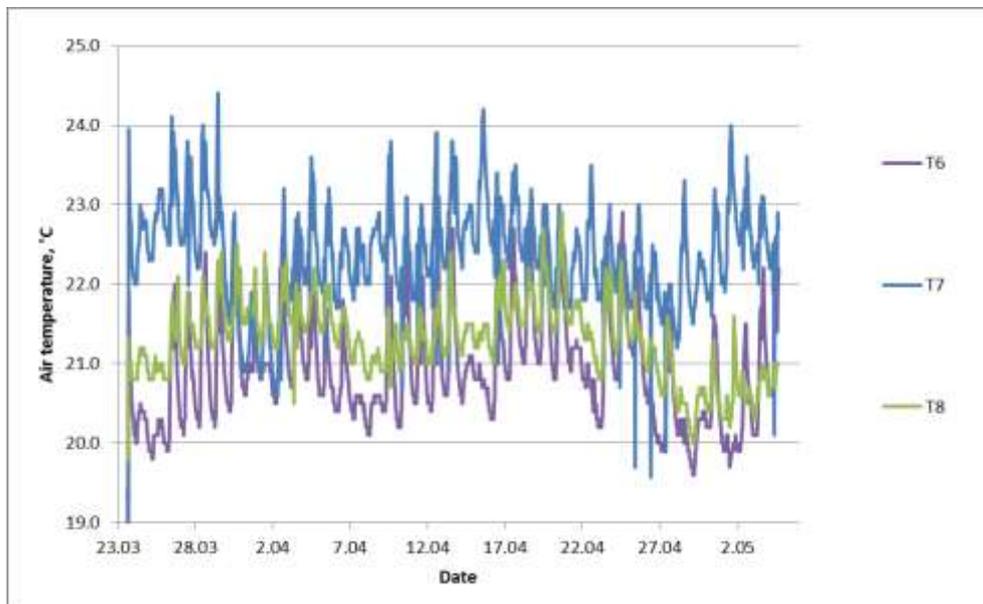
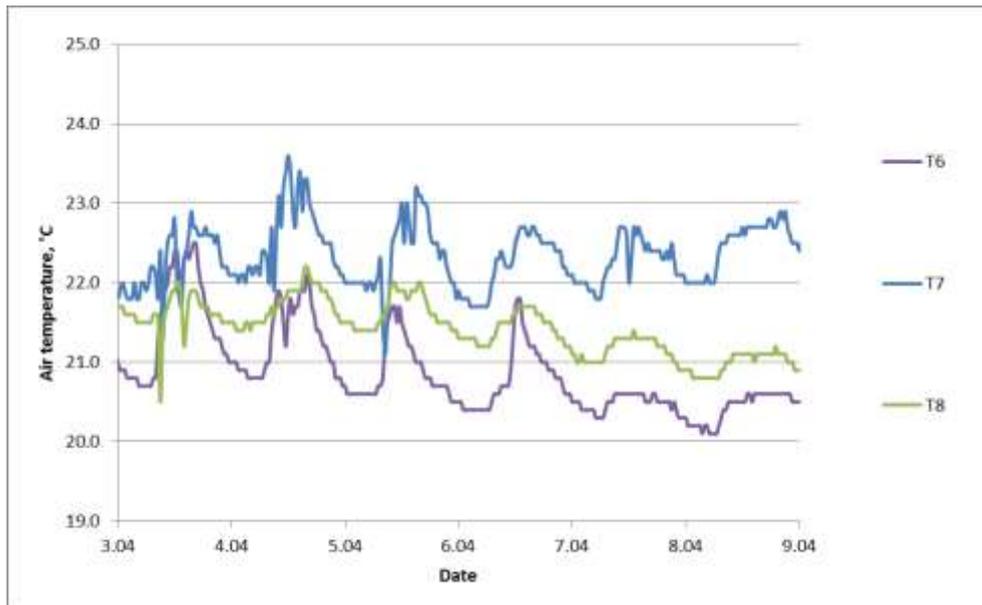
The following graphs illustrate Tiigi 11 building air temperatures during the spring period (March-May), when outside air temperature varied from -6 to 18 °C.

Figure 1 Outside air temperature and indoor air temperature in Tiigi 11 building (March – May period)

Figure 2 Indoor air temperature in Tiigi 11 building (March-May period)

Figure 3 Indoor air temperature in Tiigi 11 building during the week period, when outside air temperature varied -6...6 °C

- Indoor air temperature varies 19,8...24,3 °C,;
- II floor room (logger 7) air temperature is ca 1...1,5 °C outside higher compared to other measured rooms. From energy performance perspective the heating set point in the room should be lowered by ca 1...1,5 °C;
- During the working hours indoor air temperature fluctuation is ca 1...1,5 °C;
- The building heating system have managed to react on the outside air temperature changes in time and ensured stable air temperature conditions in rooms.

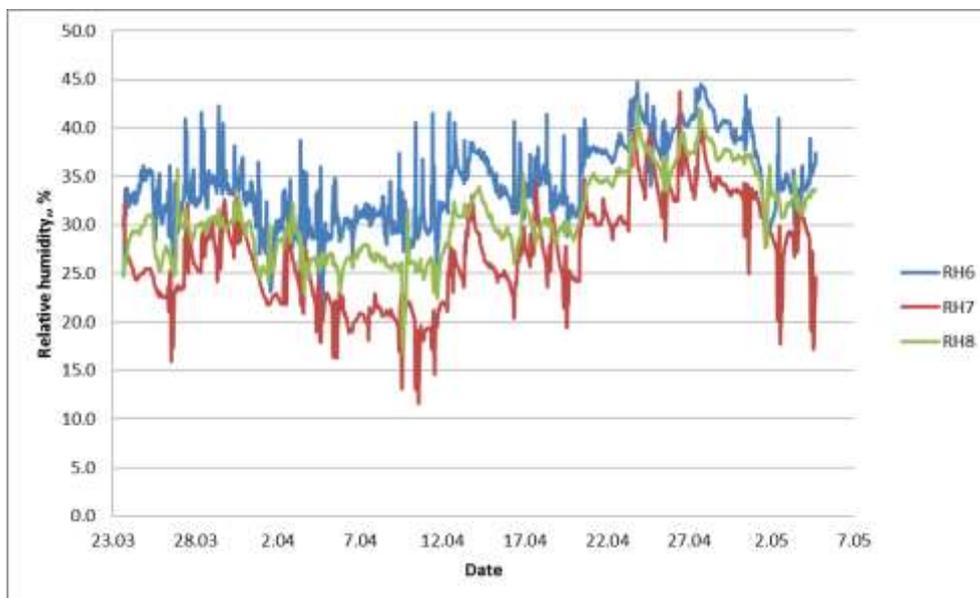
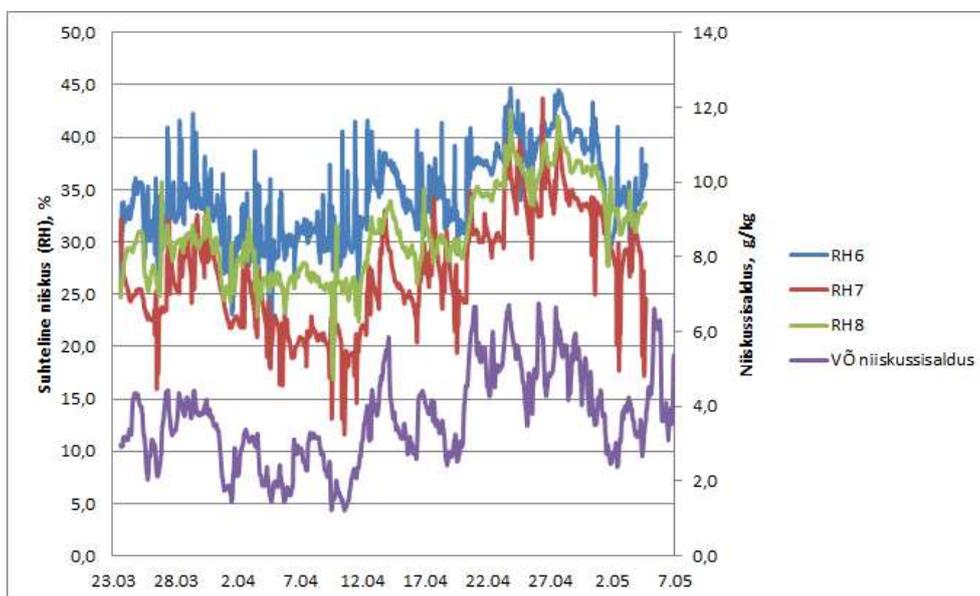
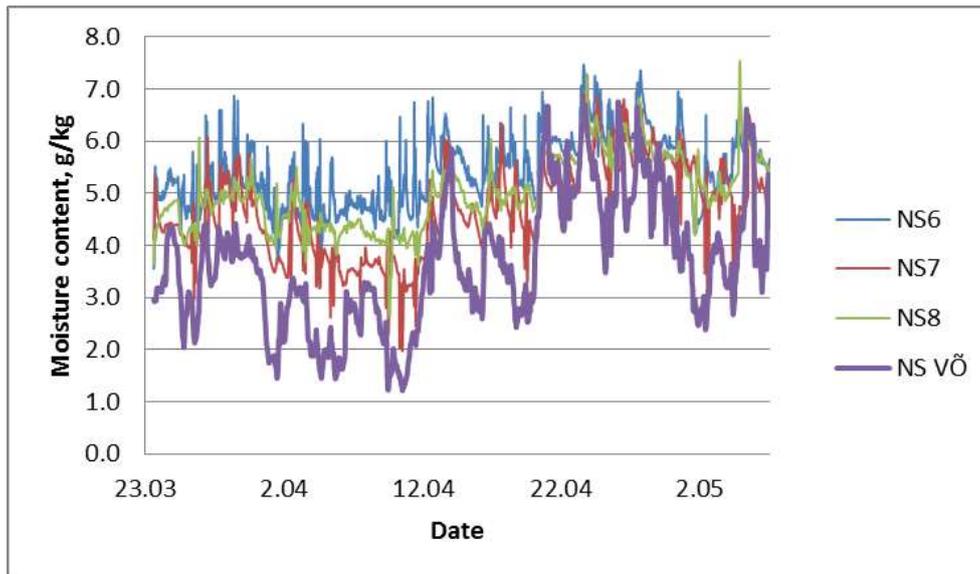
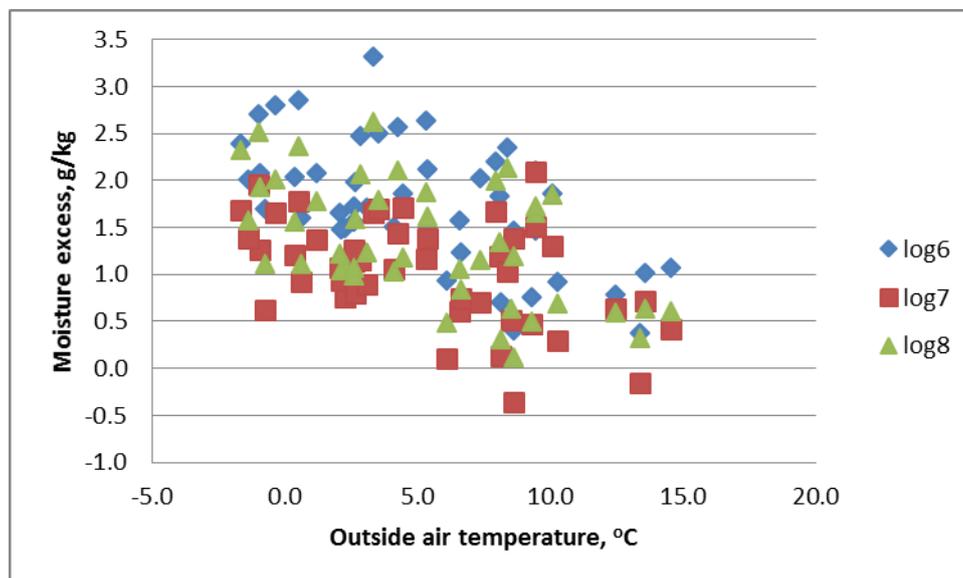
Figure 4 Tiigi 11 building indoor air relative humidity

Figure 5 Outside air moisture content and indoor air relative humidity correlation in Tiigi 11 building (spring period)

Figure 6 Outside and indoor air moisture content in Tiigi 11 building (spring period)

Indoor air quality is characterized by the difference between indoor and outdoor air moisture content, which is defined as moisture excess. The higher the indoor air moisture excess value, the lower is the air exchange in the room and the higher is the risk of moisture damage. Moisture excess values during the winter season should not exceed 2,5 g/kg (3 g/m³). The following graph describes the daily average moisture excess in measured rooms depending on the outside air temperature.

Figure 7 Daily average moisture excess content depending on the daily average outside air temperature

- Indoor air relative humidity varies 15...45%;
- Indoor air relative humidity is tend to be lower in room (logger 7) with higher indoor air temperature in comparison to room (logger 6) with lower indoor air temperature;
- Indoor air relative humidity correlates to outside air moisture content;
- Daily average moisture excess did not exceeded 3 g/kg. The building has a slight risk of moisture damage.

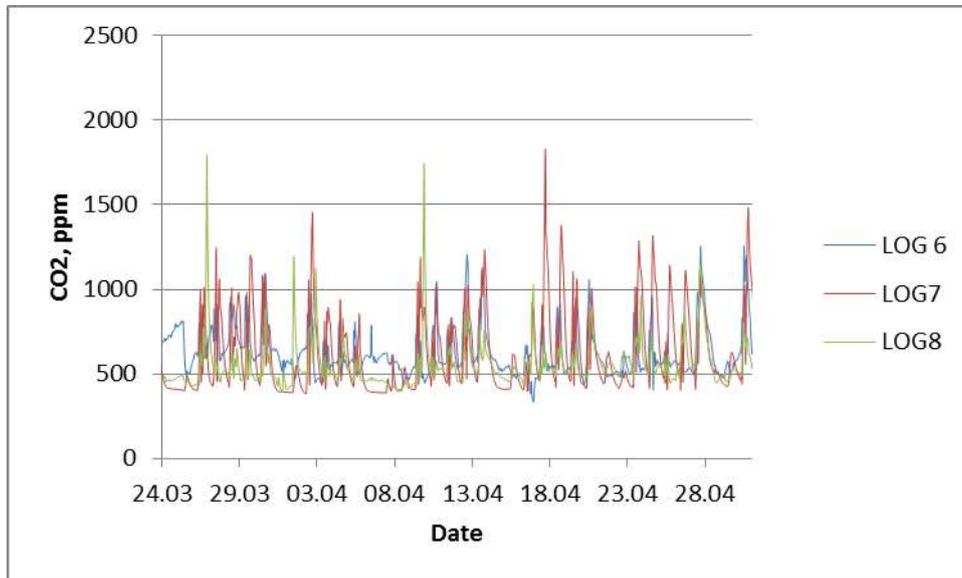
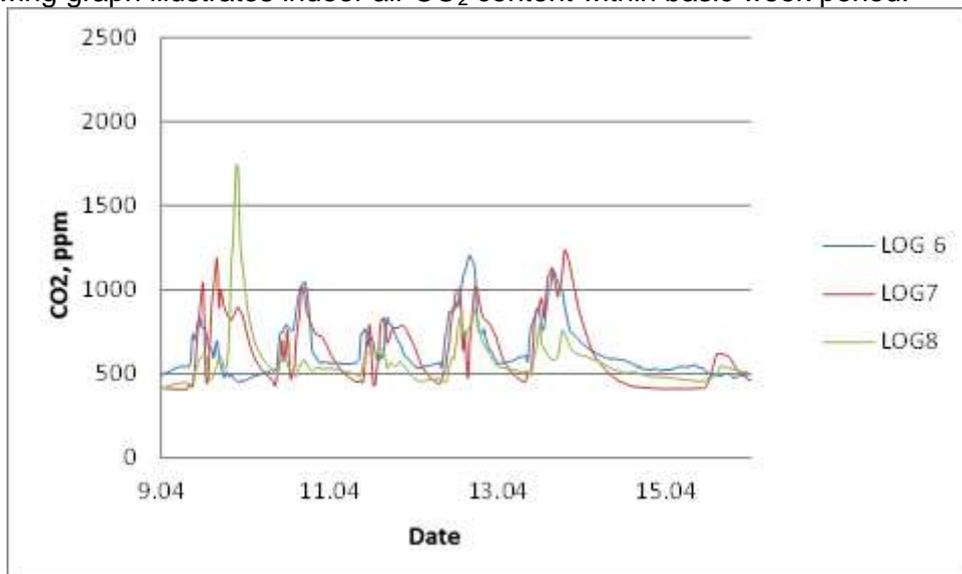
Figure 8 Indoor air CO₂ content within spring period

Figure 9 Indoor air CO₂ content within basic week period

In accordance with the World Health Organization (WHO) recommendations, CO₂ content in the indoor air should not exceed 1000 ppm.

- General CO₂ content during working hours stayed below 1000 ppm;
- Indoor air carbon dioxide content exceeded recommended 1000 ppm value for several hours a day;
- Considering that the building is being naturally ventilated, the air exchange effectiveness for this type of system is sufficient.

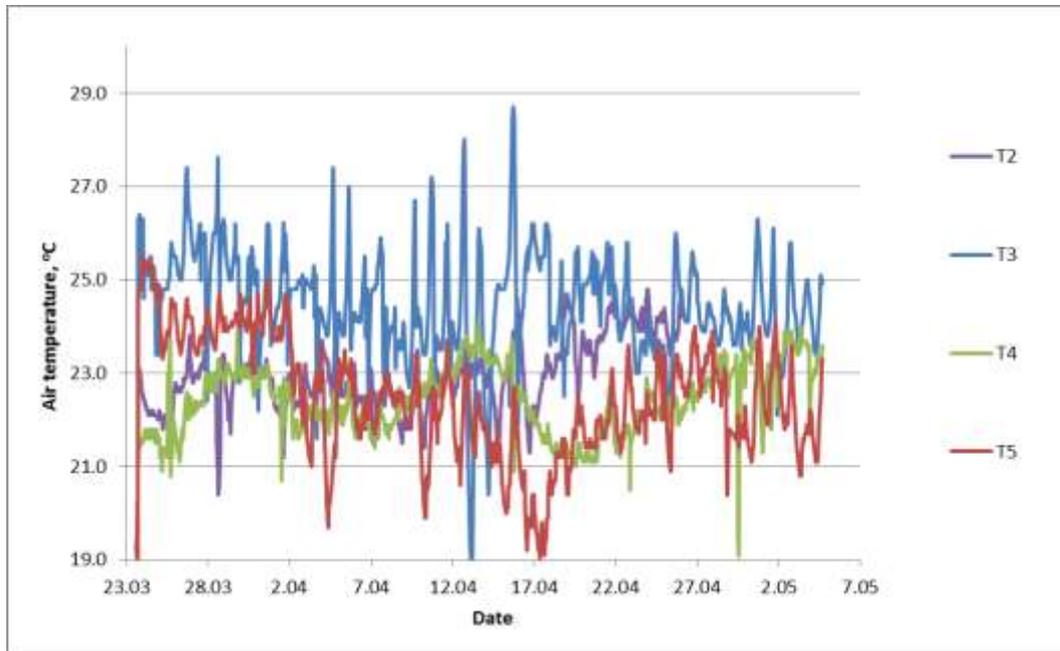
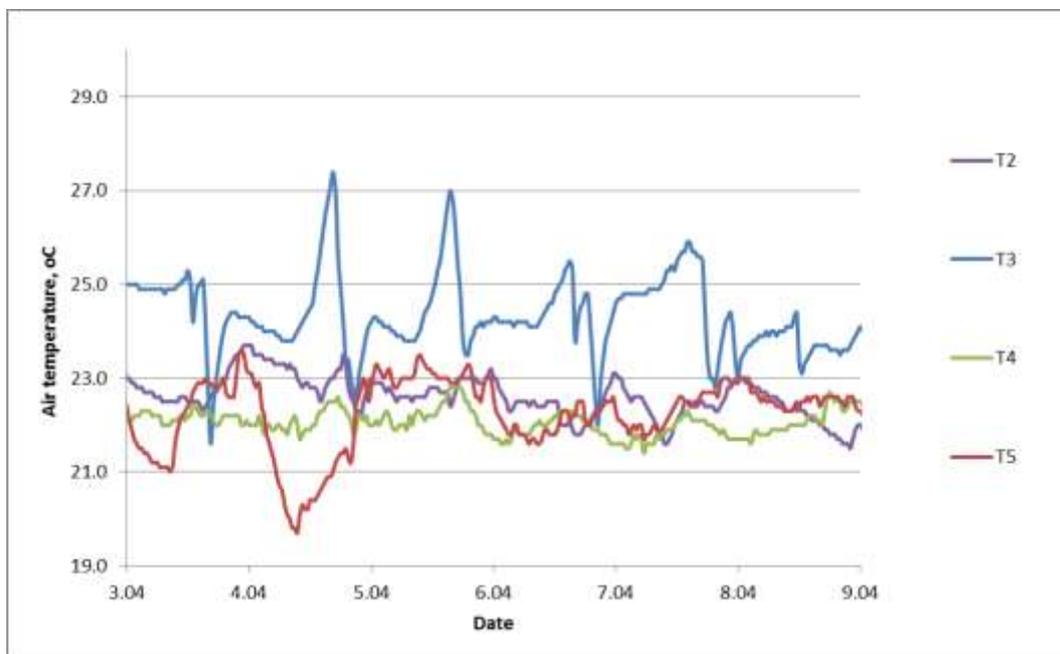
The following graphs illustrate Herne 32 building air temperatures during the spring period (March-May), when outside air temperature varied from -6 to 18 °C.

Figure 10 Indoor air temperatures in Herne 32 building (March-May)

Figure 11 Indoor air temperature in Herne 32 building during the week period, when outside air temperature varied from -6 to 6 °C
