INDOOR CLIMATE STUDY OF THE BRICK AND STONE BUILDINGS IN TARTU

Tallinn
2013

This report presents measurement results of two buildings indoor climate in two brick buildings in Tartu, subject to INTERREG IVB program project Nr 61 “Co₂ol Bricks” performed by Hevac Ltd for the Centre of Development Programs EMI-ECO (Project partner 12). Obtained results cover the period from 23.03.12 to 01.04.13.

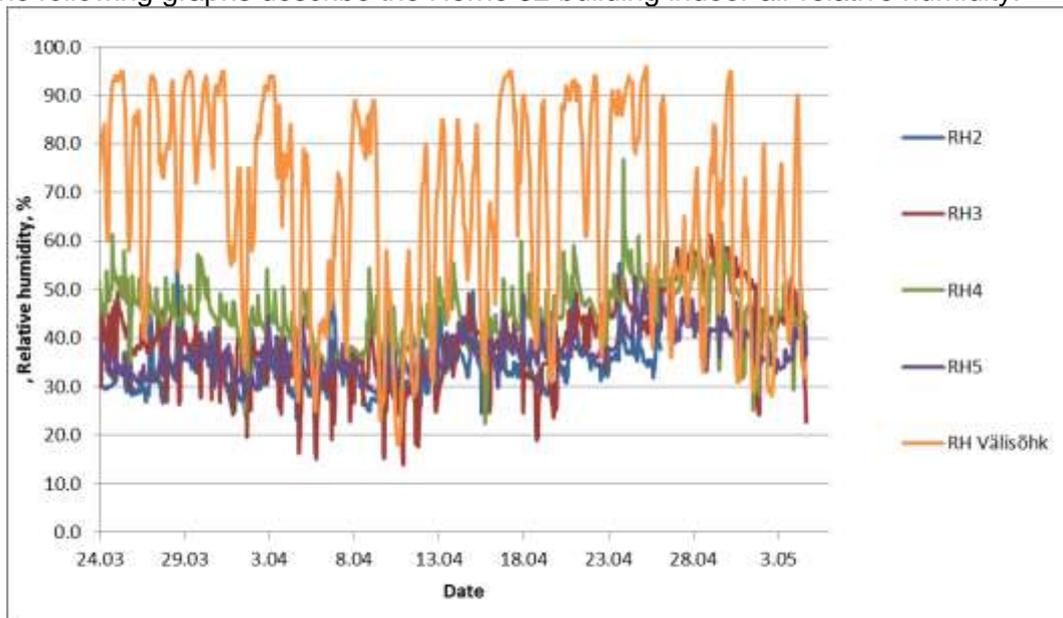
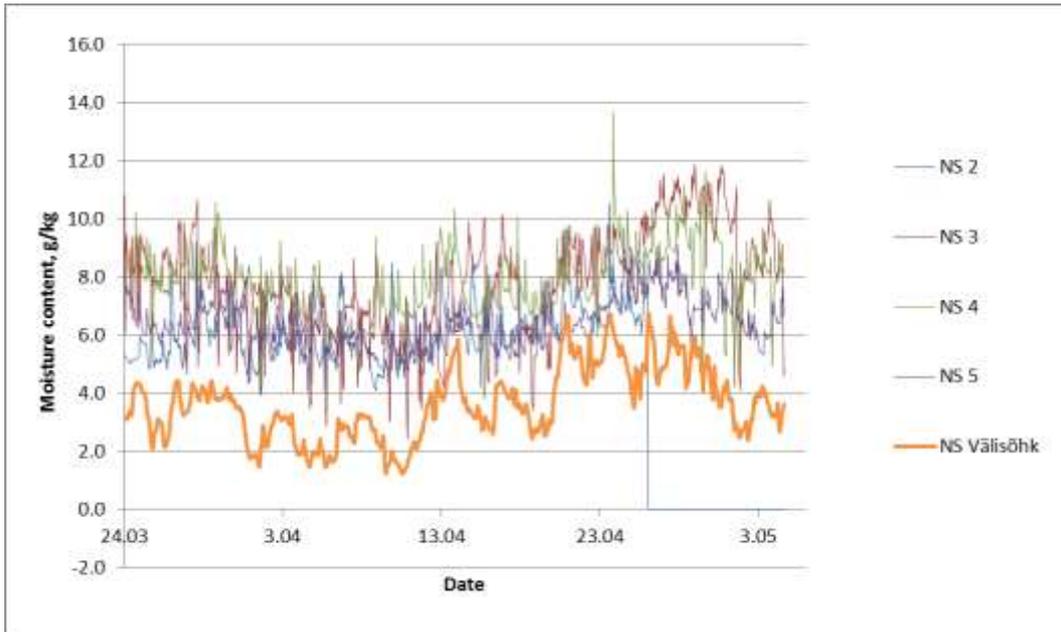
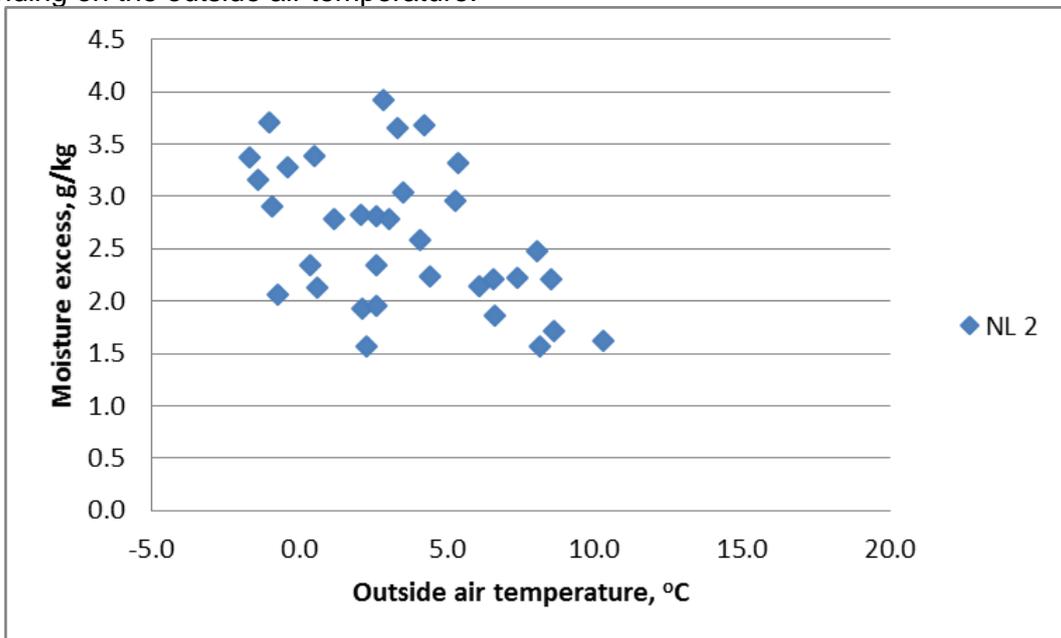
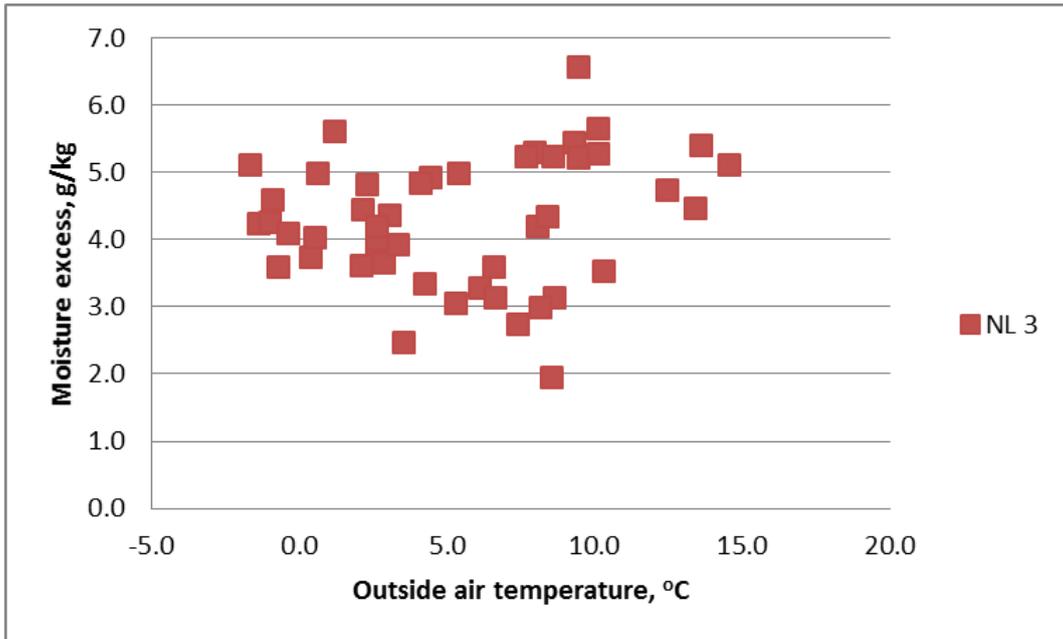
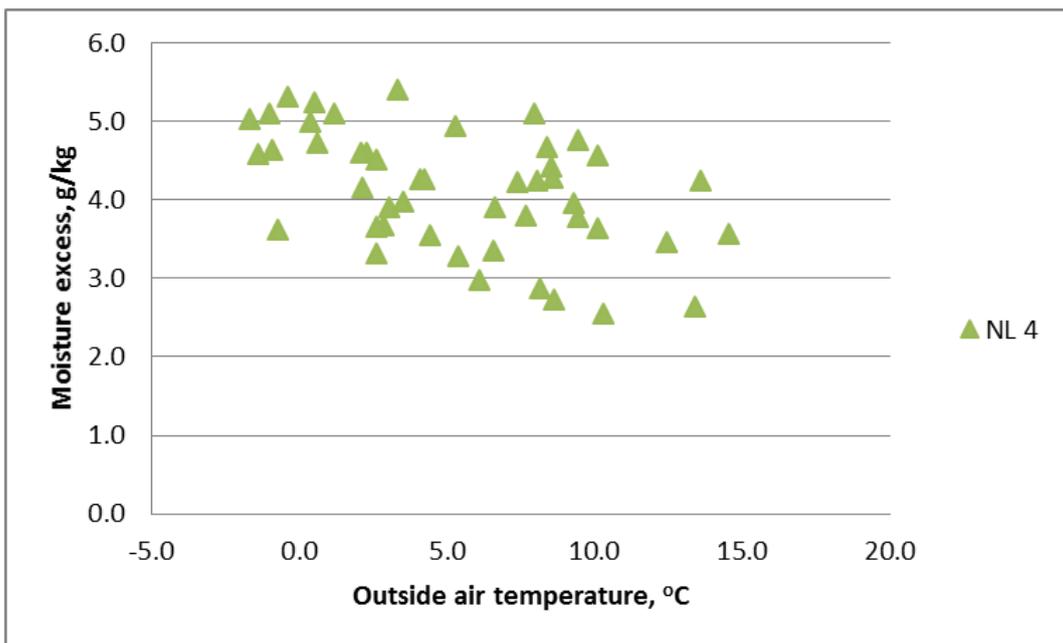
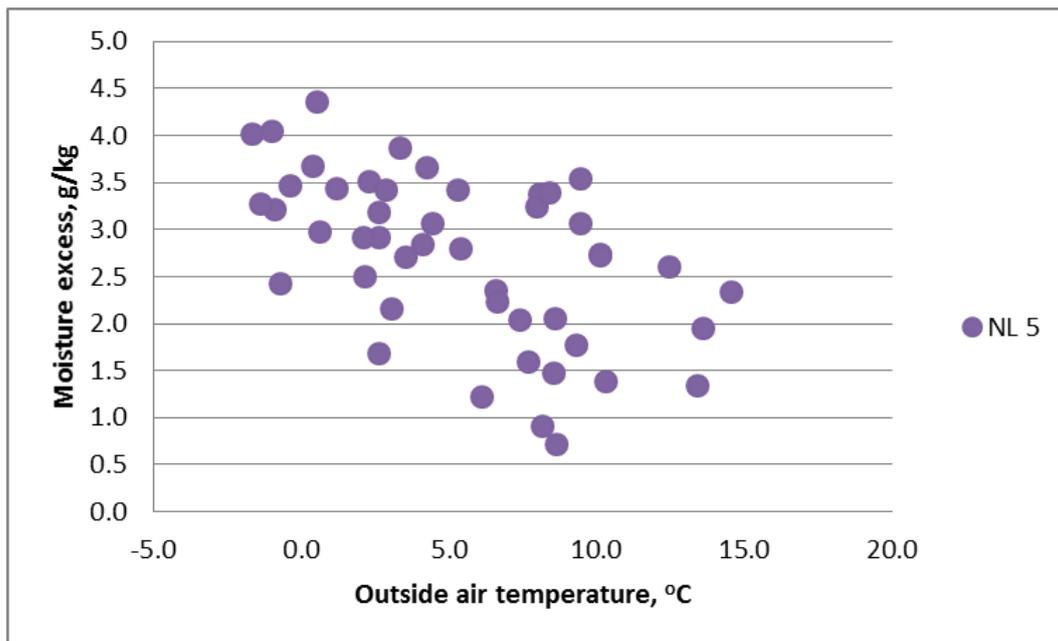
Figure 12 Herne 32 building indoor air relative humidity (March-May period)

Figure 13 Outside and indoor air moisture content in Herne 32 building (spring period)

Indoor air quality is characterized by the difference between indoor and outdoor air moisture content, which is defined as moisture excess. The higher the indoor air moisture excess value, the lower is the air exchange in the room and the higher is the risk of moisture damage. Moisture excess values during the winter season should not exceed 2,5 g/kg (3 g/m³). The following graphs describes the daily average moisture excess in measured rooms depending on the outside air temperature.

- Indoor air relative humidity varies in 25...60 % range;
- The indoor air moisture excess during the spring period significantly exceeded (sometimes twice) recommended value of 2,5 g/kg and there is a high risk of moisture damage. The peak moisture excess was recorded in rooms, where data logger 3 and 4 were located.
- Not sufficient air exchange (ventilation) rate in the building results in a high moisture excess of the indoor air;
- As the outside temperature decreased, the moisture excess in the room air increased. This indicates, that during the colder weather period windows in rooms are being less opened.

Based on the analysis above, apartment building (Herne 32) is overheated. The indoor air moisture excess during the spring period significantly exceeded (sometimes twice) recommended value and there is a high risk of moisture damage. The air exchange in a building is not sufficient.

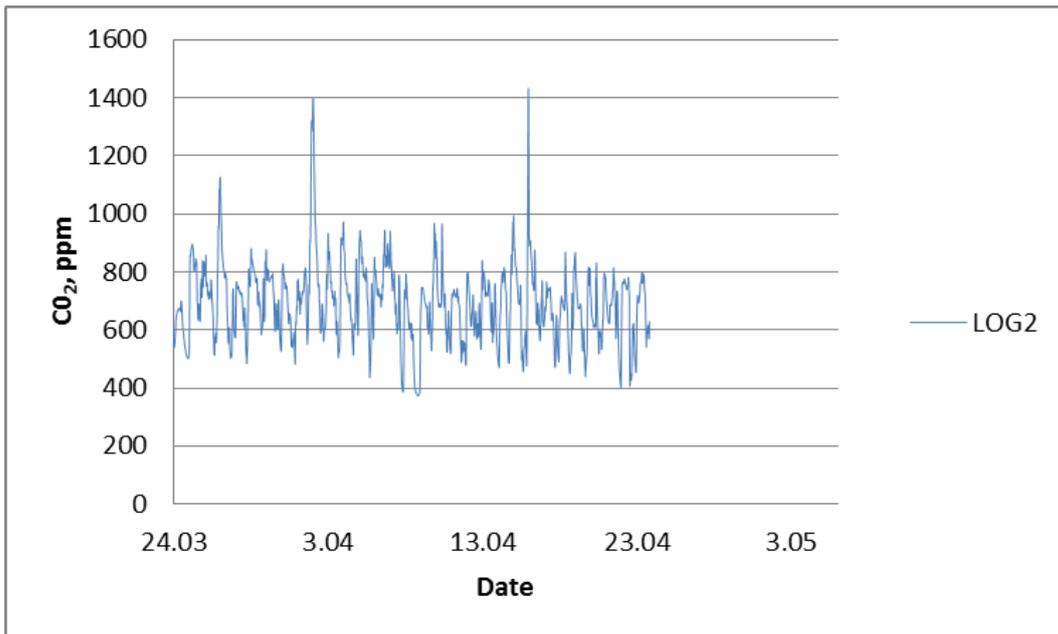
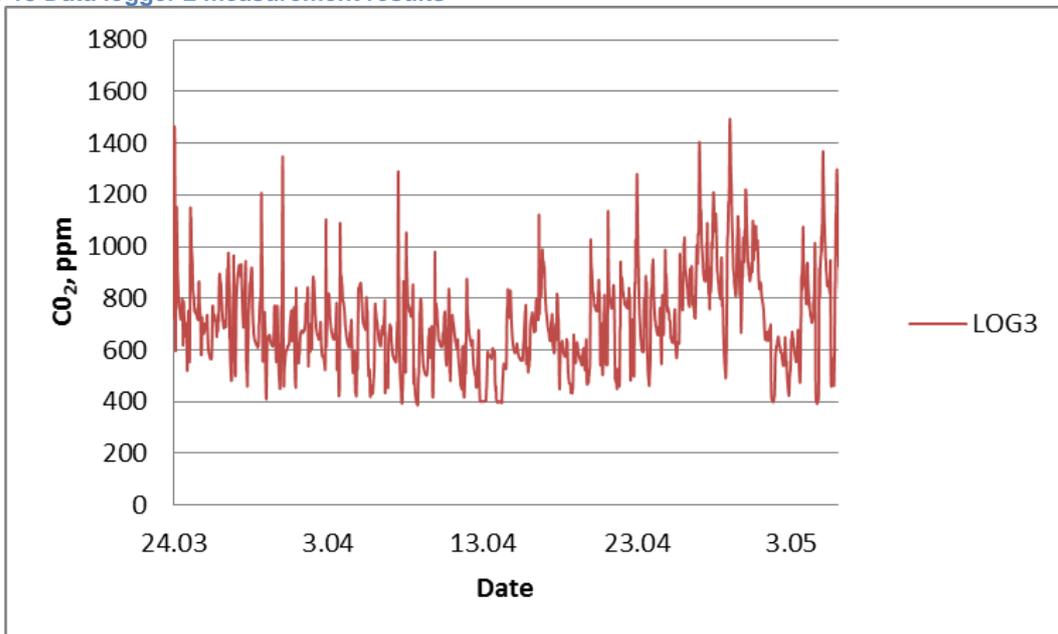
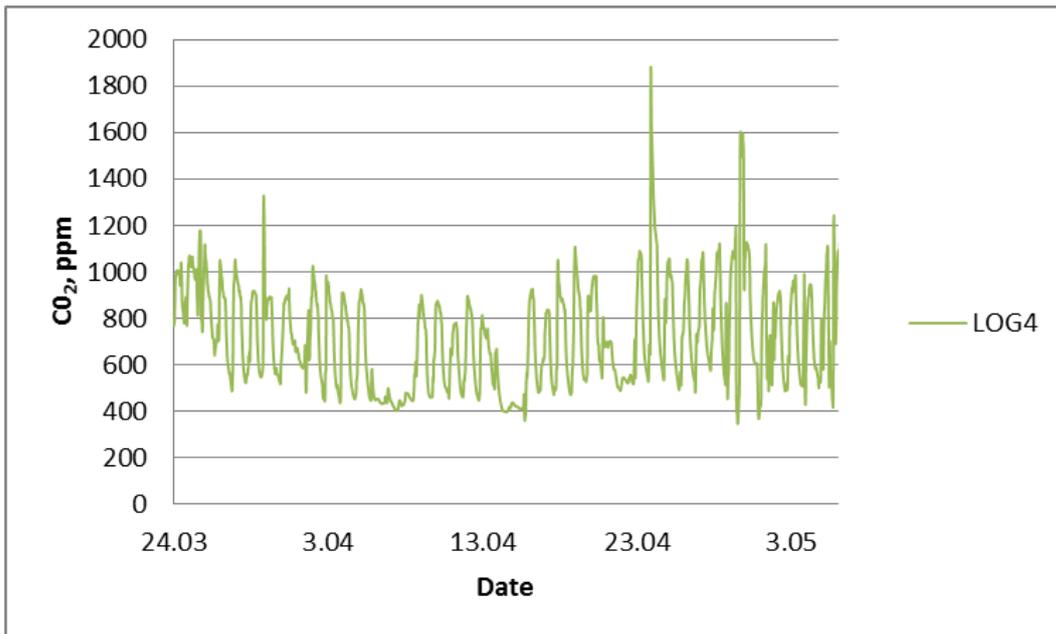
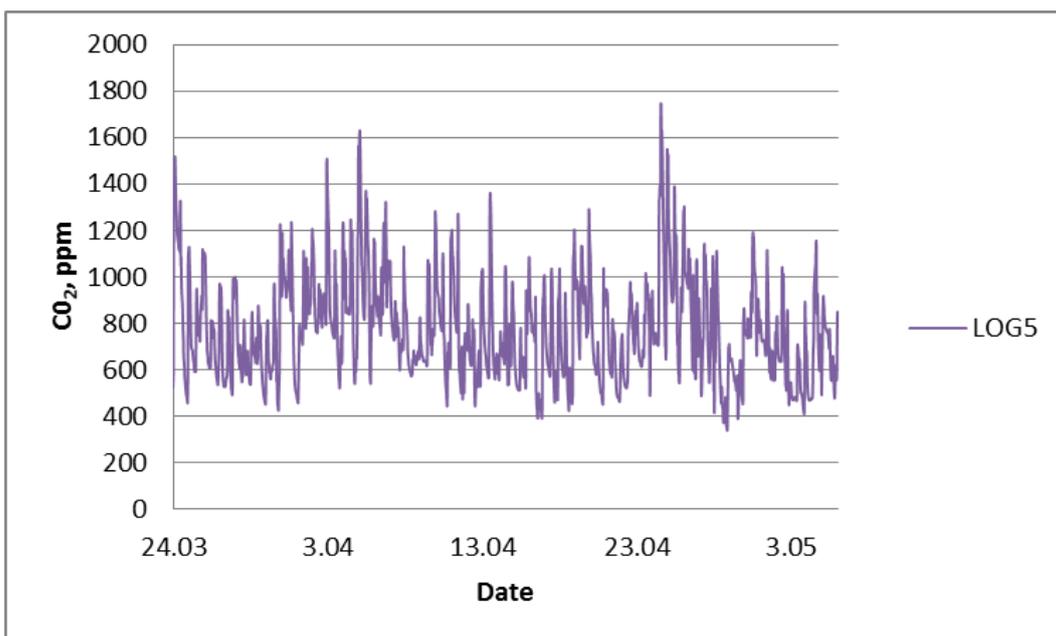
The following graphs describe the Herne 32 building indoor air carbon dioxide content within spring period.

In accordance with the World Health Organization (WHO) recommendations, CO₂ content in the indoor air should not exceed 1000 ppm.

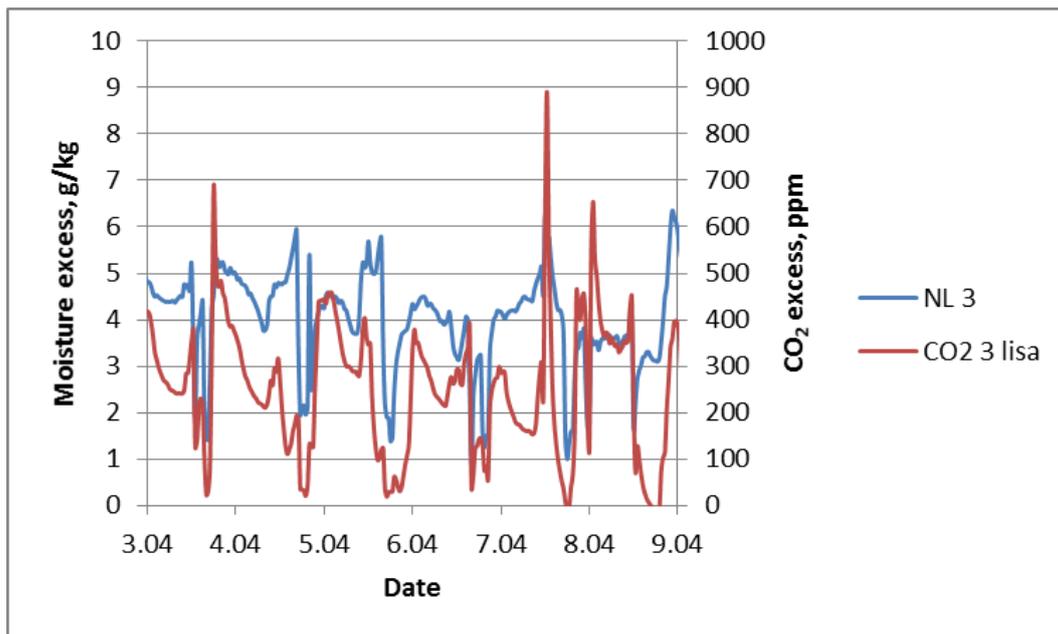
Figure 22 Indoor air moisture excess to CO₂ excess dependency

The following graph illustrates the correlation of moisture excess to CO₂ excess (outside air and indoor air CO₂ content difference). There is a noticeable dependency between moisture excess and CO₂ excess.

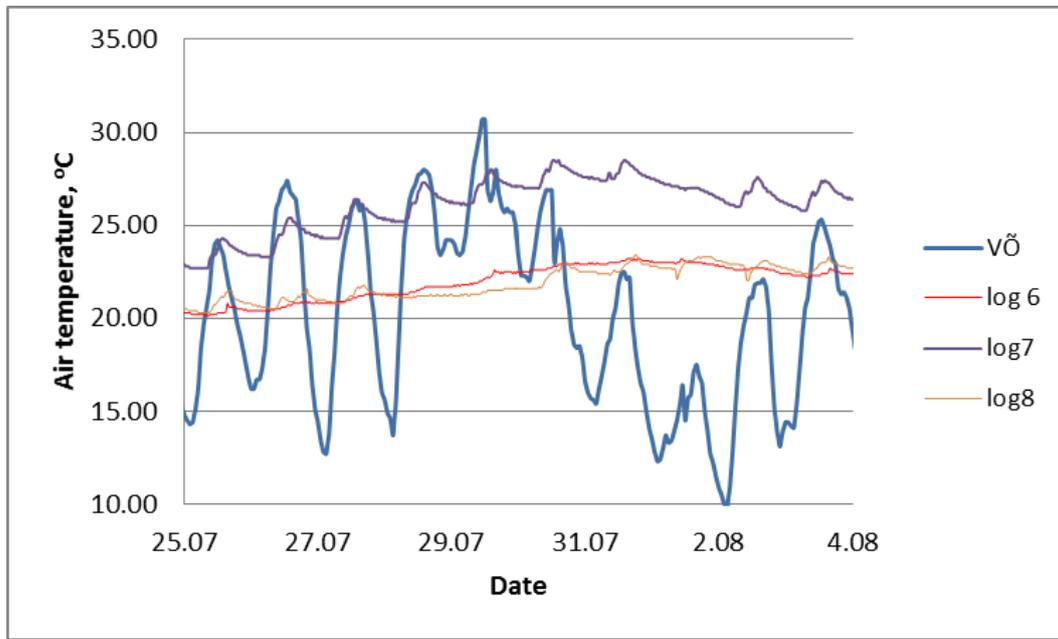
Figure 16 Indoor and outside air temperature in Tiigi 11 building within warm period

Summer period in 2012 was relatively cool and outside air temperature exceeded 25 °C only for several days. At the end of July eventually outside air temperature reached its peak at about 30 °C. The following graph illustrates the indoor and outside air temperature at the end of July.

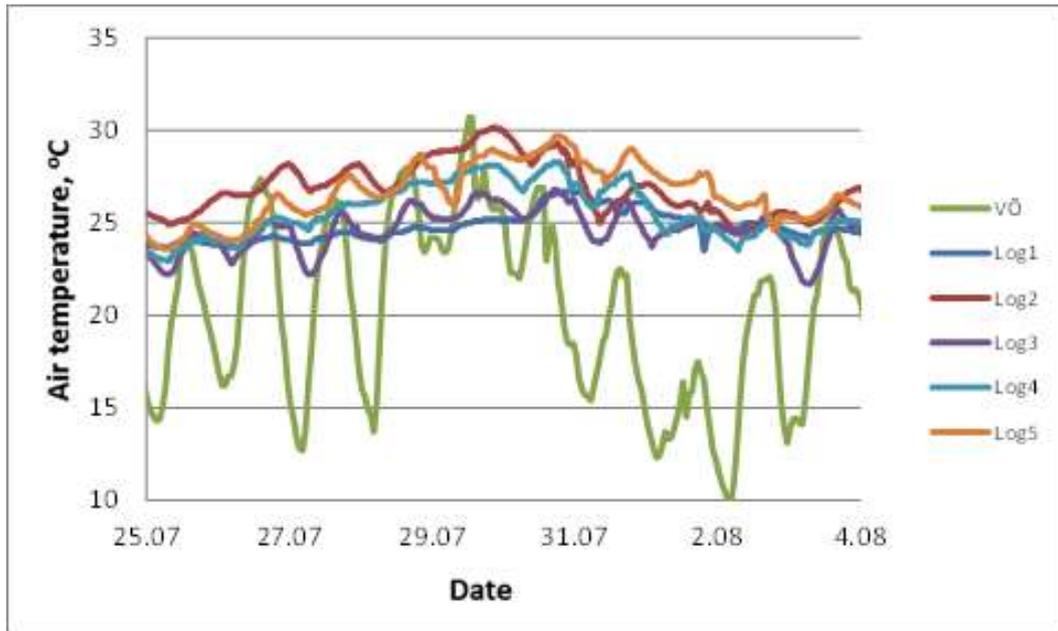
Figure 2 Indoor and outside air temperature in Herne 32 building within warm period

The following graph describes the indoor and outside air temperatures during the warm period.

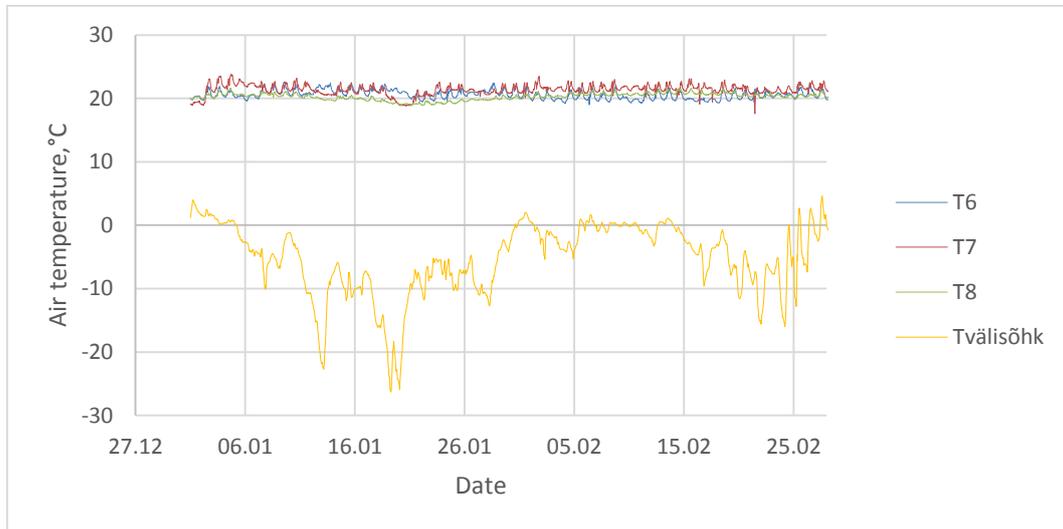
Figure 7 Indoor and outside air temperature within cold period

In the second half of January, the outside air temperature managed to go below -20°C . Most of the measured period the outside air temperature stayed below 0°C . When outside air temperature reached -20°C and below, indoor air temperature dropped below 20°C .

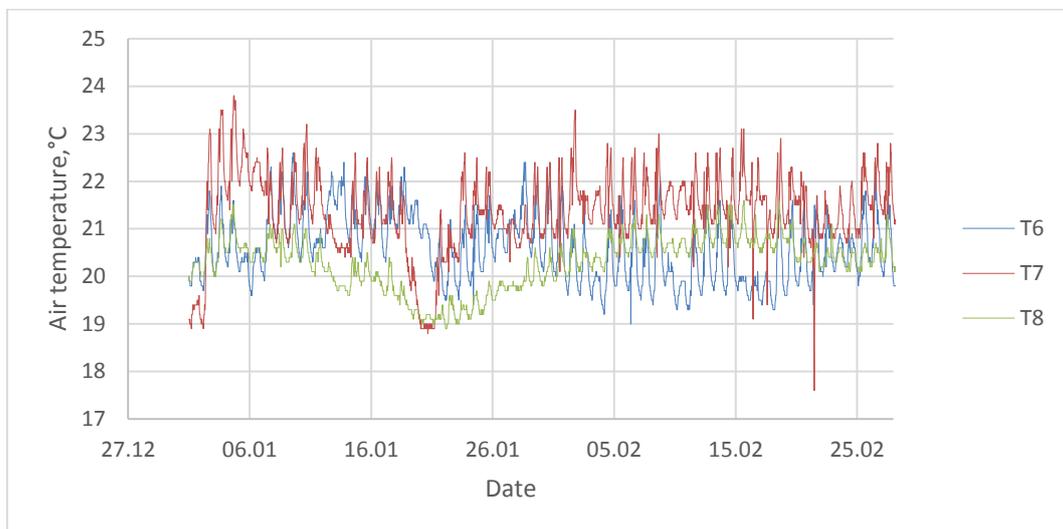
Figure 8 Indoor air temperature within cold period

Second floor room (T7) air temperature was ca 1°C higher in comparison to first floor rooms.

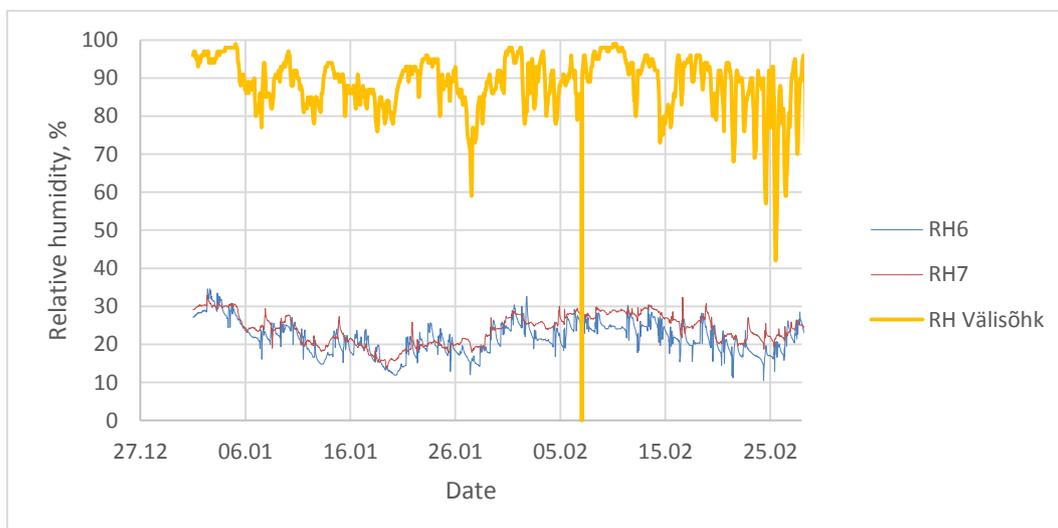
Figure 10 Indoor and outside air relative humidity within cold period

Indoor air relative humidity varied in $10\text{...}35\%$ range within cold period. Indoor air relative humidity correlates to outside air temperature – the colder the outside air is, the smaller is relative humidity value.

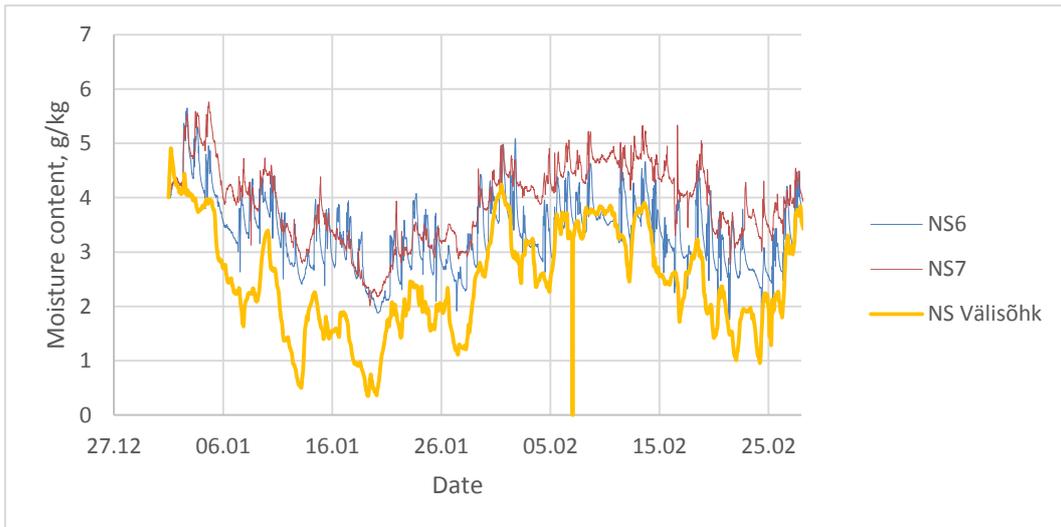
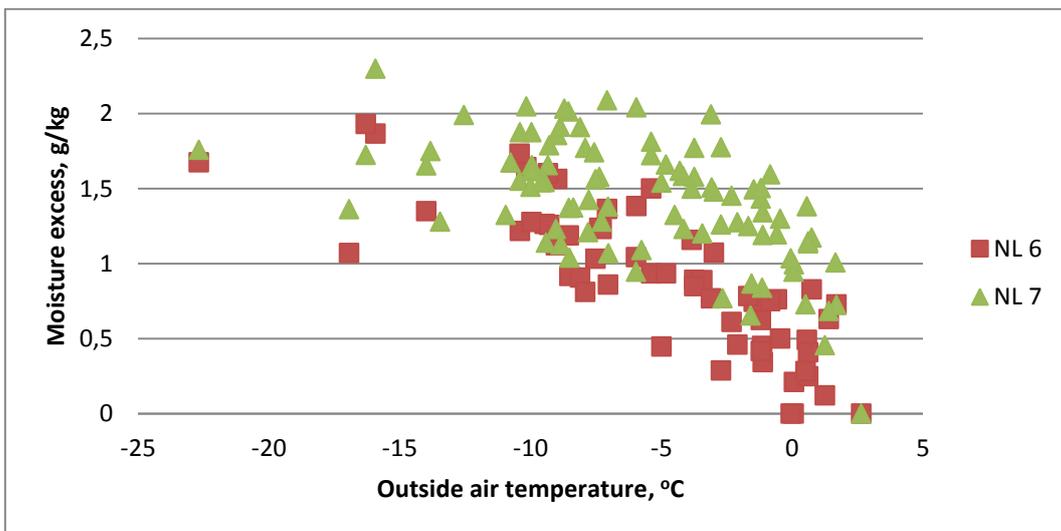
Figure 11 Indoor and outside air moisture content within cold period

Indoor air quality is characterized by the difference between indoor and outdoor air moisture content, which is defined as moisture excess. The higher the indoor air moisture excess value, the lower is the air exchange in the room and the higher is the risk of moisture damage. Moisture excess values during the winter season should not exceed 2,5 g/kg (3 g/m³). The following graph describes the daily average moisture excess in measured rooms depending on the outside air temperature.

Figure 6 Daily average indoor air moisture excess content depending on the daily average outside air temperature

Indoor air moisture excess within cold period stayed below 2,5 g/kg and the building moisture conditions meet the requirements. There is no moisture damage risk in this building.

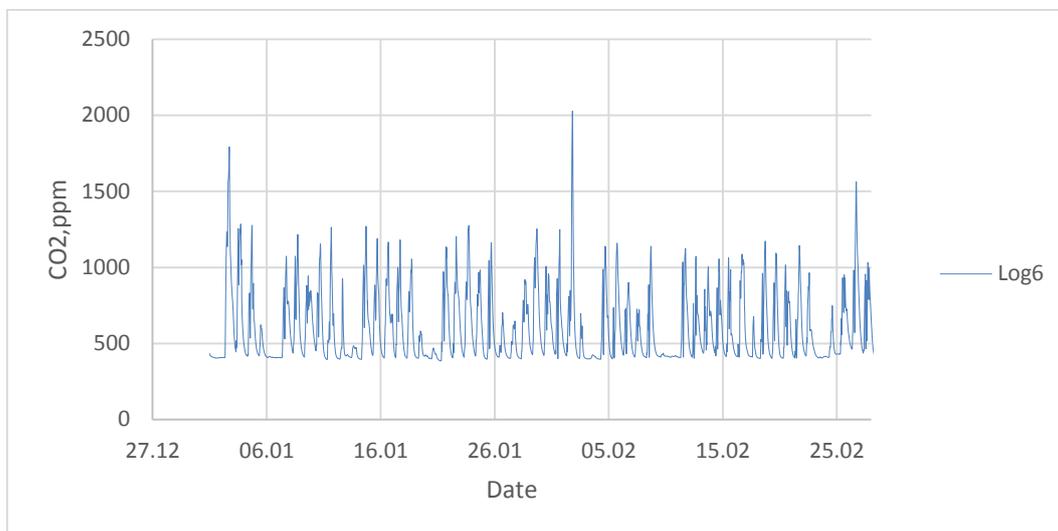
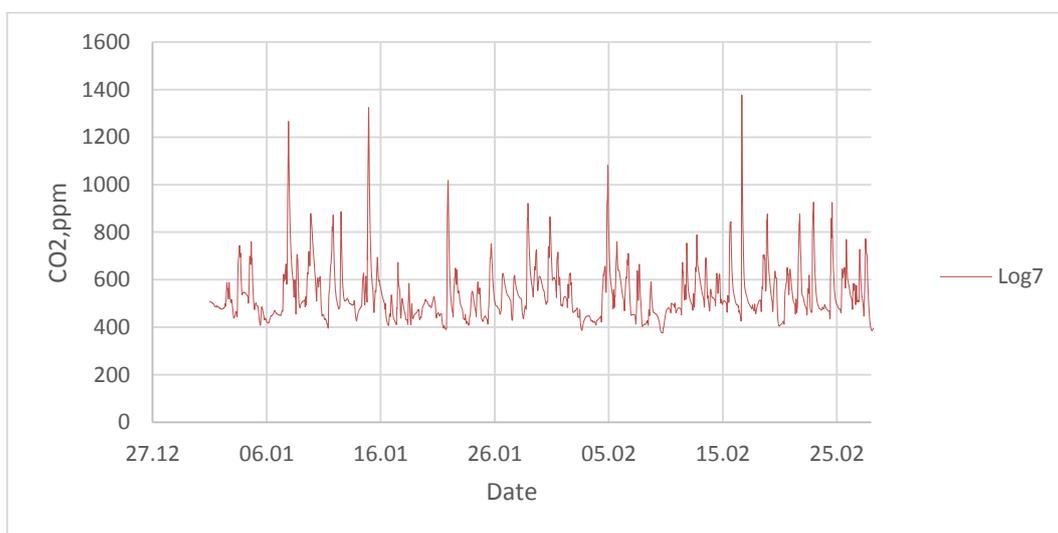
Figure 7 First floor room air carbon dioxide content within cold period

At a short-term perspective, indoor air CO₂ content peaked at ca 1500 ppm, but most of the time CO₂ content was below 1200 ppm.

Figure 8 Second floor room air carbon dioxide content within cold period

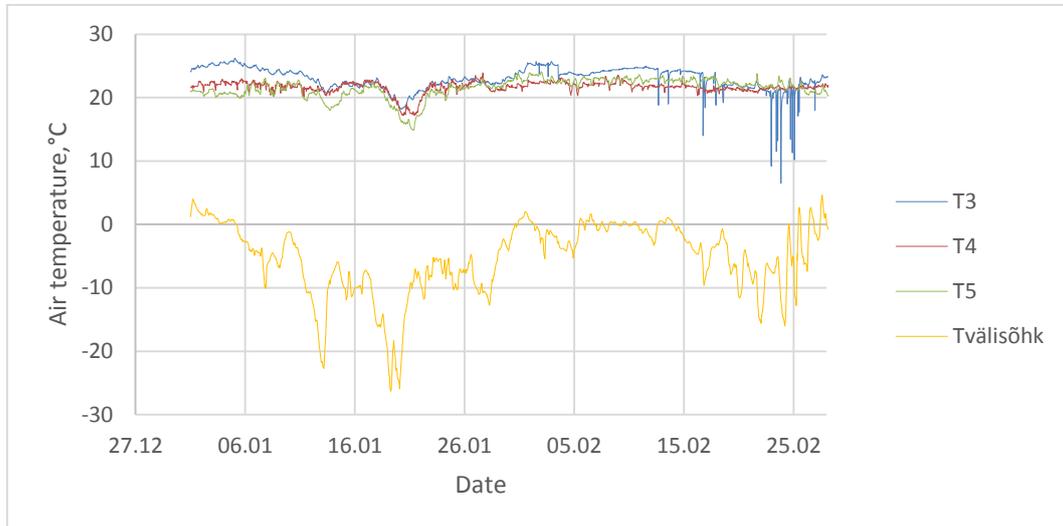
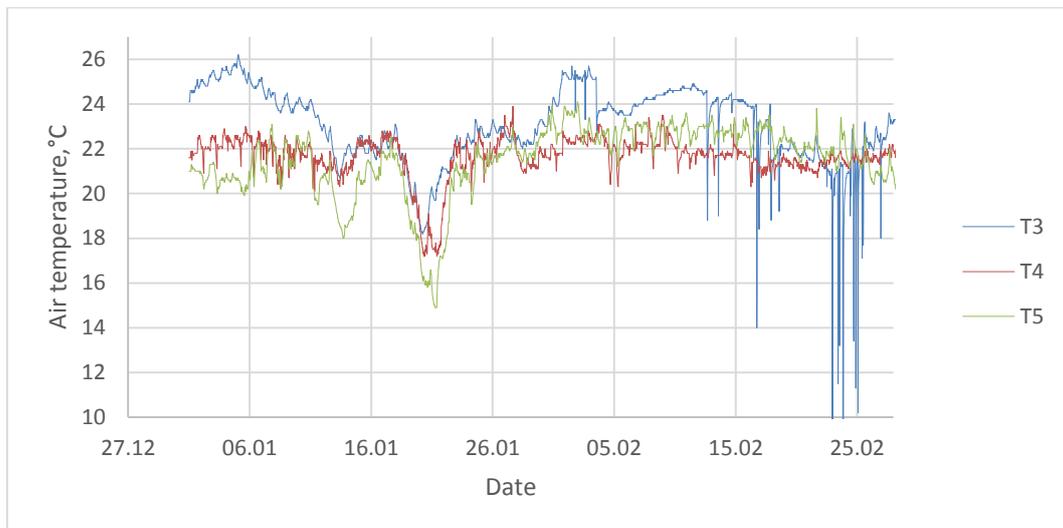
Figure 9 Indoor and outside air temperature within cold period

Figure 10 Indoor air temperature within cold period

During the low outside air temperatures it was not possible to sustain recommended indoor air temperature and it eventually dropped to 15...18 °C. Building was constantly overheated during the cold period. Air carbon dioxide content in measured rooms exceeded 1000 ppm. Indoor air moisture excess was way above the recommended value of 2,5 g/kg and the building has a risk of moisture damage.

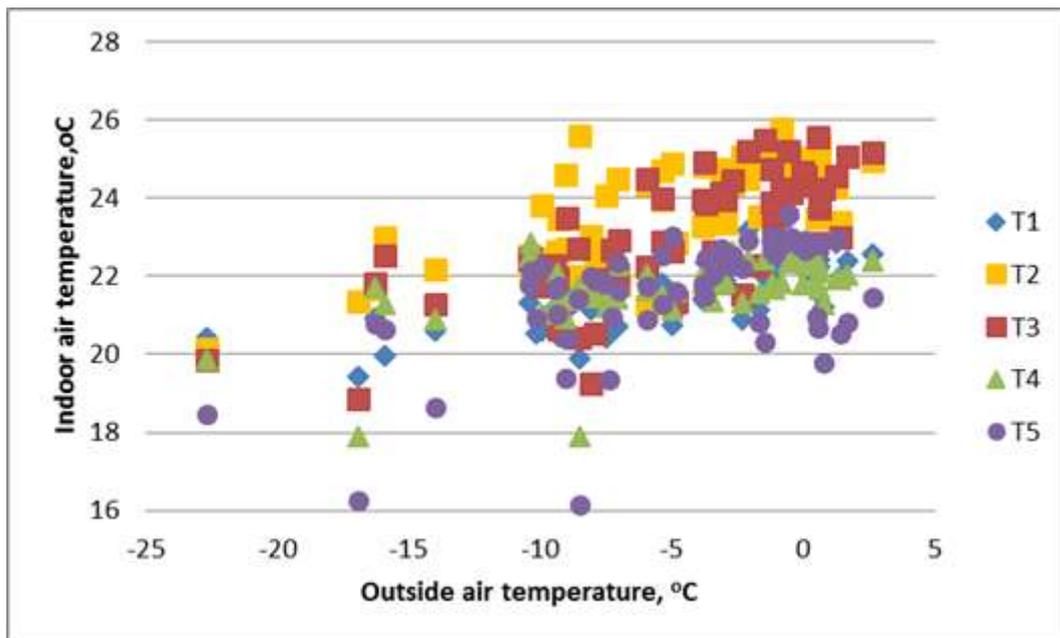
Figure 11 Daily average indoor and outside air temperature within cold period

The following graph illustrates the dependency of daily average indoor air temperature to daily average outside air temperature.

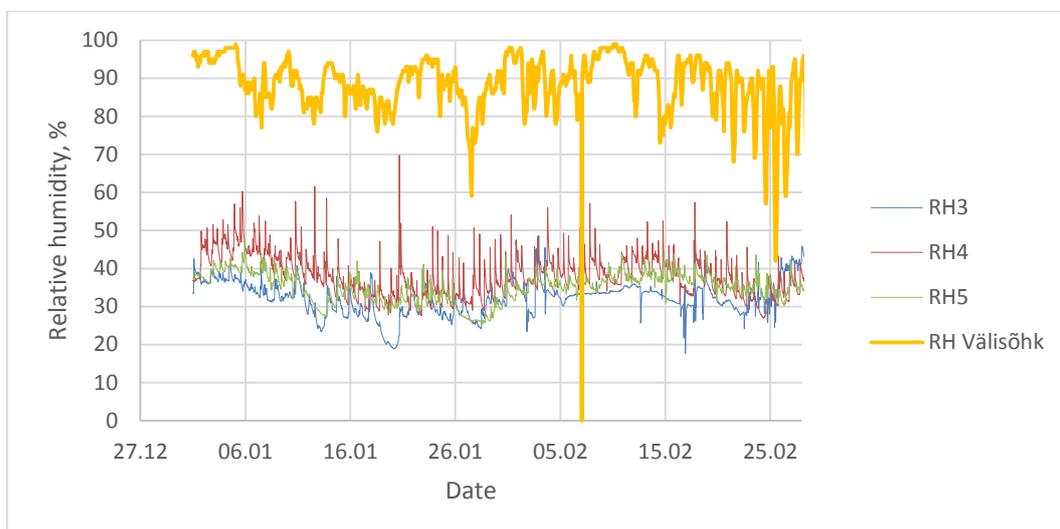
Figure 12 Indoor and outside air relative humidity within cold period

Indoor air relative humidity varied within 25...50 % range.

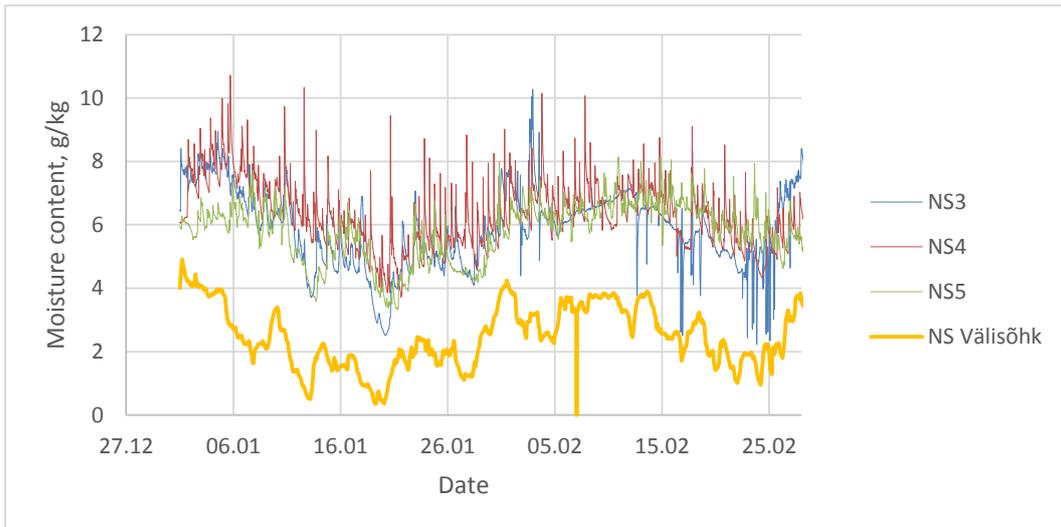
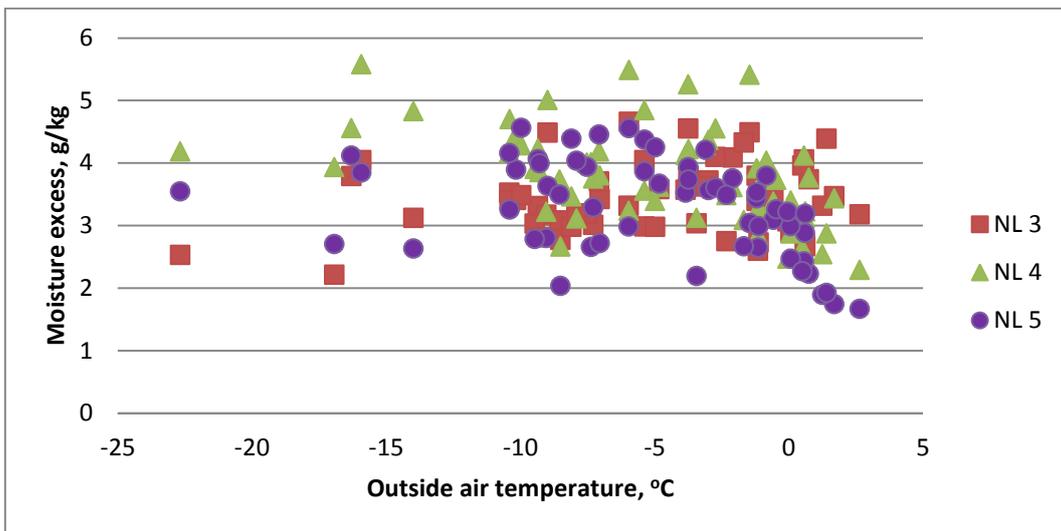
Figure 123 Indoor air moisture content in comparison to outside air moisture content

The following graph displays the daily average indoor air moisture excess at defined daily average outside air temperature.

Figure 14 Daily average indoor air moisture excess depending on the outside air temperature

The indoor air moisture excess was continuously above the recommended 2,5 g/kg and the building has a risk of moisture damage.

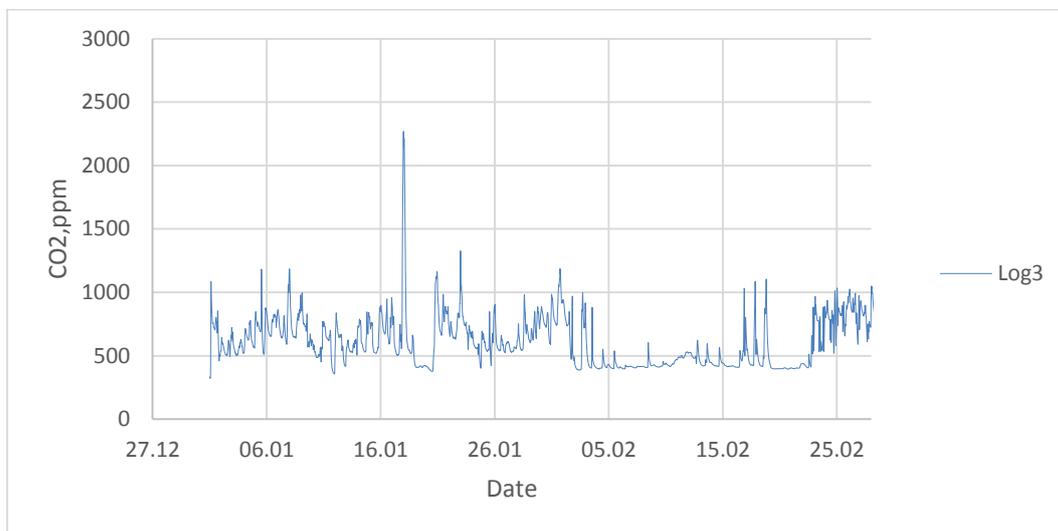
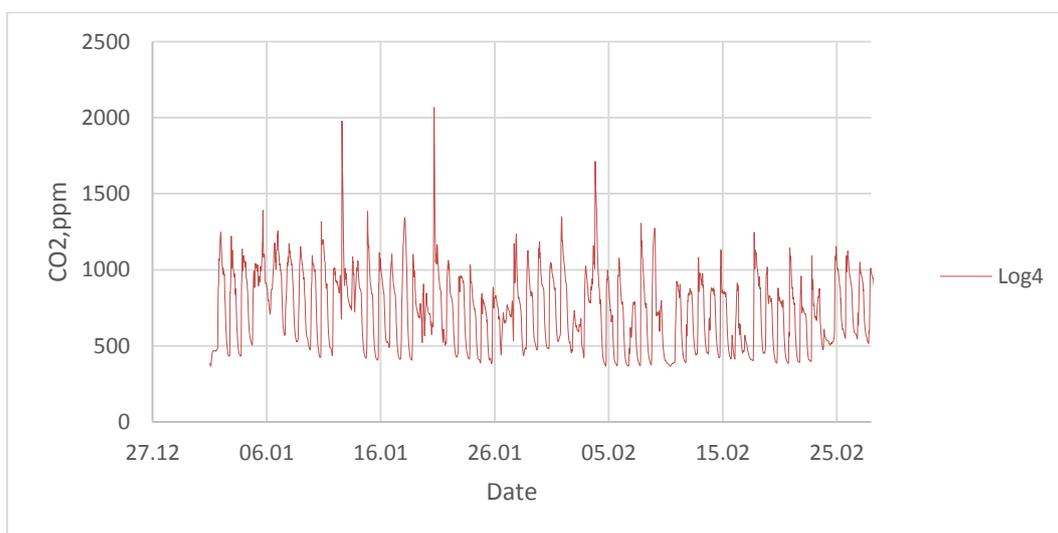
Figure 15 First floor room air carbon dioxide content

Figure 16 Second floor room air carbon dioxide content

Indoor air carbon dioxide content constantly exceeded recommended value of 1000 ppm. During the short-term period, CO₂ content from time to time reached its peak at 1500 ppm.

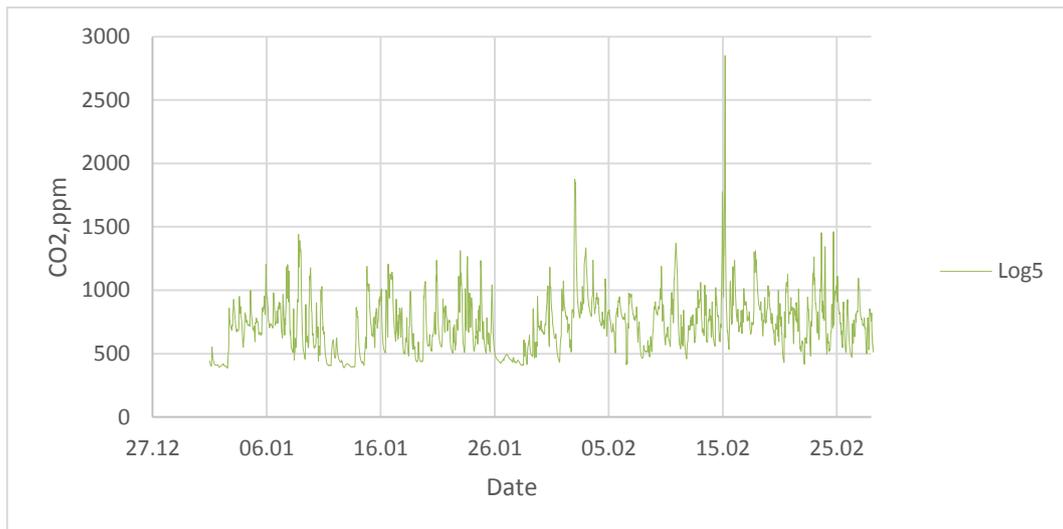
Figure 17 Third floor room air carbon dioxide content

Indoor air carbon dioxide content exceeded the recommended 1000 ppm quite often. CO₂ content reached its peak at 2800 ppm.
