ТЕХНИЧЕСКОЕ СОСТОЯНИЕ ПЛАНИРУЕМОЙ ПОД РЕКОНСТРУКЦИЮ ЧАСТИ ЗДАНИЯ – СПОРТЗАЛА БЫВШЕЙ ШКОЛЫ ПО АДРЕСУ Спорди 2, Кохтла-Ярве

**TECHNICAL CONDITION OF THE PART OF THE
FORMER SCHOOLBUILDING - GYM, WHICH IS
PLANNED TO BE RECONSTRUCTED.**

Инженер: Айво Рауд (Zoroaster OÜ)
Engineer: Aivo Raud (Zoroaster OÜ)

Kohtla-Järve, 23.05.2012

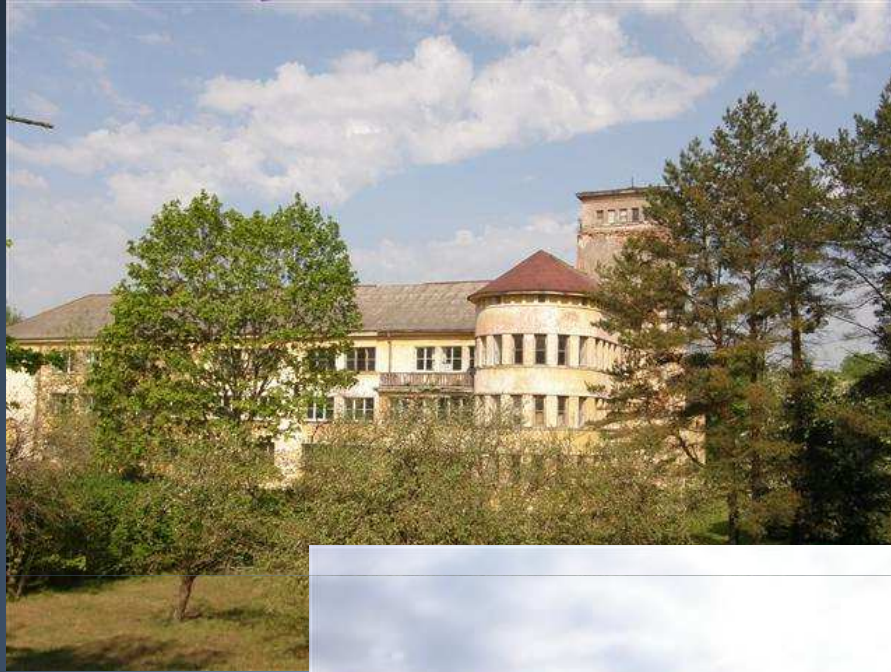
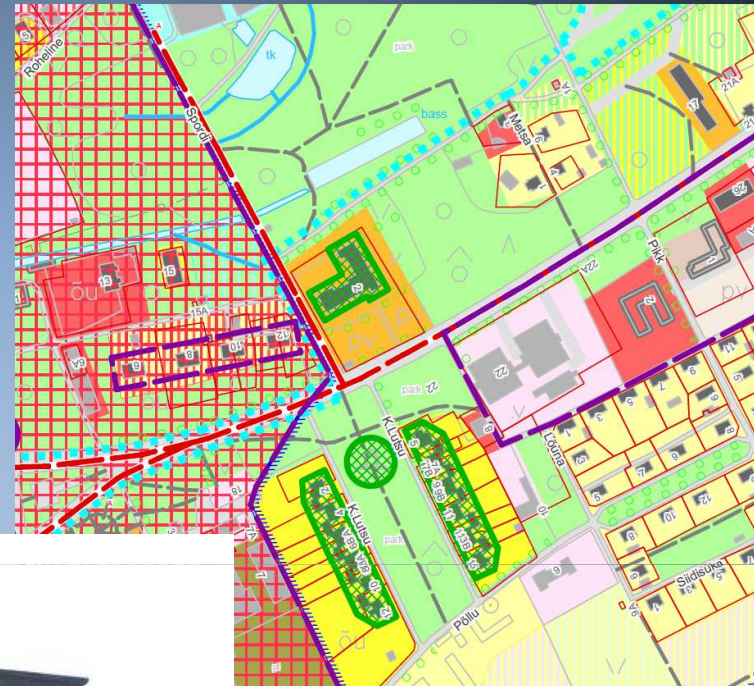
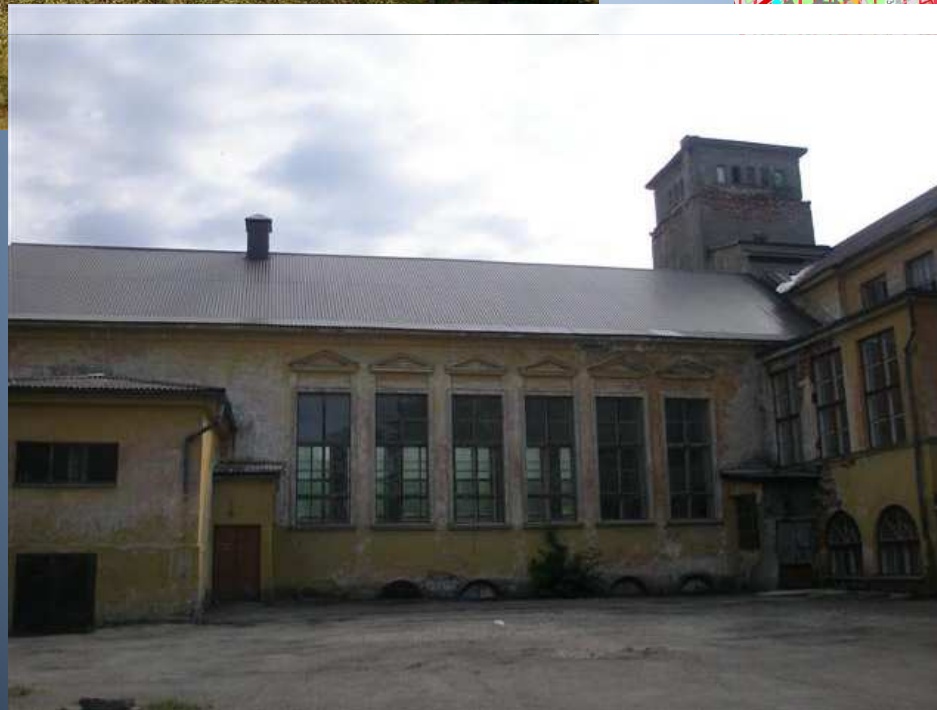
In the following years, internal layout of the rooms in the building was partially redesigned. At present, the tower and staircase adjacent to the gym are in particularly poor condition.
