# Pilot project 'Information Centre', Riga

## LATVIA

## 1 Project description

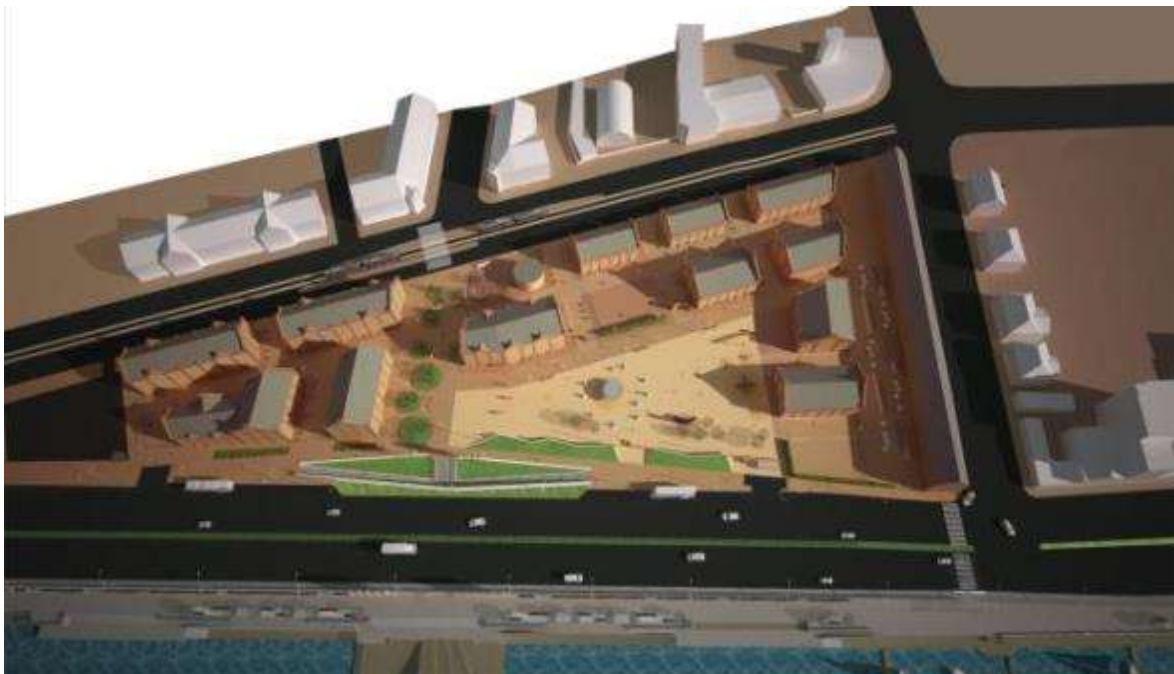
Urban development plan (source: Riga City Development department, Architect: Ltd."ARPLAN")
