Bricks and Brick buildings

History, Weaknesses and Potentials

Script of the lecture for Module 3 – Bricks and joints/heritage monument protection problems

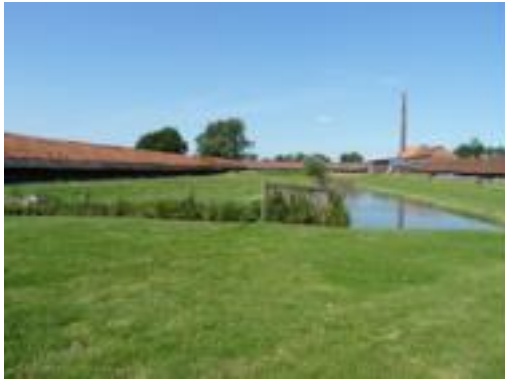
Picture 1

The site of the Drochtersen brick factory, with the former clay pit which has now become a pond.

On the right and left in the picture are the structures housing the conveyor belts for the bricks that run from the kiln to the storage location. The transport route is also used for cooling the fired bricks.

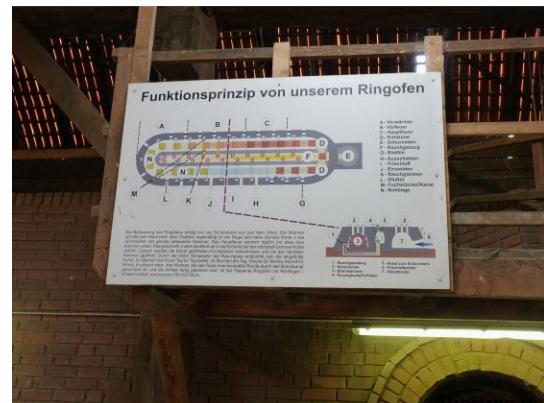
Picture 2

The diagram illustrates the functional principle of the ring kiln.

batch is walled in, the chamber is filled with coal and ignited. For the finished batch of baked bricks, the brickwork wall is removed in order to cool the burned material. At the same time, a new batch of raw bricks are inserted for pre-drying and preheating.

This results in a permanent process of: cooling – burning – filling – pre-heating – pre-drying – burning – cooling.

In a ring kiln "the fire never goes out." From one side the kiln is filled with raw bricks, then the access opening is walled-off. Then, from the top, the coal is added, the fire ignited and controlled. In the meantime, the next batch of raw bricks is placed into the kiln, so that the heat of the preceding internal fire continues to dry the newly introduced raw bricks. After completion of the firing cycle, the newly introduced and pre-dried

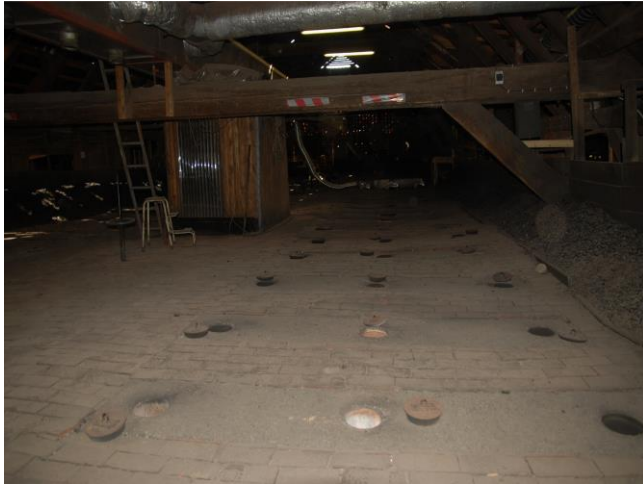
Picture 3

The roof of the ring kiln furnace, with openings for fuelling and fire control of the furnace.

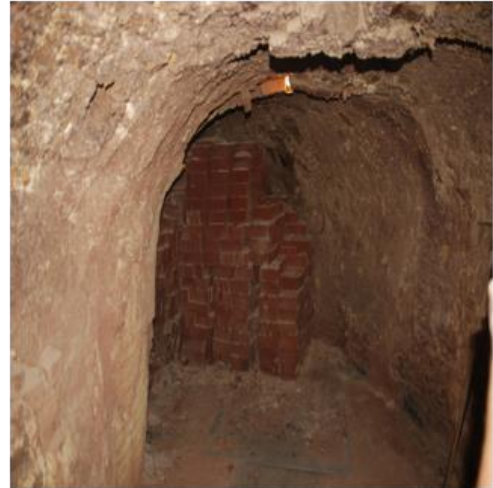
Picture 4

The fired, cooled bricks in the ring kiln.

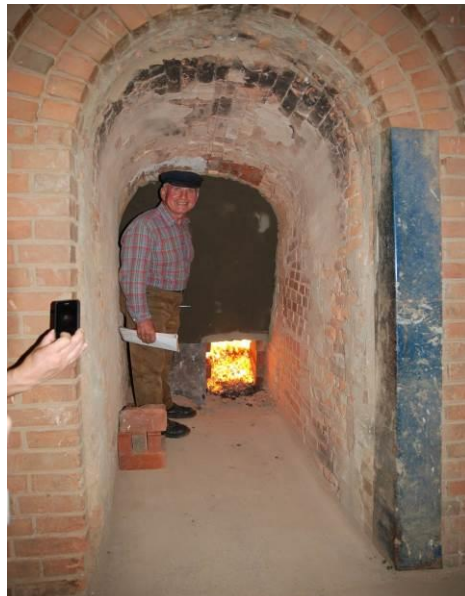
Picture 5

The lateral access to the kiln furnace, walled off, with open fire door.

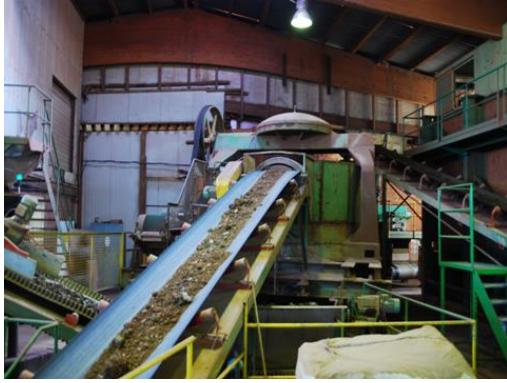
Picture 8

Transportation of the raw material to the mixer.

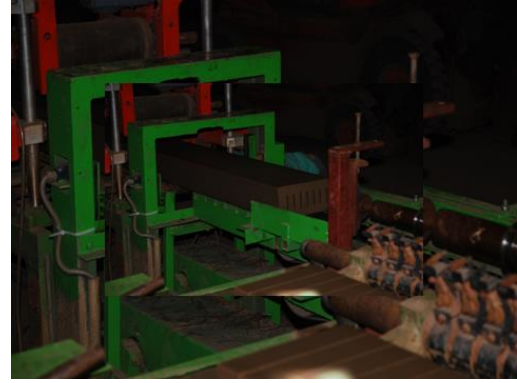
Picture 9

The extruded mass after leaving the extruder on its way to the wire cutting machine.

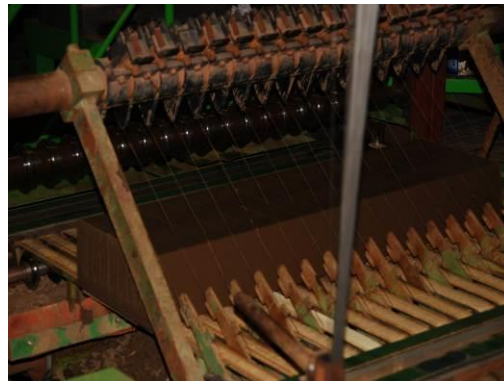
Picture 10

The cutting of the raw brick is done by a wire cutter so that the raw brick now has its form. Through shrinkage during the drying process and during the firing process the "raw size" of the bricks is reduced to its final dimensions

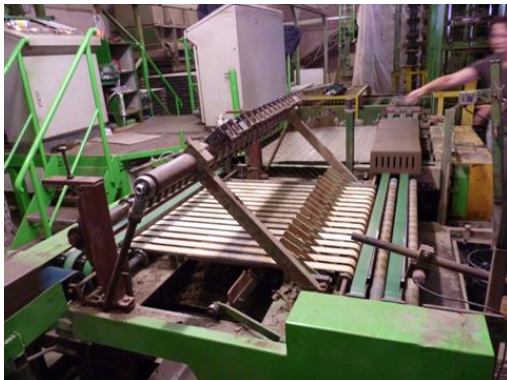
Picture 11

The cut brick train on the way to pre-drying.

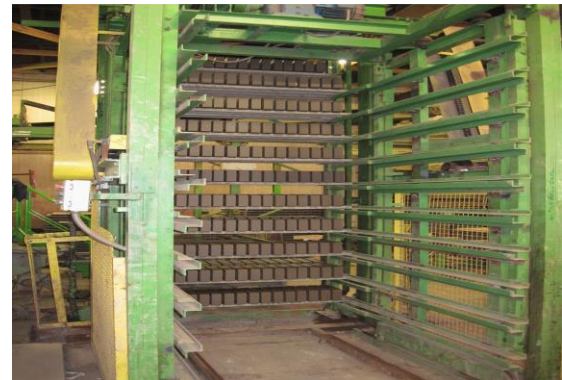
Picture 12

The "staggered" raw bricks in pre-drying.

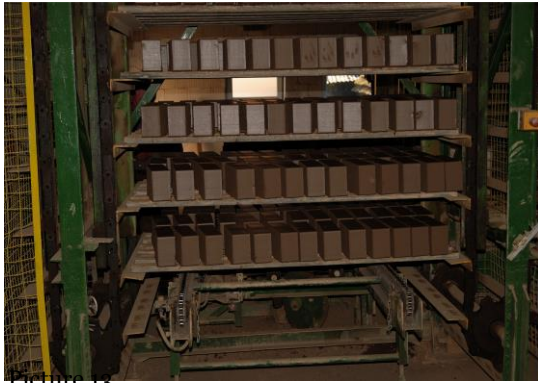
Picture 13

The filled pre-drying chamber.

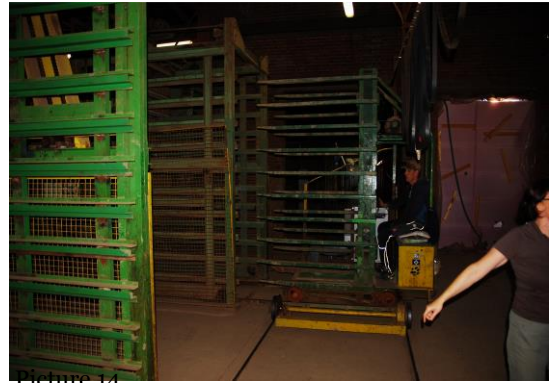
Picture 14

The removal of the raw bricks to the drying chamber.

Overall, the raw bricks remain in dry areas for about a week in order to ensure crack-free shrinkage through slow drying (higher use of energy).

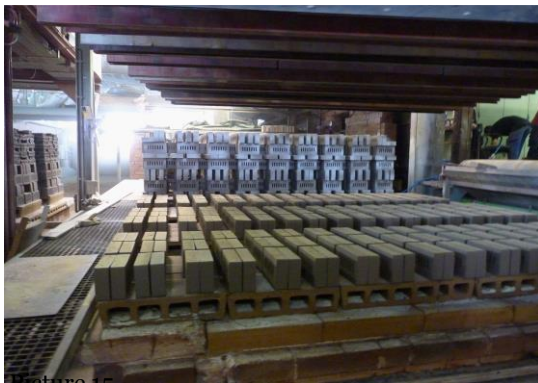
Picture 15

Raw bricks stacked on the "kiln car" on the way to the kiln.

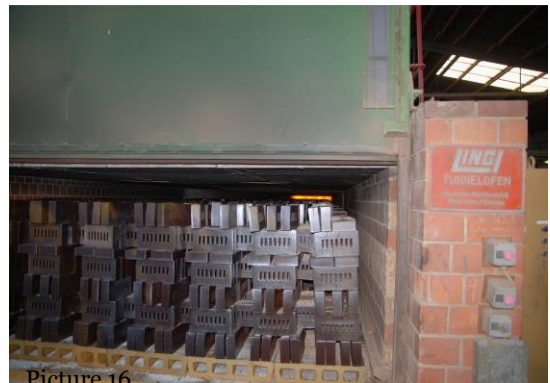
Picture 16

The bricks after firing when exiting the kiln.

This brick cooling process also needs time and the heat of the kiln. Only slow cooling, by slowly rolling the bricks out of the combustion chamber, prevents cracking.

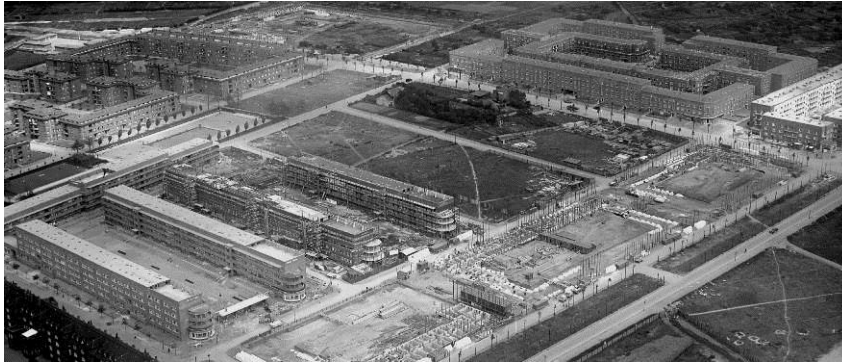
Picture 19

The construction site of the Frankschen Laubenganghäuser (portico-style) on the Dulsberg, at the end of the 1920s, example of the level of construction at the time. The northern quadrant is not yet completed, the two eastern quadrants in the north-south direction are not yet underway.

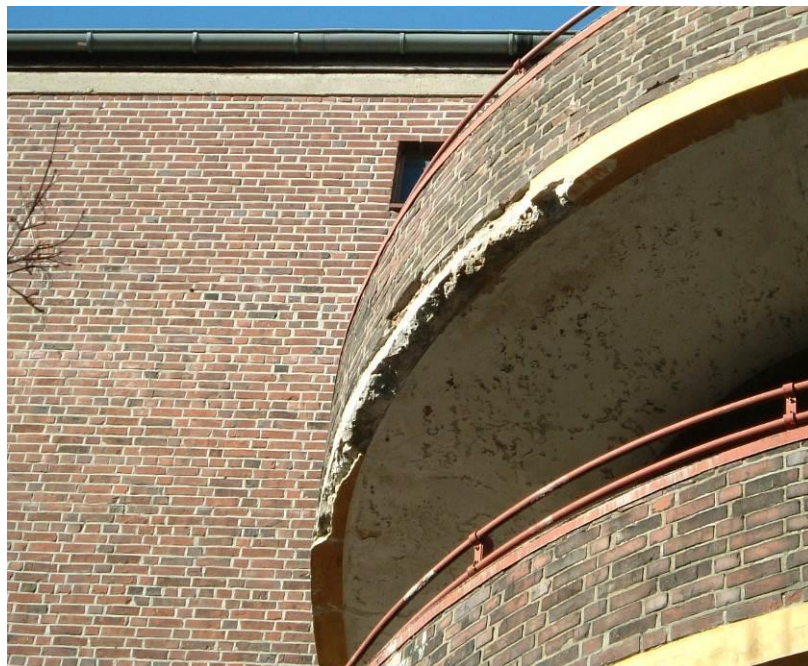
Picture 22

Detail of the edge of a circular balcony.

The mortar layer over the bent steel girder of the substructure burst repeatedly due to the thermally induced length changes. Bricks in the border area therefore fall off.

Permanent restoration is not possible.

Due to thermal action, the steel elements and the plaster covering in the facade construction expand differently, resulting in the separation of the two materials. This thermal behaviour is clearly shown in the following images.

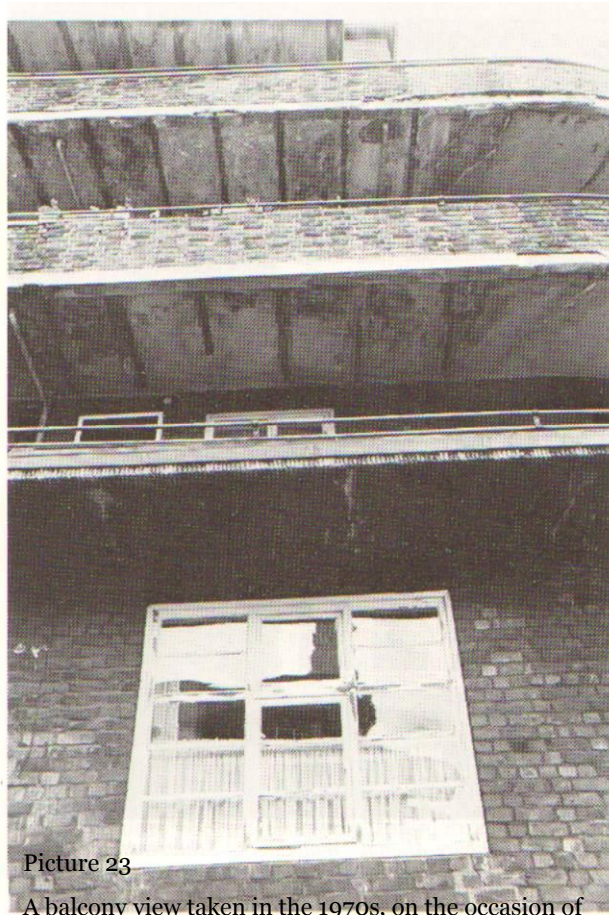
Picture 23

A balcony view taken in the 1970s, on the occasion of a lecture by former Department Director Prof. Fischer.

The support system is clearly visible on the underside of the balcony; the plaster covering has fallen off.

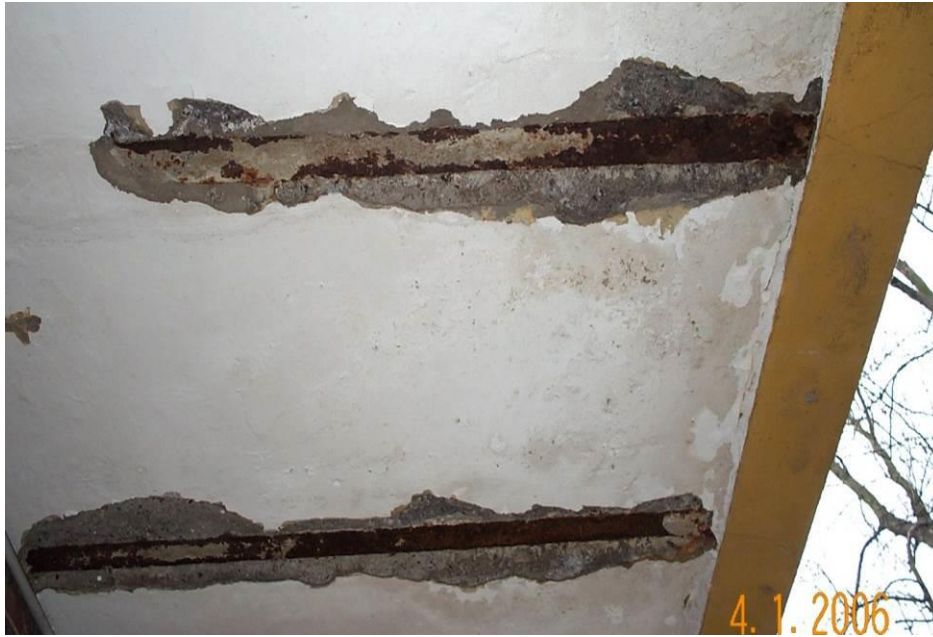
Picture 24

A balcony view taken in 2006, by A. Schett, with the same damage pattern.

- The steel support layer is clearly visible.
- The plaster layer has fallen off.
- The damage is recurring.
- Permanent restoration is not possible.

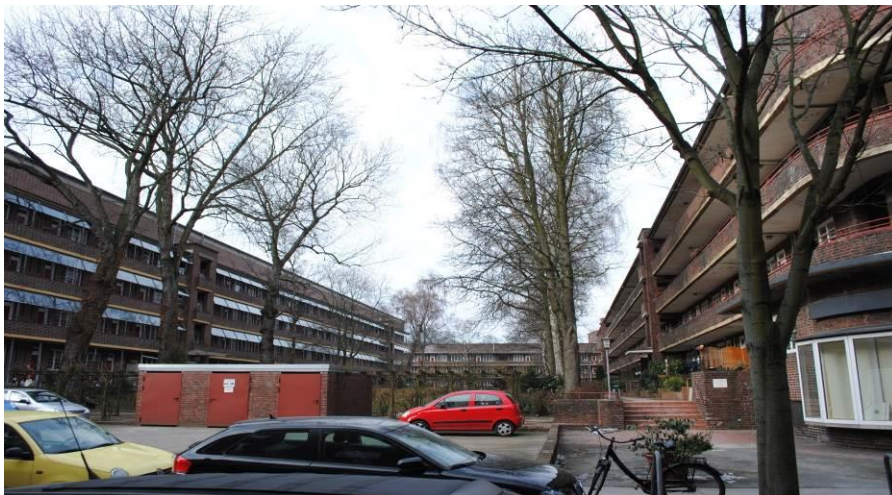
Picture 25

Left: The "water deflector" attached to the balconies. Because loads for the structure were exceeded through the attachment of the water deflector, an additional load-bearing system of steel supports (10/10) were introduced to cope with the load transfer.

There was no doubt about the analysis of the damage pattern; through the use of auxiliary structures, to reinforce what was there and enable ordered water management. The facade was given a new "water management layer" (composite heat insulation system with a clinker brick appearance), the balconies got "water deflectors", the circular balconies were closed-in with fenestration to prevent large amounts of precipitation from entering the structure. The following pictures show these individual measures.

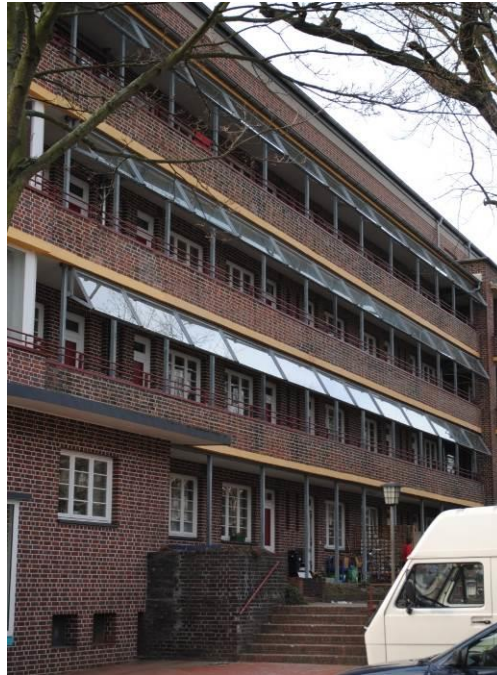
Picture 26

The first variation in the construction of the auxiliary water deflectors. The load is transferred vertically toward the ground with 10cm x10cm hollow steel pillars.

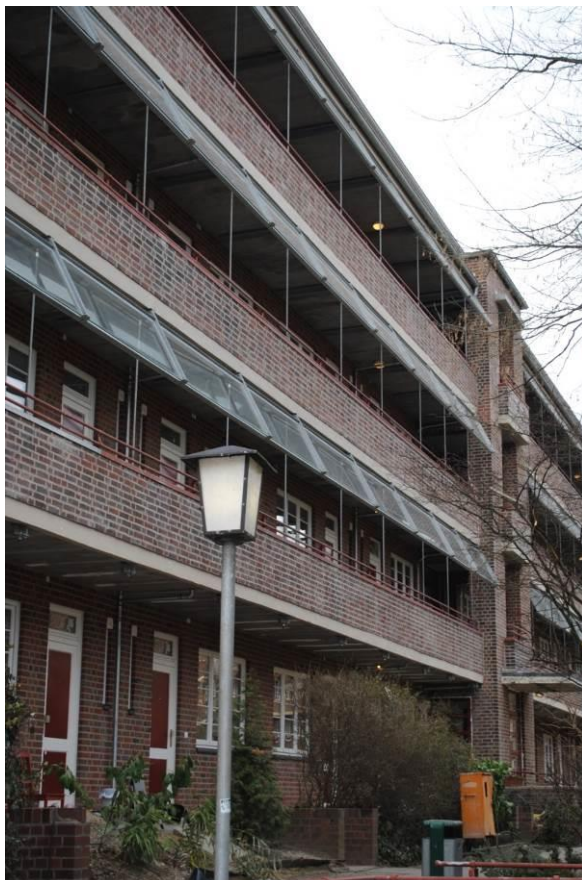
Picture 27

The second variation in the construction of the auxiliary water deflectors.

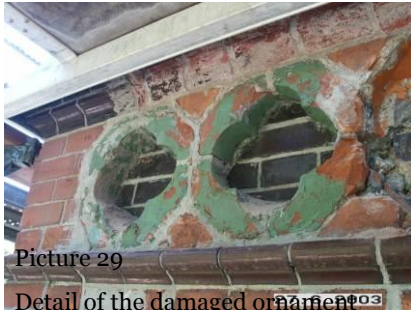
Picture 29

Detail of the damaged ornament below the cornice. The form stones were originally green with a glazed surface. The form stones of the cornice above are also damaged by frost.

Water penetrates into the joint areas, the non-evaporated moisture leads to frost-shattering and thus to the destruction of the water-repellent surface.

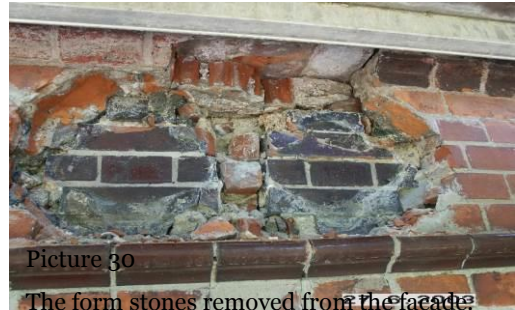
Picture 30

The form stones removed from the facade.

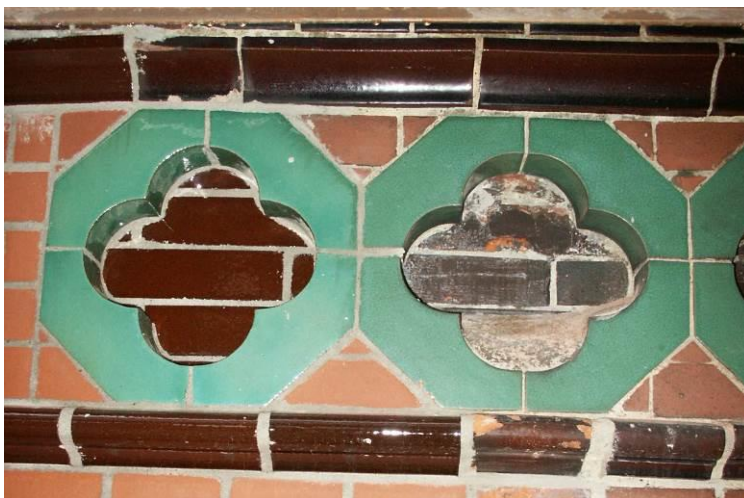
Picture 31

The newly burned stones, replaced into the facade. This is how it looked originally (surface/colour/size).

Applying a second water-bearing layer on the facade was rejected for reasons of heritage preservation. Therefore, all the damaged bricks, stones, etc., which had lost their technical characteristics (weather resistance), were removed from the facade, and replaced by bricks with similar properties. In the case of the natural stone elements, repair was no longer possible, replacement too expensive, so they were covered with a copper coat and remained at the location.

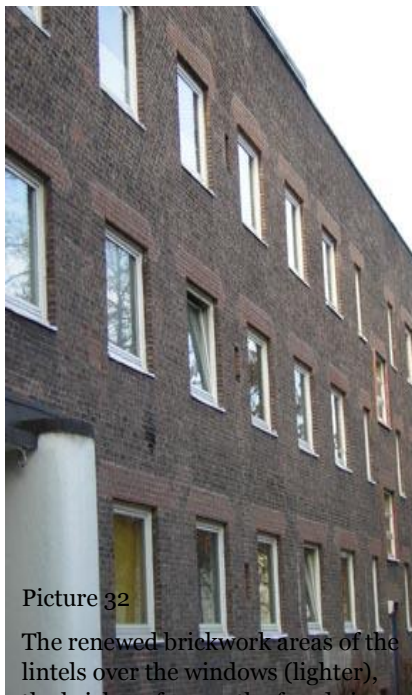
Picture 32

The renewed brickwork areas of the lintels over the windows (lighter), the brick surface on the facade is dull.

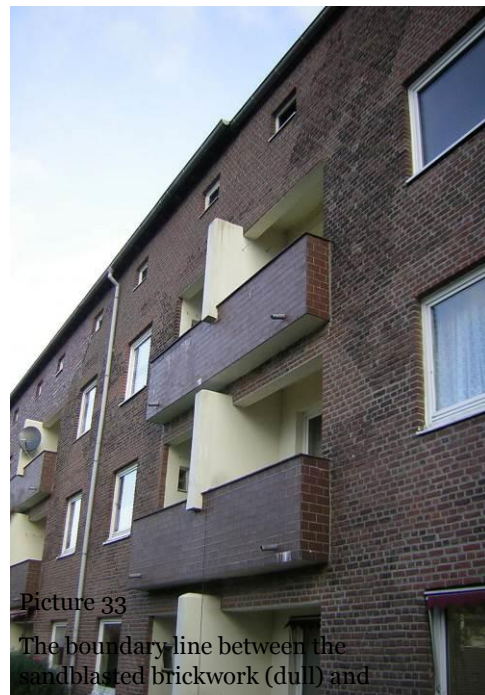
Picture 33

The boundary line between the sandblasted brickwork (dull) and untouched brickwork (glossy) in the upper left corner.

Through the application of hard blasting on the brickwork, the burned skin of the bricks was destroyed, the capillaries of the bricks made open for the absorption of water, which then enables water to be transported from the external side of the facade to the interior room side.

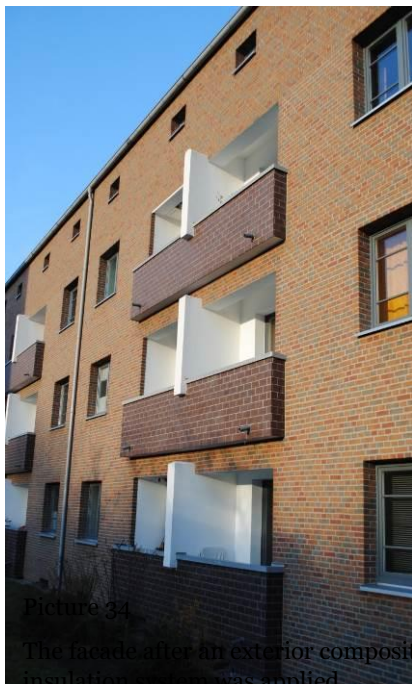
Picture 34
The facade after an exterior composite heat insulation system was applied.

In the end, only a second functional water-bearing layer in the form of a composite heat insulation system could be applied, the insulation carried out simultaneously was a "by-product".

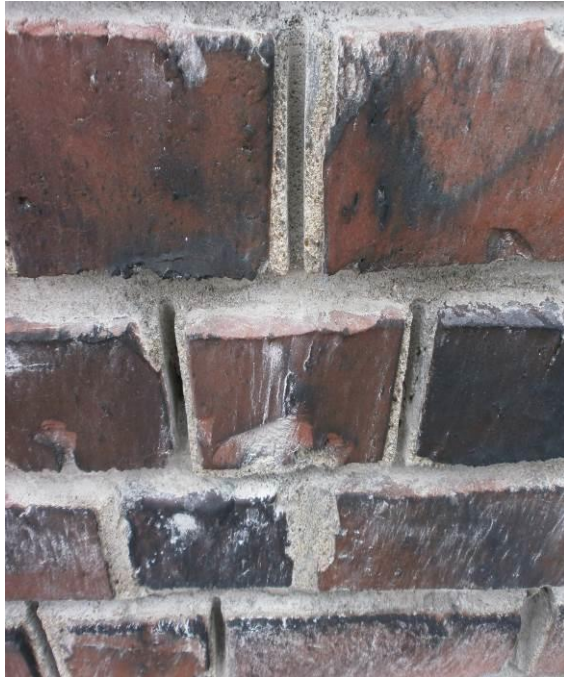
Picture 37

An almost correct opening of the joints
(few edge trims).

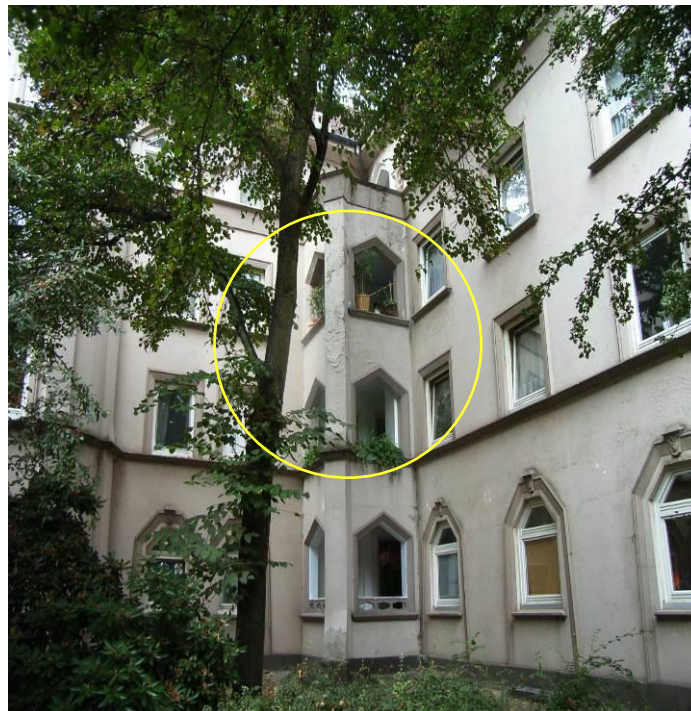
Picture 38

An example of penetration of rain water behind the paint layer (second floor).

These coating systems become brittle over time, cracks in the system are the result. Precipitation water can penetrate the cracks, which in turn can lead to the formation of water-saturated pockets, which in turn leads to water penetration of the wall construction from outside!

Thus, the moisture enters the interior walls, mould growth can be the result. In our example, the damage location, the internal damage pattern, can be traced to the external damage type.

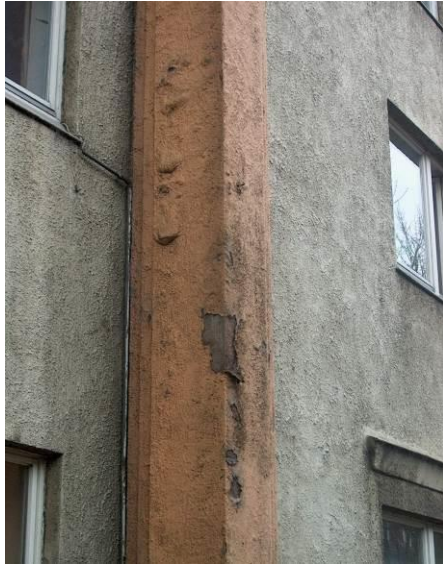
Picture 39

The formation of a saturated area and water pockets which have already burst on the dark painted pilaster.

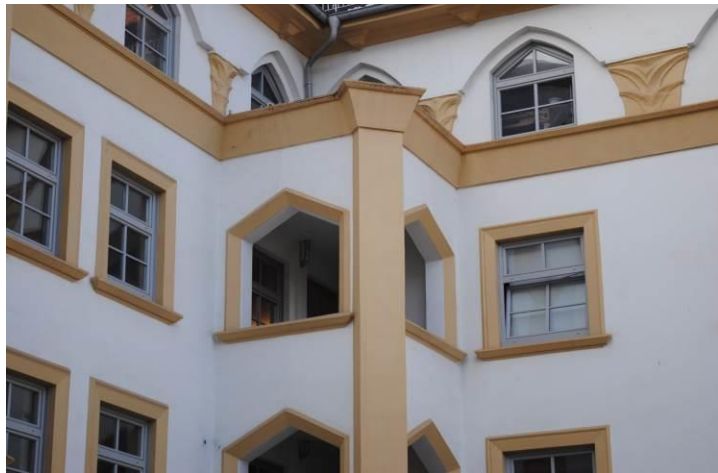
Picture 40

The building after renovation. The facade was stripped, a mineral paint applied, the colour of the facade was restored after research which found the original colour.

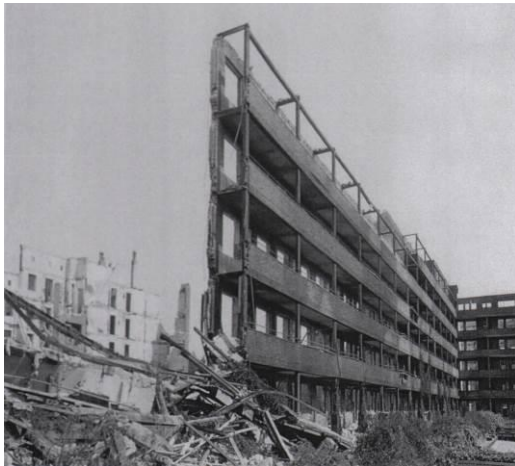
Picture 41

The porticos on the courtyard side of the building complex Heidhörn.

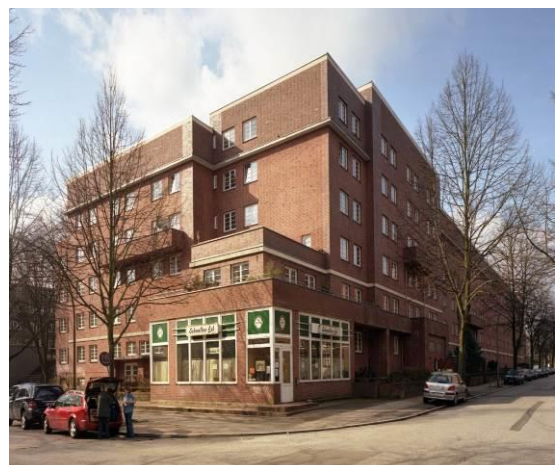
Picture 42

Afterwards: the reconstructed building with the same dimensions and same shape as before its destruction. The portico was preserved and reintegrated into the restoration concept. It still serves today as an integral

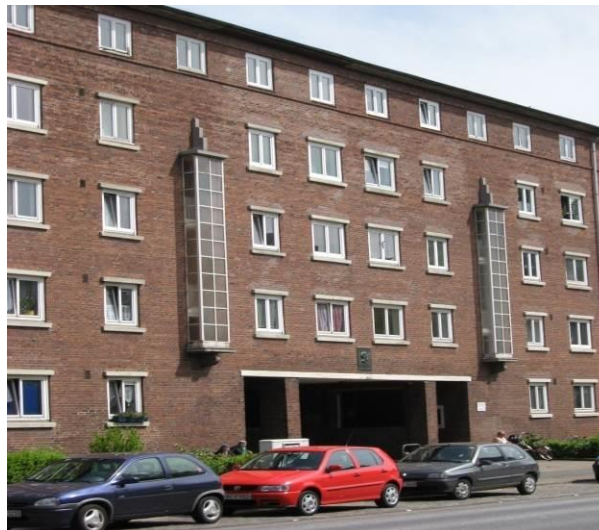
Picture 43

The facade before renovation with a composite heat insulation system. Clearly visible through the different colour of the bricks over the lintels, are the window supports which were almost completely replaced.

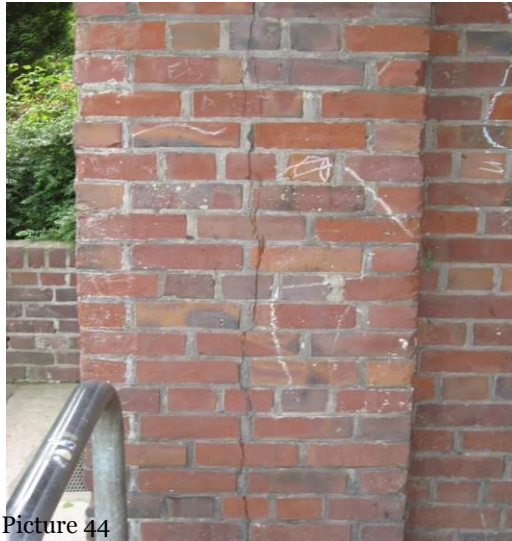
Picture 44

Crack in the pillar at the entrance; the stress fracture could probably be due to the effects of war.

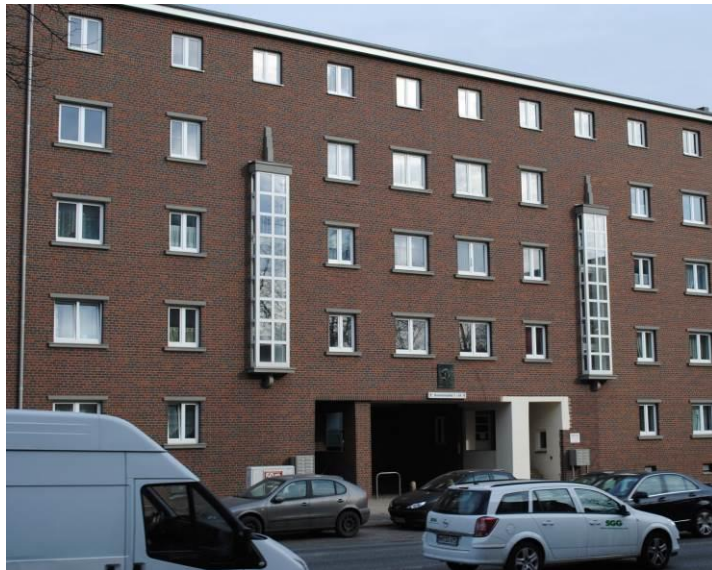
Picture 45

The facade after renovation with a composite heat insulation system.

The changed surface is clearly visible.

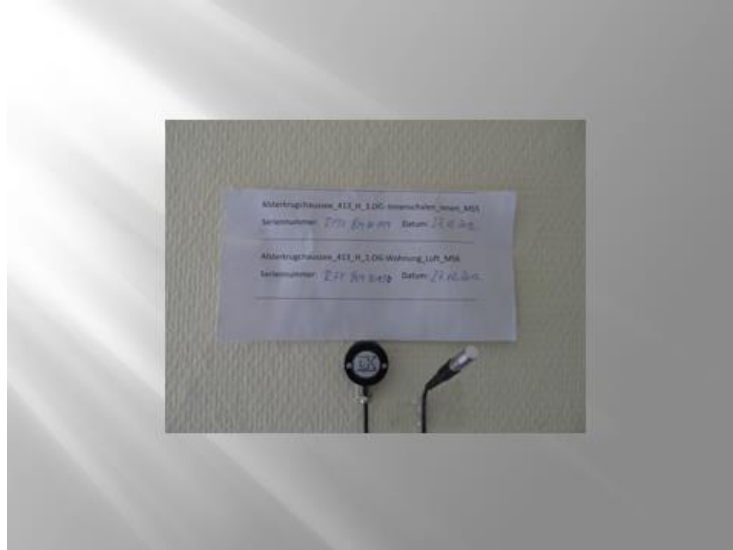
Picture 48

A humidity and a temperature sensor.

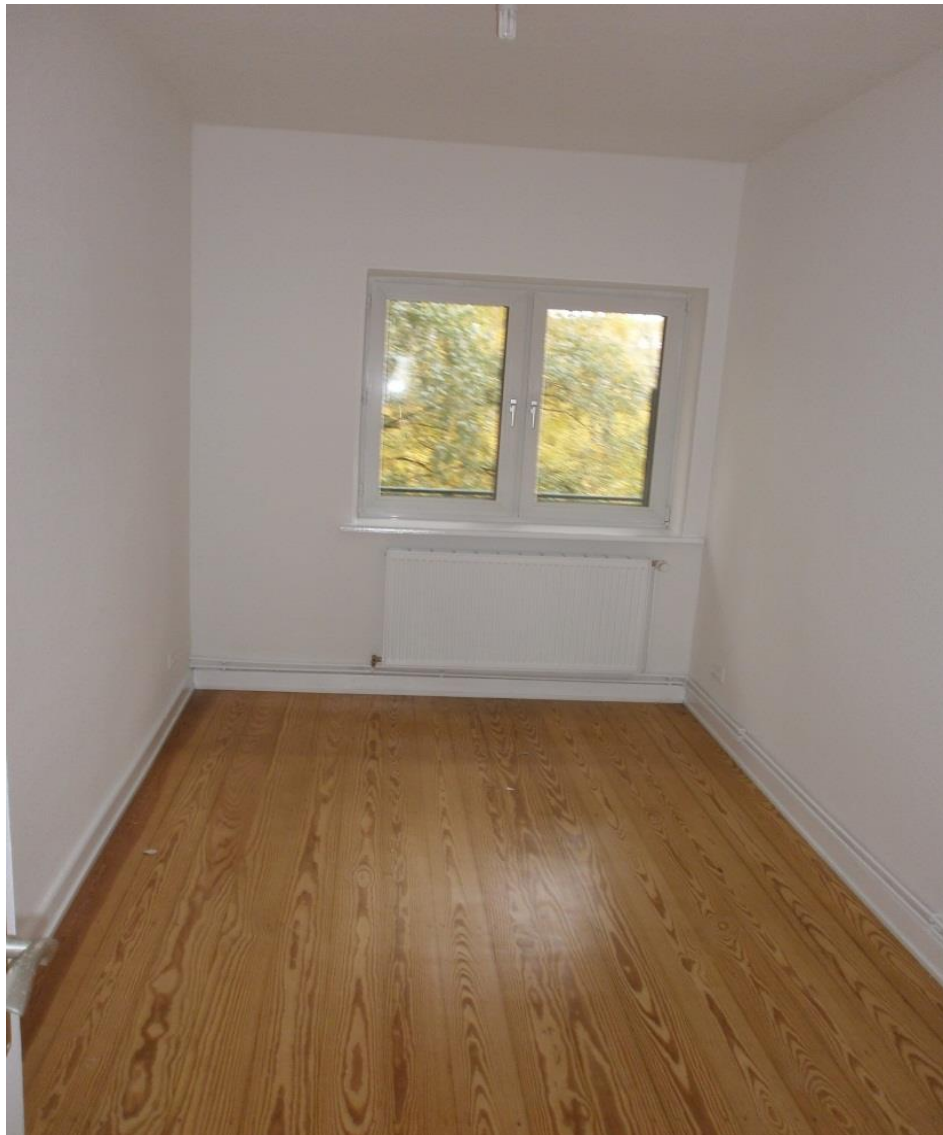
Picture 55

A room in the apartment with a flat panel radiator (air heating) on the inside of the outside wall after renovation.

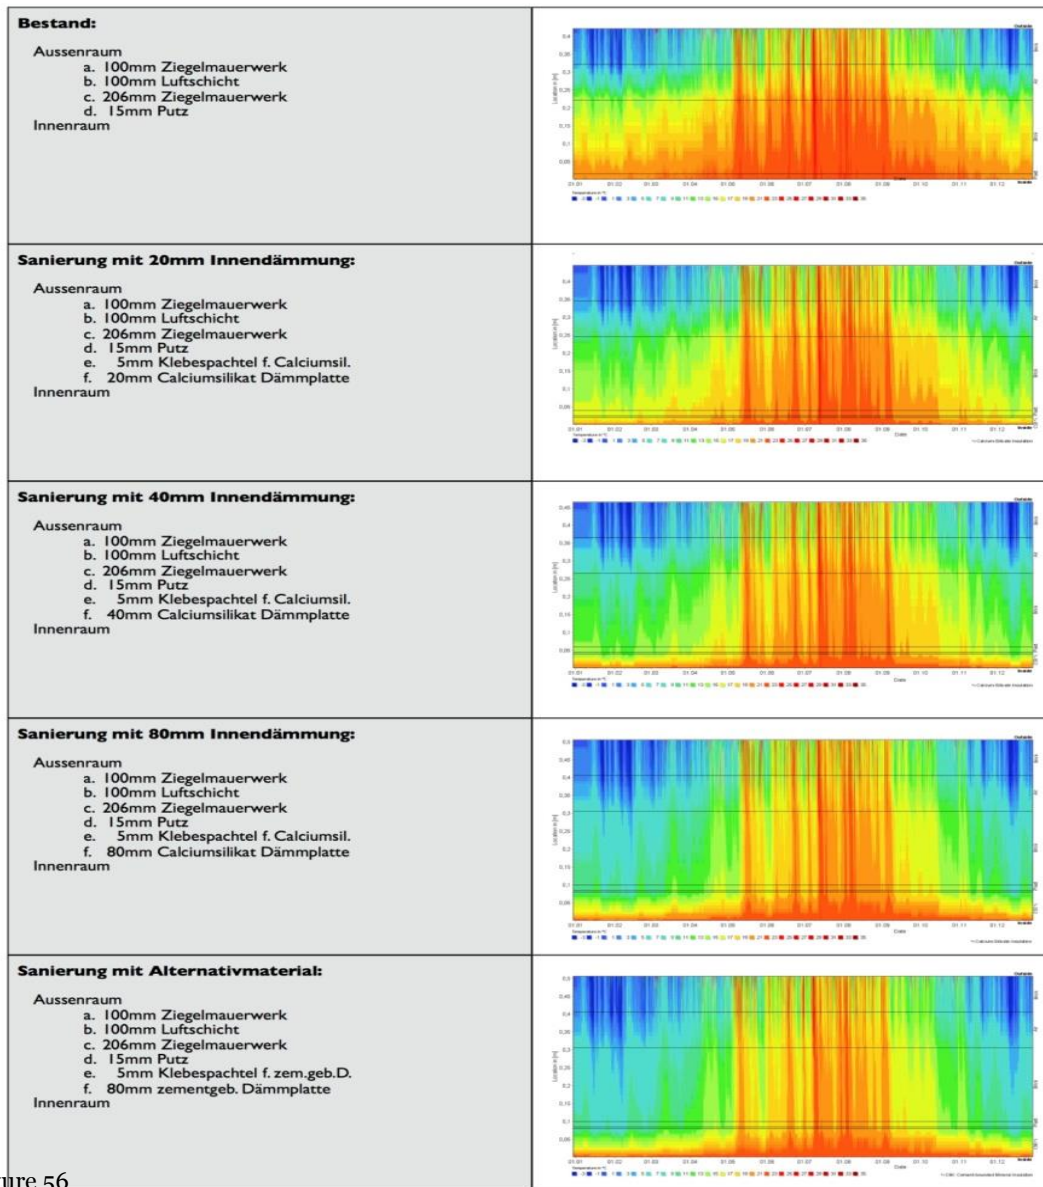
The graph shows, from top to bottom:

1. Graph: uninsulated object
- 2, 3, and 4. Graph: internal insulation with calcium-silicate insulation panel
5. Graph: cemented insulation panel

The facts are displayed graphically below in pictures 56 and 57 (Page 58 and 60).

Moisture penetration/drying – surface temperature, wall cross-section temperature as related to thickness of insulation (see Picture 56 below)

In the graph above (of the non-insulated object) the depth of heat penetration of the wall cross-section during the heating period is clearly distinguishable (red/high temperature to blue/low temperature). Starting at 20mm internal insulation, the energy input into the structure declines; from an insulation thickness of 40mm, an optimum insulation thickness is, in this case, achieved. The temperature distribution on the room-side surface is uniformly high, the heating of the wall cross-section is significantly reduced (relative to the non-insulated version), the frost-hazard area is limited to the outer leaf, the doubling of the insulation thickness to 80mm does not cause a significant improvement in the temperature characteristics, however in contrast results in that the frost-hazard area extends to the inner supporting leaf.

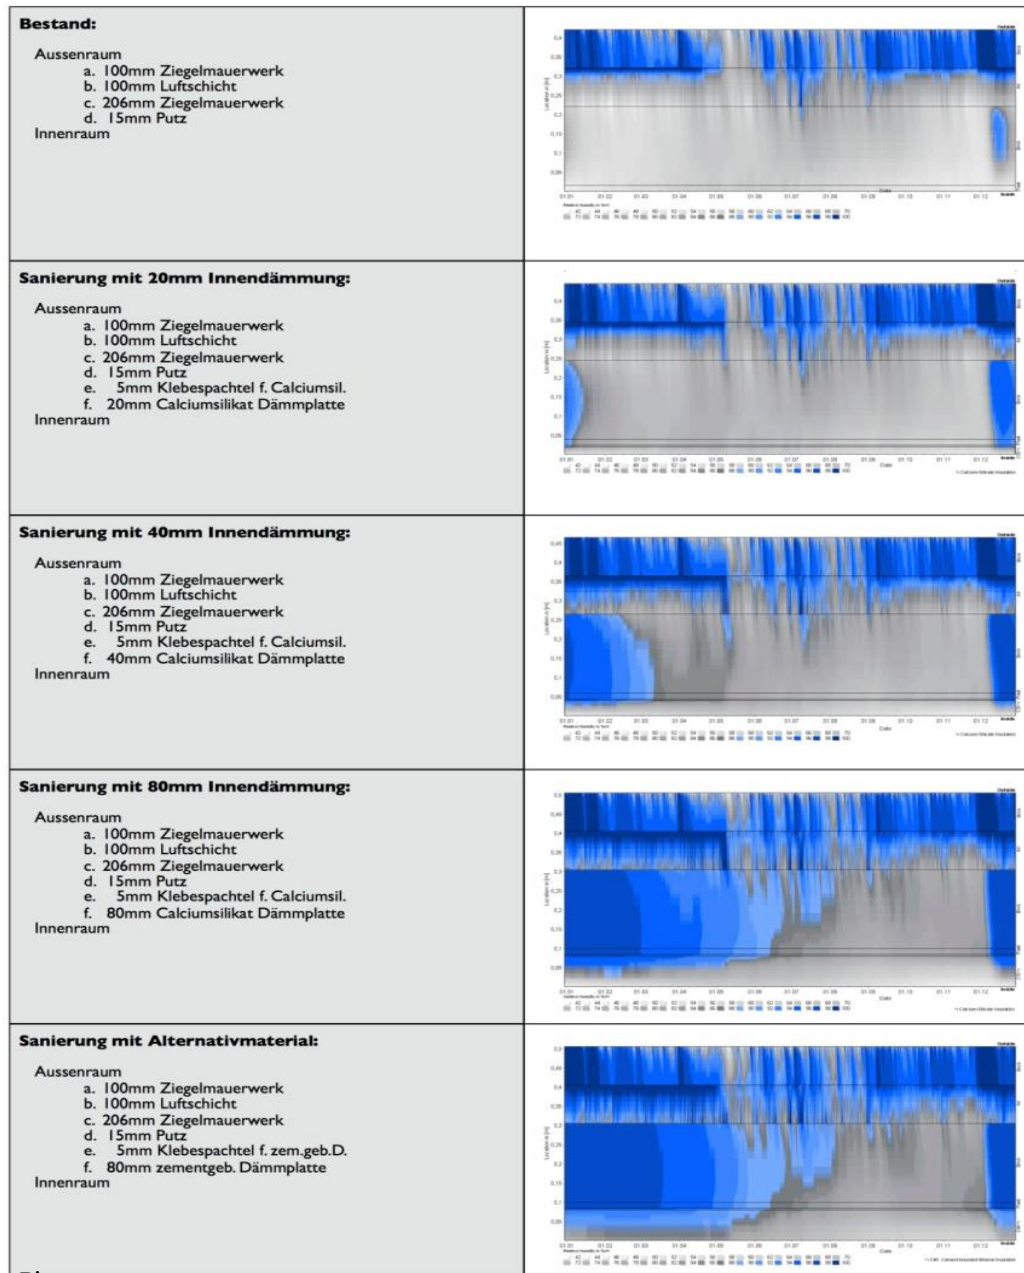
The graph shows, from top to bottom:

1. Graph: uninsulated object
- 2, 3, and 4. Graph: internal insulation with calcium-silicate insulation panel
5. Graph: cemented insulation panel

The moisture penetration and drying properties of the wall cross-section, depending on the insulation thickness.

Moisture penetration/drying – surface temperature, wall cross-section temperature as related to thickness of insulation (see Picture 57 below)

It is clear to see in the non-insulated version (top image) that the inner leaf always dries to a damage free moisture level. The outer, water-bearing leaf, moisturises without damage to the supporting structure.

From 40mm of insulation thickness, the process of moisture penetration of the inner leaf continues further until March. The remaining period for drying out is sufficient to ensure damage-free drying of the inner leaf.

From 80mm of insulation thickness, the process of moisture penetration of both leafs is so significant that the time allowed for drying is no longer sufficient to ensure damage-free drying of the inner leaf.

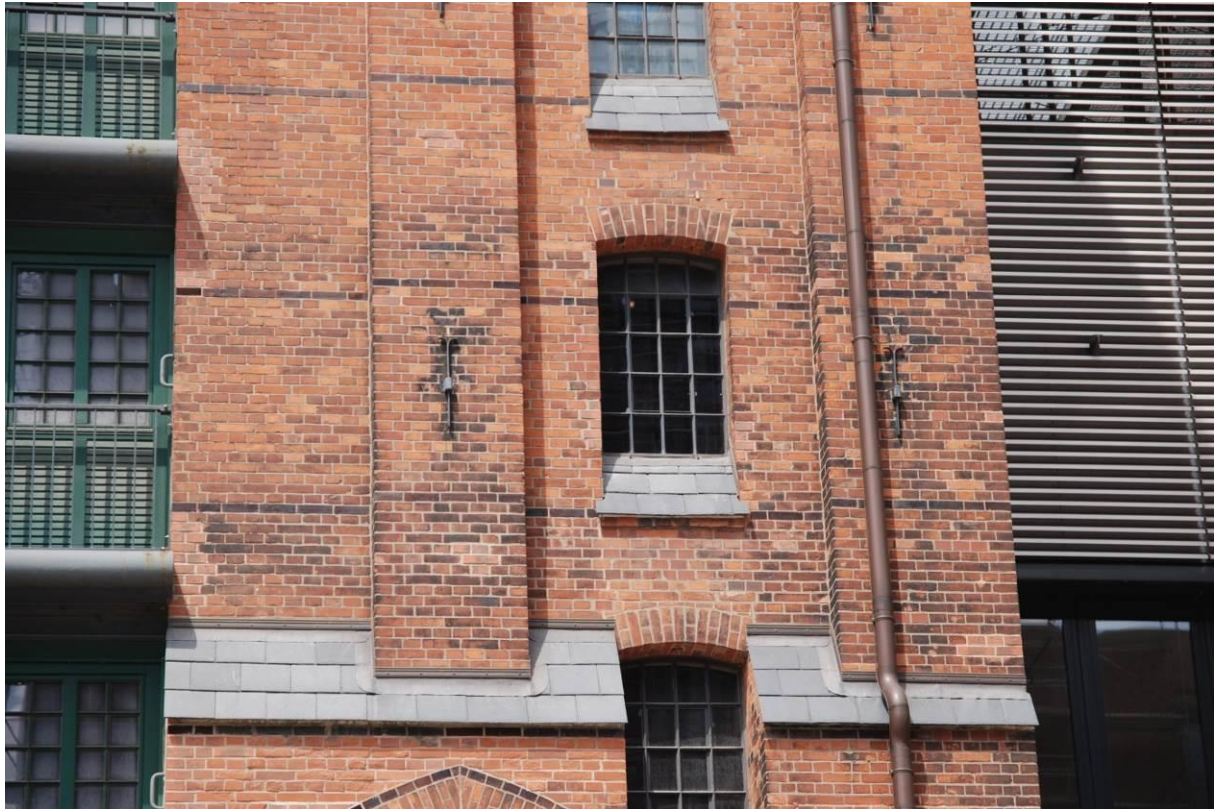
Picture 59

A window and masonry detail after renovation. The cleaning "preserves" the history of the facade.

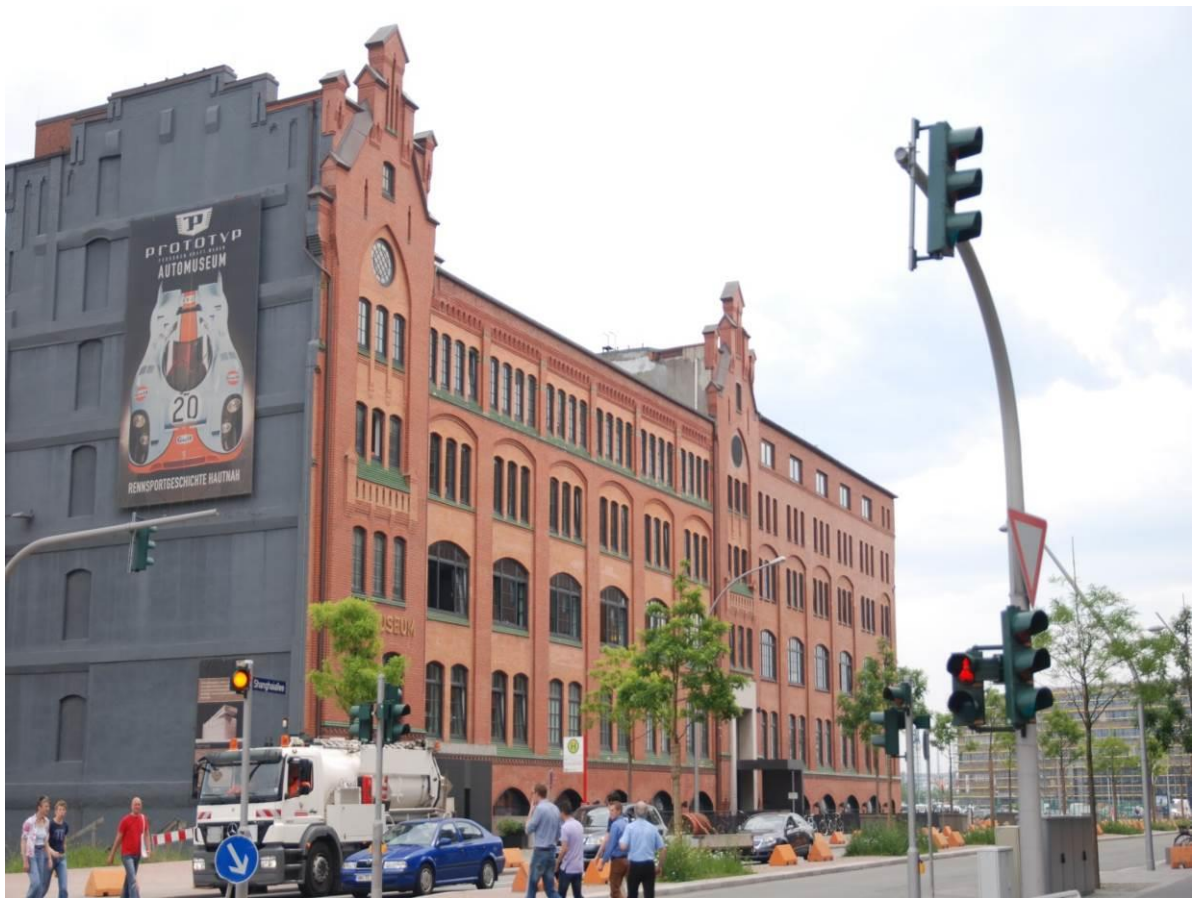
Picture 60

The former factory building (1902 to 1908) which is now the Prototype Museum at Lohseplatz. The facade was cleaned almost simultaneously as that of the Maritime Museum. As can be clearly seen, the cleaning level was set too high. After the renovation, the building gives the impression of a "new building".

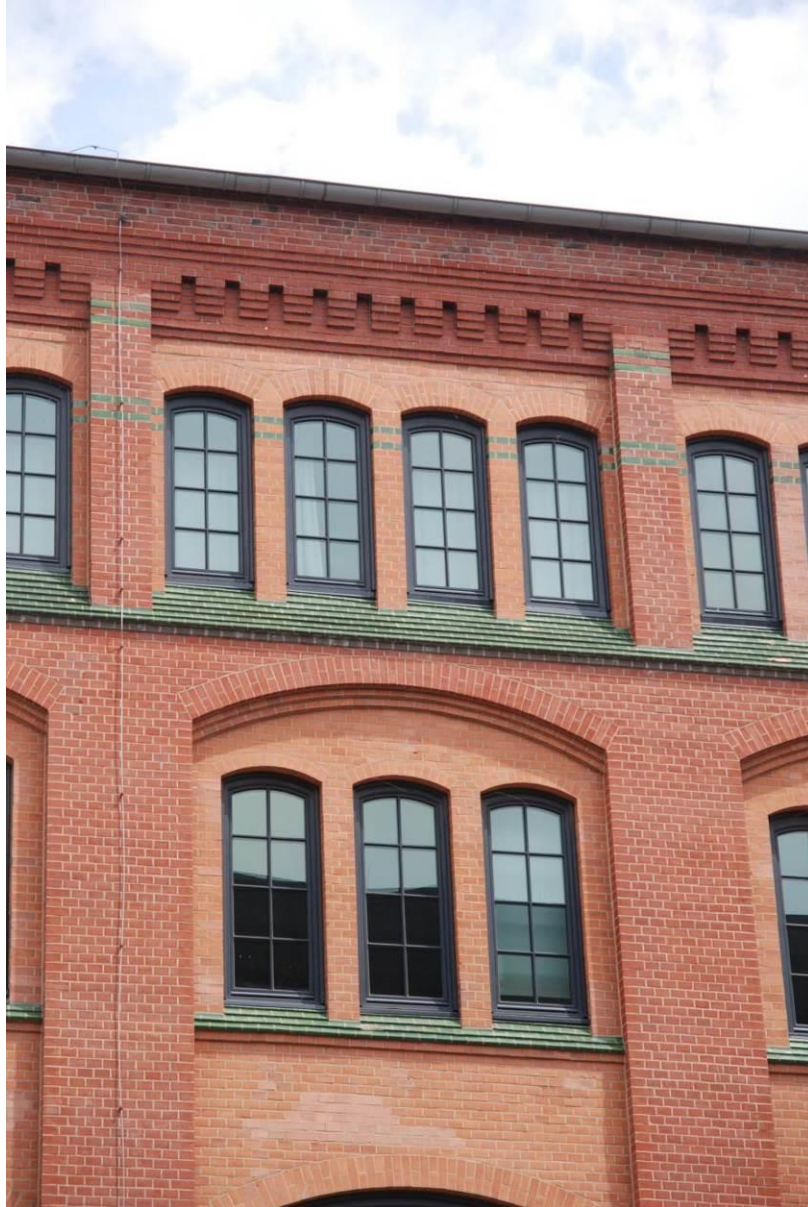
Picture 61

A window and masonry detail after cleaning. The facade gives the impression of a "new building". The small masonry repair under the windows, which was carried out in former times, has the appearance of "forgotten work". The cleaning "destroyed" the history of the facade.

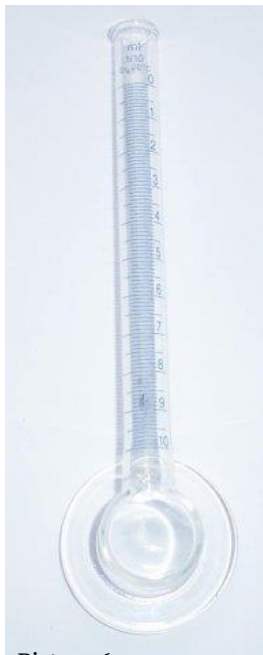
Picture 62

Water penetration test
tube (aka
Karstensch's
Röhrechen).

Should moisture penetration occur on the interior in brickwork buildings, the relationship between water penetration into the facade (rain) and water migration through the outer wall is easy to ascertain. Simple test methods, such as the placement of a water penetration test tube, deliver fast results, whether the brick or the joint are the causes of damage.

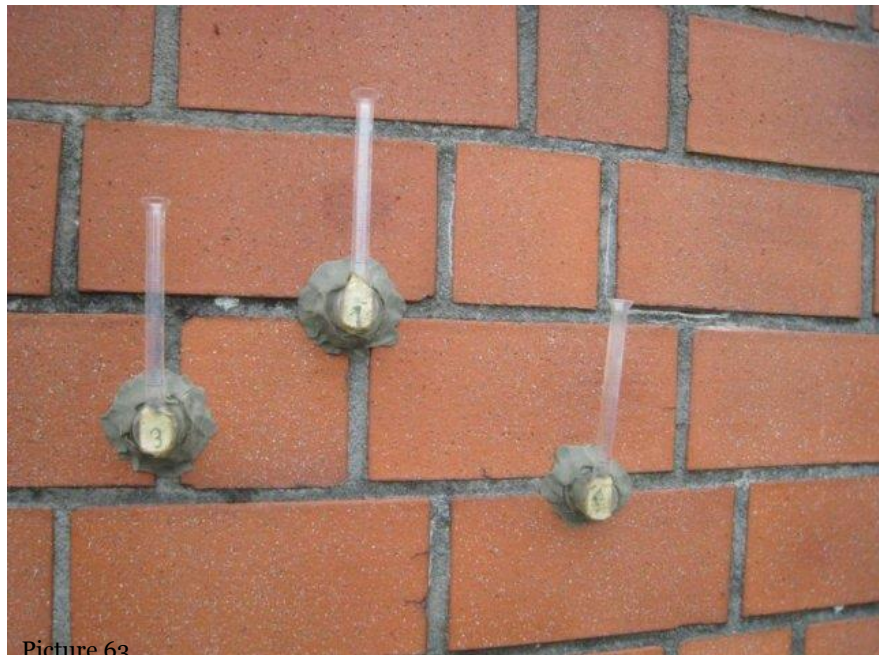
Picture 63

Water penetration test.

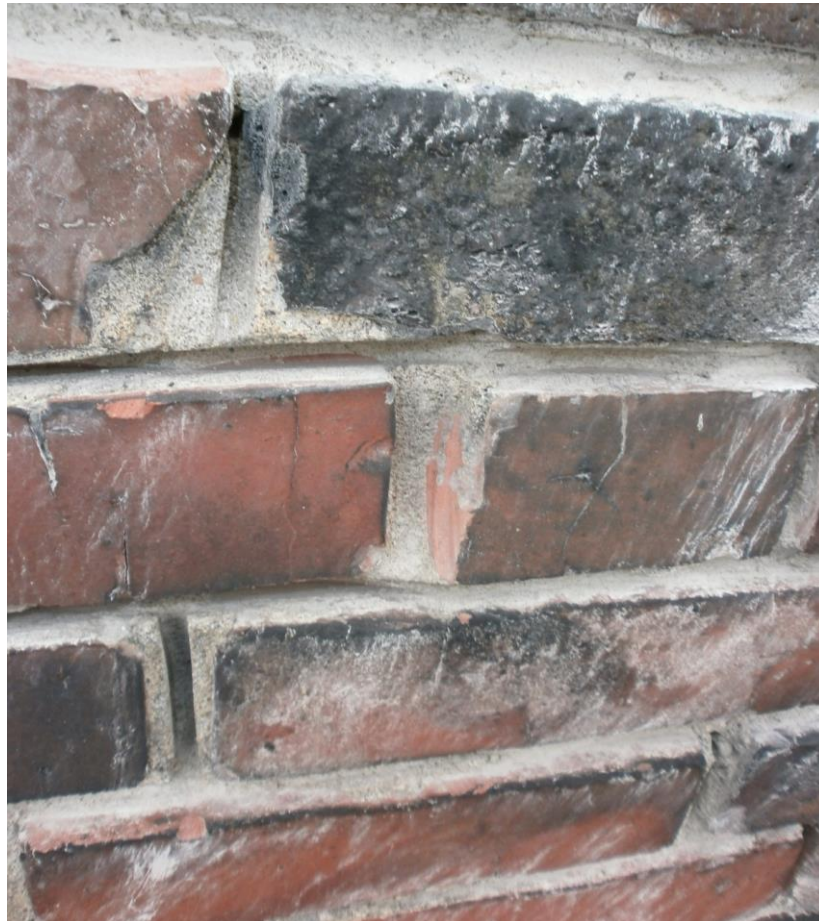
Picture 36

As can clearly be seen, not just a relief cut was made in the centre of the joint. The edges of the bricks were "trimmed" in the set and horizontal joint area.

of the joint cutter blade, brick edges of the surrounding bricks are trimmed in the area of the set and horizontal joint (Picture 36).

Even with a technically correct opening of the joint with a cutter, the first cut to relax the joint is not in the centre, in order to remove the excess mortar from the brick edges without damage, but rather at the brick edges (Picture 36).
